# **BASILDON TOWN CENTRE HIGHWAYS IMPROVEMENTS**

## **COMBINED STAGE 3 & 4 ROAD SAFETY AUDIT**

| Road Safety Audit Register Number: | 9286 |

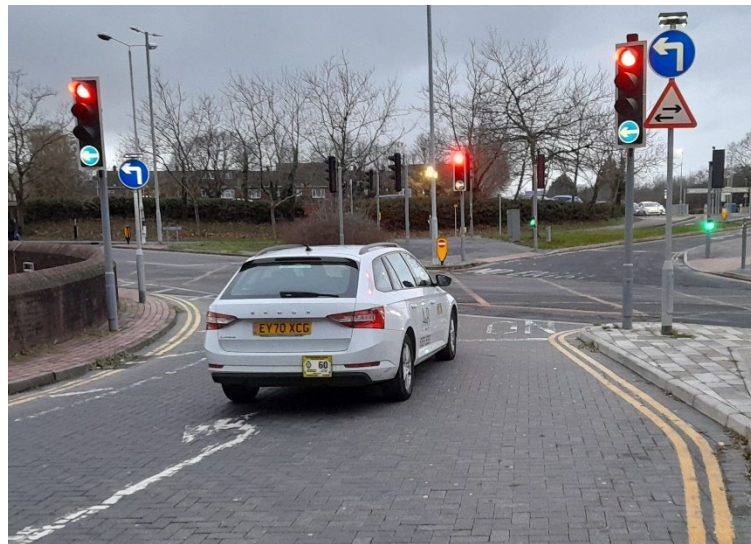
During the Stage 3-4 site visit it was noted that there are several 'Turn Left' regulatory signs and carriageway marking to direct road users. However, at the time of the site visit, the vehicle in the image below was observed turning right into Station Way. It is recommended that this issue is monitored and remedial / enforcement actions taken as appropriate.

Agree: The image shown above and the review at RSA3 are referring to a different location to the comments in RSA 1 location D11. The image above is at location D8. However, both locations have clear signage and physical measures implemented (kerb line changes) . Due to the width of the station way carriageway, it is impossible to stop cars (Taxis) from making right turns without a central median or barrier. The situation should be monitored and if instances persist, camera enforcement could be considered.

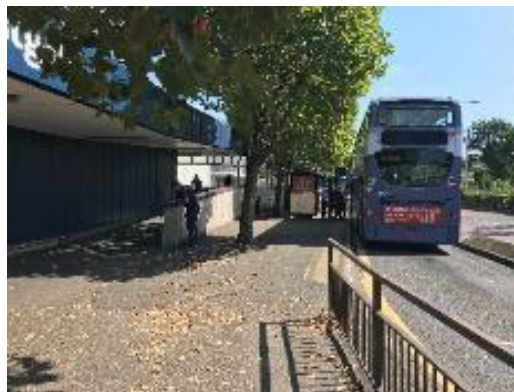
Summary: Risk of pedestrians colliding with trees and bus shelter due to the restriction of width.

The proposals include the relocation of the existing bus stop, approximately 40m to the east, without removing the existing bus layby. This issue has been identified in Problem 6.1 above. However, no indication has been submitted with regard to the landscaping proposals and whether the shelter will be relocated. Consequently, it is not clear if there would be sufficient footway width remaining. If the footway width is insufficient, then there is a risk of pedestrians colliding with the trees and shelter, where injuries may occur. Image No. 1

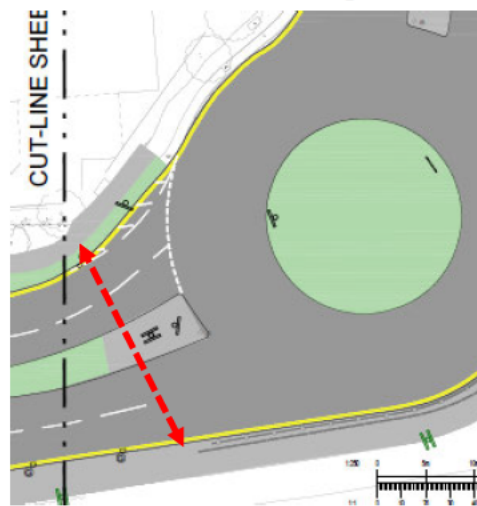
Image No.2

Summary: Risk of pedestrians colliding with road users due to no pedestrian crossing.

The existing highway layout includes pedestrian guardrail on the northern and southern footways of Southernhay, as well as along the central reserve of the dual carriageway. During the site visit the Audit Team observed a number of pedestrians crossing Southernhay by climbing over the pedestrian guardrail from the north side to gain access to the south side, as indicated by the brown arrow in Image No.2. This increases the potential for pedestrians to collide with road users who may be entering or leaving the roundabout, particularly as drivers would have their attention drawn to the roundabout and other traffic using it, especially when observing the access to the ASDA superstore.

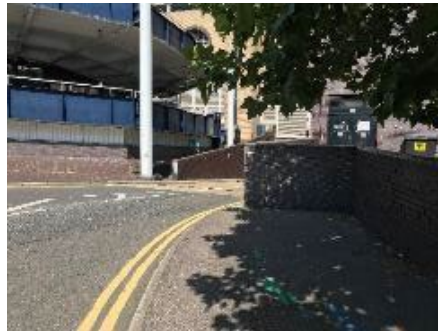
Summary: Risk of collisions between vehicles exiting Eastgate shopping area and pedestrians due to a lack of visibility

The site visit revealed that pedestrians would have difficulty in seeing any vehicles exiting the access to the delivery area Eastgate shopping centre and vice versa due to the lack of visibility, as can be seen in Image No.3 above. There are no proposals to amend the existing kerb line on the eastern side, which adds to the problem of a lack of visibility. There is a potential for collisions to occur between vehicles exiting the area and pedestrians who are crossing or standing in the carriageway in order to achieve a line of sight. This may result in pedestrian injuries.

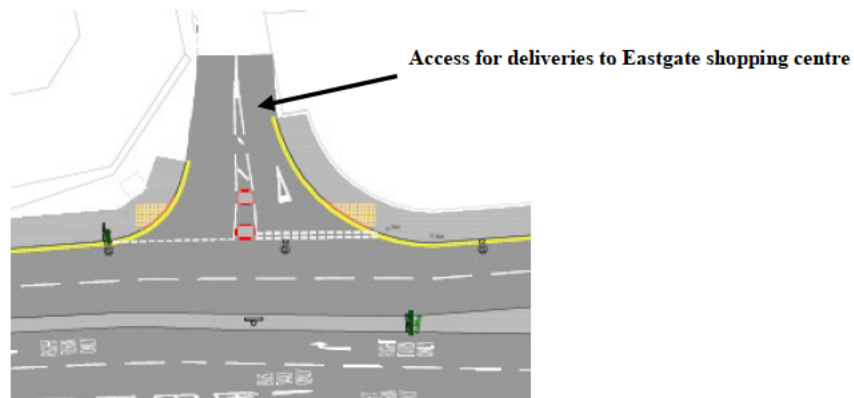
Image No.4

Summary: Risk of collisions between vehicles and partially sighted pedestrians due to no tactile paving guidance.

The drawing submitted for audit proposes two traffic islands where pedestrians may wait for traffic to access the Eastgate shopping area. These islands would form a safe haven for crossing pedestrians. However, no tactile paving is proposed between the two traffic islands. This would be a particular issue for partially sighted pedestrians who would be following the orientation that the tactile paving either side of the junction would give them. Partially sighted pedestrians may not be aware of the two traffic islands and may continue through the junction until they reach the opposite side. Consequently, there is a risk of pedestrians colliding with vehicles exiting or entering the delivery access to Eastgate shopping centre, which may result in injuries to pedestrians.

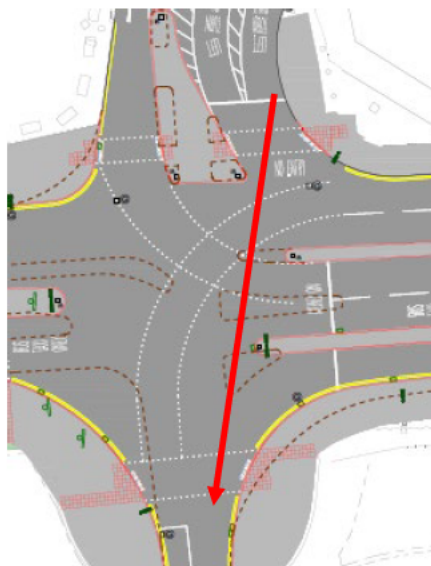
Image No.5

Summary: Risk of vehicle side impact collisions due to vehicles exiting multi-storey car park.

The drawing submitted for audit shows two lanes exiting the multi-storey car park above the Eastgate Shopping Centre. The design suggests that the median strip separating the traffic lanes will be reduced eastwards. The amendments to the junction are as a consequence of the reconfiguring of the junction. However, the reduction of the median separating island provides the potential for vehicles exiting the multi-storey car park to travel across the junction southwards and continue their journey along Clay Hill Road. (The suggested direction of the potential risk is shown by a red arrow). The result of this issue is that there is a risk of vehicle side impact collisions, with the potential of serious injuries occurring or even fatalities.

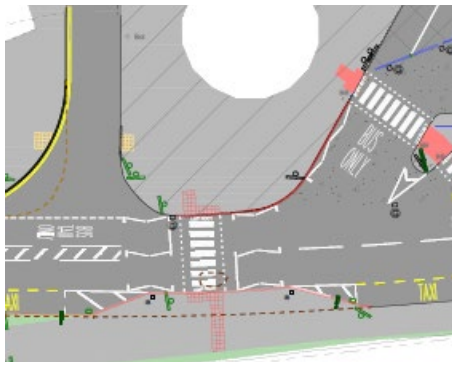
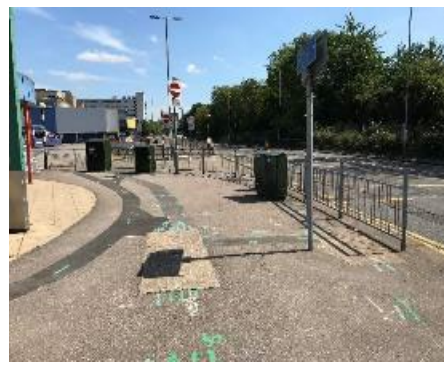
Summary: Risk of collisions between pedestrians and vehicles.

Image No.8, which is an extract from drawing number 14916-100-WIE-ZZ-DR-C-900103 Rev P01, shows a proposed controlled pedestrian crossing point on Southernhay, adjacent to a retail unit called The Barbers Shop. The tactile paving shown in image No.8 illustrates a proposed standard L shaped layout for this facility on the north side of Southernhay. However, the stem of the tactile paving layout is too short for visually impaired pedestrians, who may bypass the tactile unaware of the controlled crossing point available, leading to them cross the road at an inappropriate location, increasing the risk of injury should a collision with a vehicle occur.

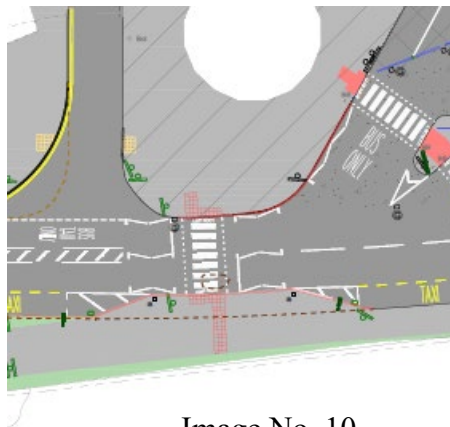
Image No. 10

Summary: Risk of collisions between pedestrians and cyclists due to confusion of shared facilities.

The southern side of the controlled crossing point shown in image 10 above appears to be a shared footway / cycleway facility. Unfortunately, due to a lack of shared use information submitted, it is not clear whether the controlled crossing is meant for pedestrians as well as cyclists. It is assumed due to the tactile paving shown that the crossing facility is meant for pedestrians. This confusion raises the potential for collisions between pedestrians and cyclists, which may result in injuries.

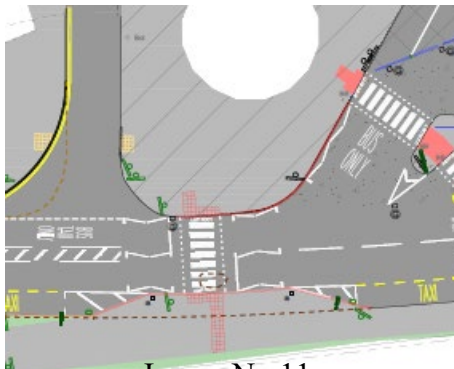
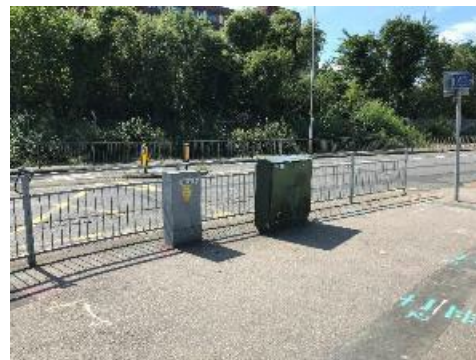
Summary: Risk of pedestrian collisions with Statutory Undertakers Apparatus.  
Statutory Undertakers Apparatus

Image No. 12 above shows two Statutory Undertakers' apparatus cabinets at the approximate location where the controlled pedestrian crossing would be on the north side of South-ernhay. The drawing submitted for audit did not have this equipment shown. If the cabinets were to remain, they may physically obstruct pedestrians using the controlled crossing and/or affect visibility. This situation would be a particular problem for visually impaired pedestrians, and they could quite easily collide with the cabinets, if they were to remain, when using the crossing.

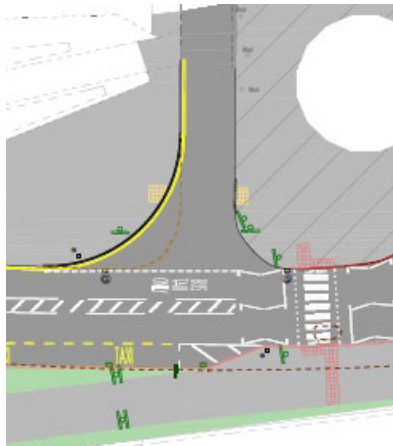
Image No.13

Summary: Risk of vehicle to pedestrian collisions  
Southernhay

The entry radii to Market Pavement is being increased to provide a smoother sweep for vehicles exiting Southernhay. This is likely to increase the speed at which vehicles exit Southernhay, which could increase the risk of a collision with pedestrians crossing this arm, especially eastbound pedestrians who will need to turn 180 degrees to observe approaching vehicles.

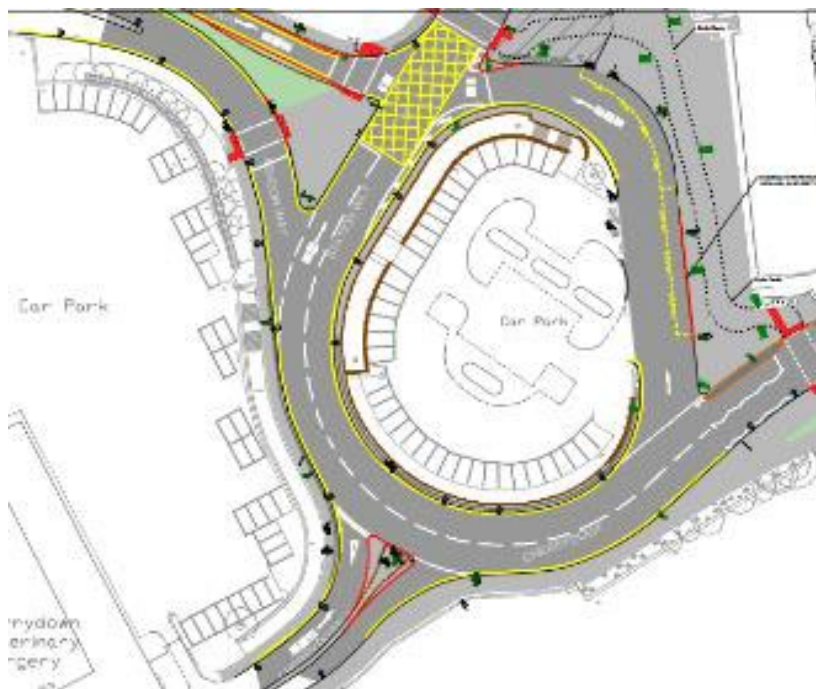
Image No. 14

Summary: Risk of head-on collisions due to making existing one-way roads two-way.

There are a number of roads that currently operate as one-way that are proposed to operate as two-way (Image No14 being one such example). Drivers become creatures of habit and may drive the current one-way roads out of habit. Following the implementation of the scheme proposals, drivers may still drive by habit failing to notice the changes in priorities/direction of travel, especially during quieter periods. This increases the risk of drivers driving on the wrong side of the road whereby head on collisions are a significant risk. The likely severity of any head on collision would be serious or even fatal.

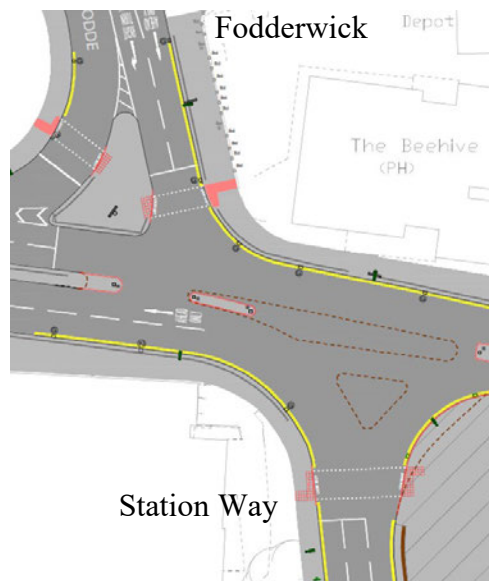
Image No. 15

Summary: Risk of head-on and / or side impact collisions due to driver confusion.

It is proposed to alter the existing controlled junction shown in the above image No. 15, where Station Way changes from a one-way carriageway to a two-way carriageway that allows vehicles to travel from Fodderwick and Southernhay south to Station Way. The Audit Team are concerned that vehicles travelling south from Fodderwick to Station Way may misalign themselves and cause a head-on collision.

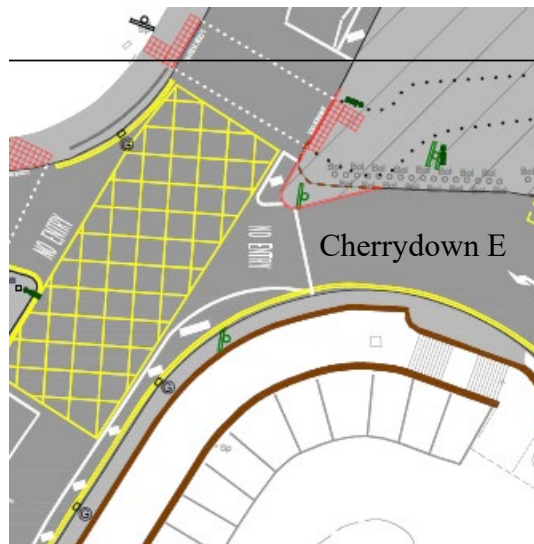
Image No. 17

Summary: Risk of side impact vehicle collisions due to lack of visibility

The drawing submitted for audit shows the north-eastern exit from the Cherrydown East roundabout with a stop-line, which suggests that this arm of the junction is to be signalised. However, no additional information has been submitted to confirm this. The required vehicle movement is also 'left turn only' from Cherrydown East. If this arm is not signalised, there is a lack of visibility due to the retaining wall, to see vehicles travelling southbound on Station Way. As a consequence of this issue there may be the potential risk of side impact vehicle collisions, which may result in injuries.

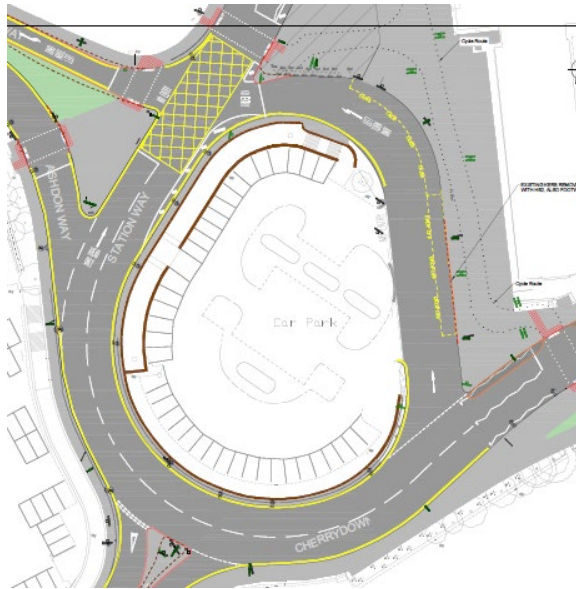
Image No.18

Summary: Risk of head-on and side impact collisions due to driver confusion

The above image, which is an extract from drawing No. 900105 Rev PO1, shows Station Way and Cherrydown East to change from one-way priority to two-way priority. The existing carriageway is very wide and operates as one-way. As such, elevated speeds and vehicles taking the racing line were observed. If this route is made two-way there is a risk that drivers may retain their previous habits and fail to observe that it is now a two-way road, still driving at elevated speeds and taking the racing line. This, combined with the reduced forwards visibility for southbound traffic, increases the risk of head on collisions.

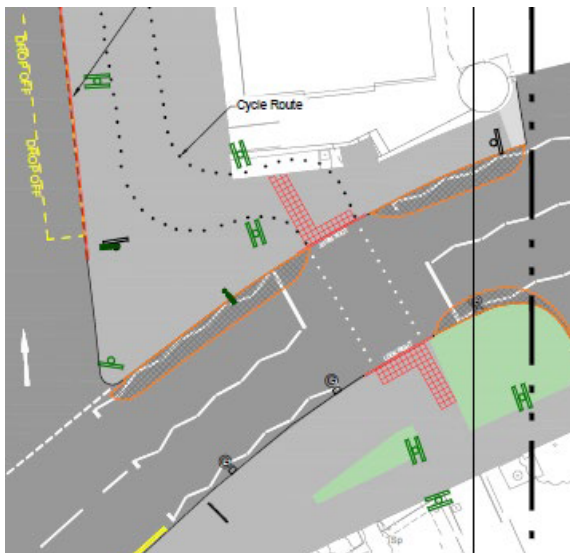
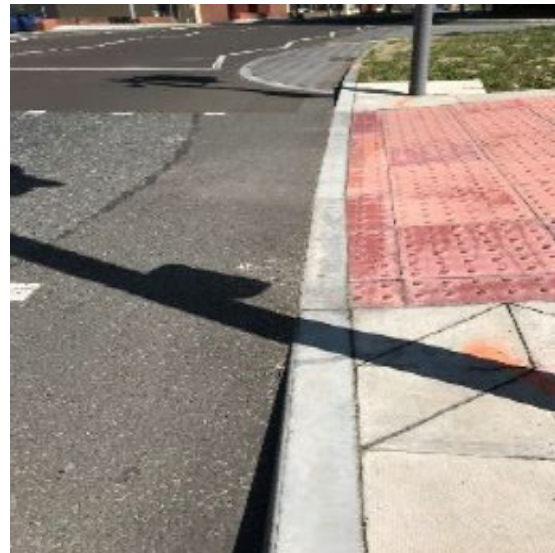
Summary: Risk of Pedestrian, Slip, Trips and Falls due to incorrect kerb levels

A toucan crossing is shown on images No. 19 and 20 above. The site visit revealed that ‘pond-ing’ had taken place during recent rainfall. This was identified by detritus being deposited at the northeast corner of the southern crossing point. There is a risk of pedestrians slipping or tripping when crossing during inclement weather and falling onto the carriageway. This is particularly significant with regard to visually impaired pedestrians.

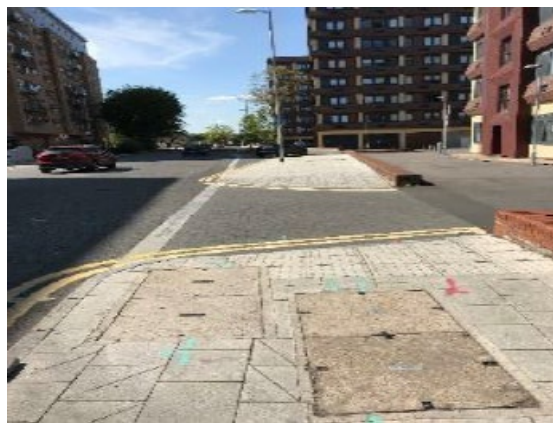
Image No. 21

Summary: Risk of collisions between vehicles and visually impaired pedestrians due to lack of colour contrast of tactile paving.

On the north side of Cherrydown East there is an entrance and exit to Trafford House. The exit is shown in image No. 21 above. It may also be seen in the image that there is no colour contrast between the tactile paving and the adjacent paving slabs. This matter is a concern for partially sighted pedestrians, who, although they may be aware that there is a change in footway surfacing, may not appreciate that they should be cautious due to the potential hazard of a vehicle exiting Trafford House. As a consequence of this issue there is a risk of vehicles colliding with pedestrians, which may result in injuries to pedestrians. Additionally, the Audit Team are aware that the footway surface will change to a flexible material, but no information has been provided for the type of tactile paving that may be included in the design

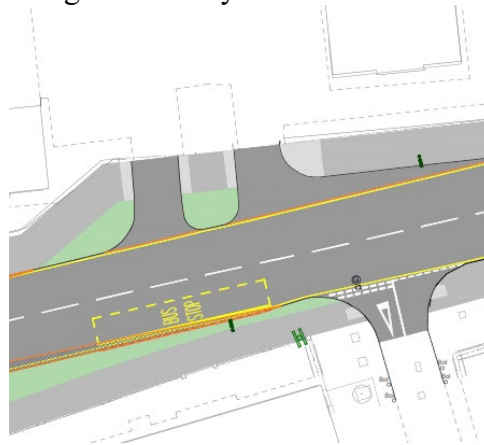
Image No.22

Summary: Risk of head-on collisions due to lack of visibility

The drawing submitted for audit, of which image No. 22 above is an extract, shows a proposed bus 'cage' in yellow on the Southernhay carriageway. No information has been forwarded to the Audit Team to show if there is sufficient visibility to look past a stationary bus at the bus stop. This matter affects vehicles exiting the residential area opposite Trafford House and wishing to turn left as may not be able to see if there are any vehicles travelling along Cherrydown East in an easterly direction. As a consequence of this issue there may be the potential risk of vehicle head-on collisions when overtaking a stationary bus.

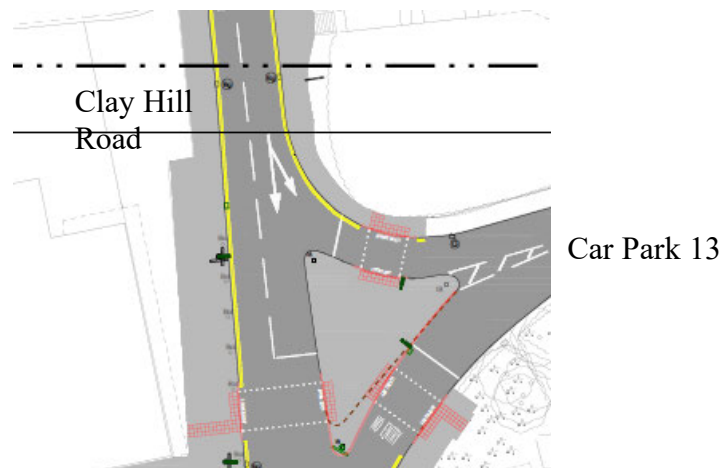
Image No. 23

Summary: Risk of vehicle rear shunt type collisions due to driver confusion

The extract from drawing number 14916-100-WIE-ZZ-DR-C-900107 Rev P01, shown above, suggests that the pedestrian crossing will be signalised for vehicles wishing to enter Car Park 13. The location of the stop-line is such that vehicles are likely to back up and block the through-flow of traffic on the main road, leading to rear end shunts. As the proposed signal phasing has not been provided, the audit team cannot establish the proposed phasing of the junction. Additionally, there is also the potential that drivers wishing to travel south along Clay Hill Road may overtake waiting vehicles wishing to access the car park, with the risk of head-on collisions with road users travelling northwards towards Southernhay, as it is proposed that Clay Hill Road will become a two-way road.

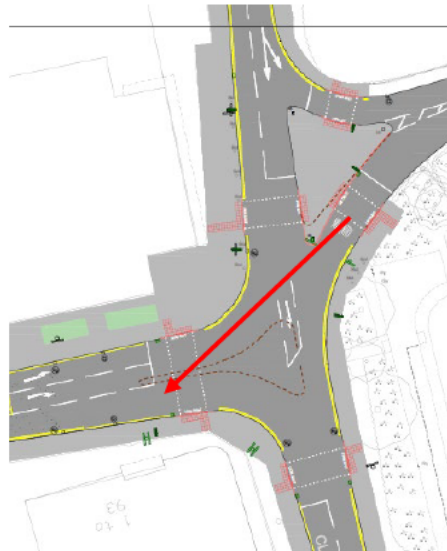
Image No.24

Summary: Risk of head-on collisions due to driver confusion

The drawing submitted for audit shows the proposed signalised Clay Hill Road/Cherrydown East/Car Park 13 junction. Currently, drivers exiting Car Park 13 enter Cherrydown East as a one-way road. The proposals make Cherrydown East a two-way road. Drivers may exit Car Park 13 out of habit, taking the racing line, which increases the risk of a head on collision with eastbound traffic on Cherrydown East. A possible conflict point may be point A shown in image No. 24.

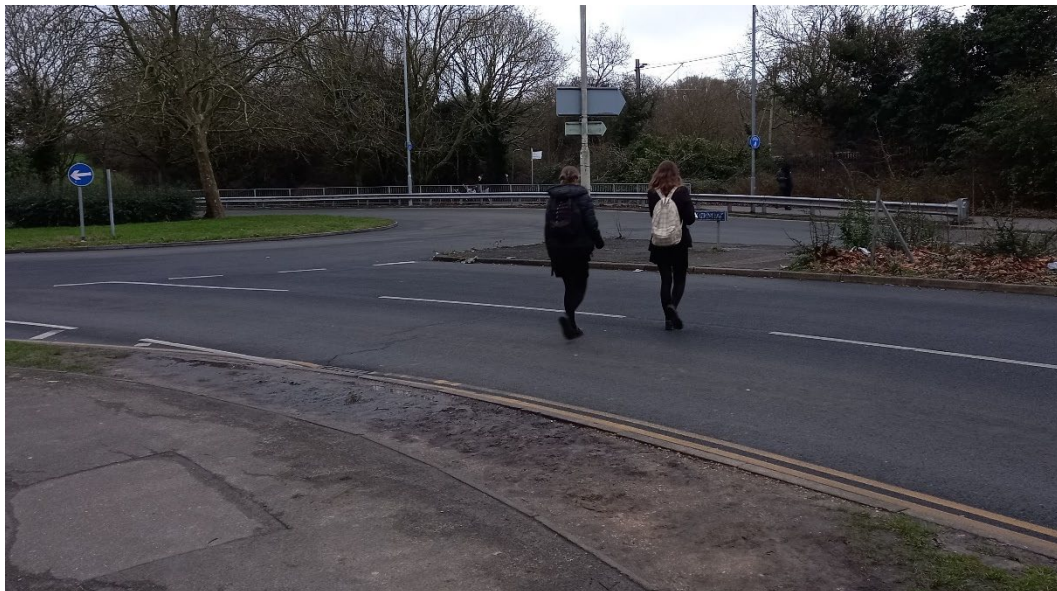
Summary: Risk of pedestrians colliding with road users.

As mentioned previously within this report, during the Stage 3-4 site visit, it was noted that there is significant pedestrian movements across Southernhay at this location (see RSA 3-4 Image1). The desire line appears to be to gain access to the footway leading to the Basildon Hall area.

RSA 3-4 Image 1 – Pedestrian desire line

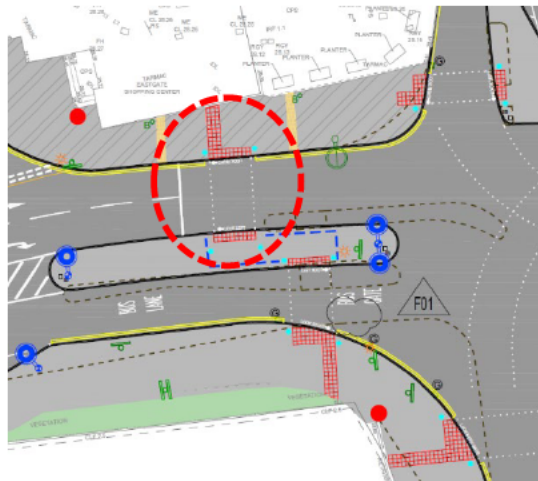
**Summary:** Risk of collisions involving pedestrians with mobility impairment.

It was noted during the site visit that the gradient of the tactile paving at the northern side of the staggered crossing appears to be steep (see RSA 3-4 Image 2). There is concern that pedestrians with a mobility impairment and wheelchair users, may find it difficult to negotiate the ramp and may be left stranded in the carriageway and be at risk of collision with approaching traffic.

RSA 3-4 Image 2 – Tactile pavement gradient

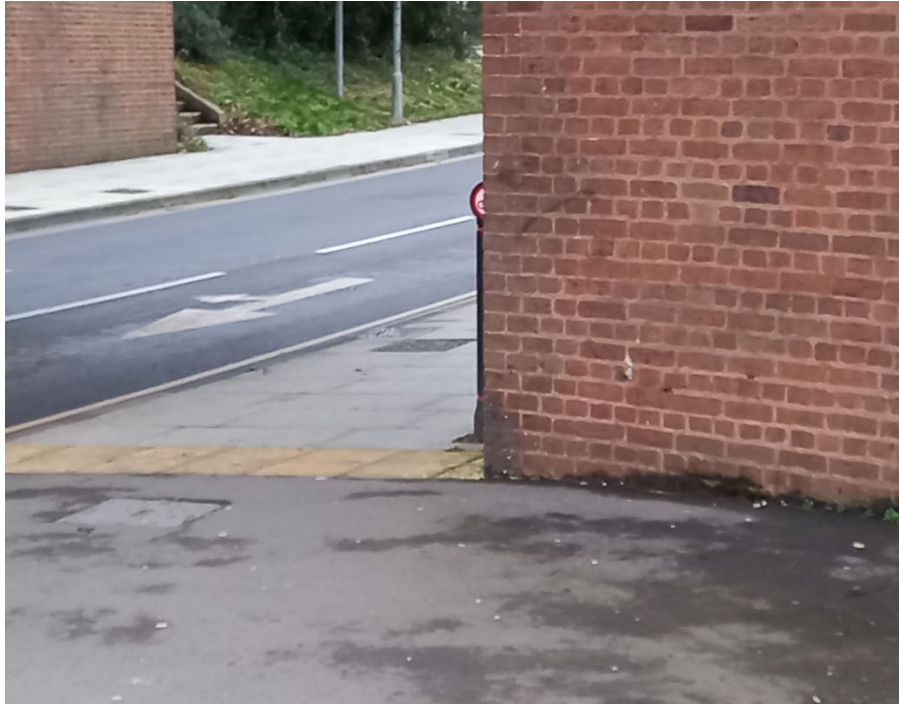
**Summary:** Risk of collisions involving pedestrians and cyclists.

Whilst it is appreciated that 'cycle-scoops' have been provided at the junction to guide cyclists rejoin or leave the carriageway, it is noted that there are no information signs advising cyclists of the 'End of Route' or 'Cyclists Rejoin the Carriageway'. It was also noted that the 'Prohibition of Cycling' signs (Diag. 951) at the junction of Southernhay and Clay Hill, are poorly located (see RSA 3-4 Image 3). There is concern that failure to provide the appropriate signing could lead to conflict between cyclists and pedestrians.

RSA 3-4 Image 3 – Location of 951 signs at Clay Hill.

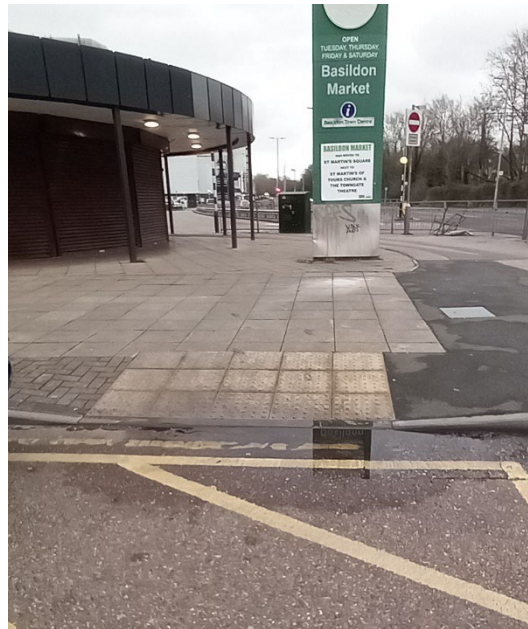
Summary: Risk of injury to pedestrians.

At the time of the site visit it was noted that there is ‘ponding’ at the eastern side of the crossing point (see RSA 3-4 Image 4). There is concern that shallow standing water at this location could form to ice in low temperatures and present a hazard to pedestrians, particularly those with a mobility impairment.

RSA 3-4 Image 4 -standing water at crossing point

**Agree:** This should be reviewed on site to ascertain if the water is ponding or just slow to drain north into the gully on market pavement. If problems persist a chute gully with connection into the existing adjacent gully should be made.

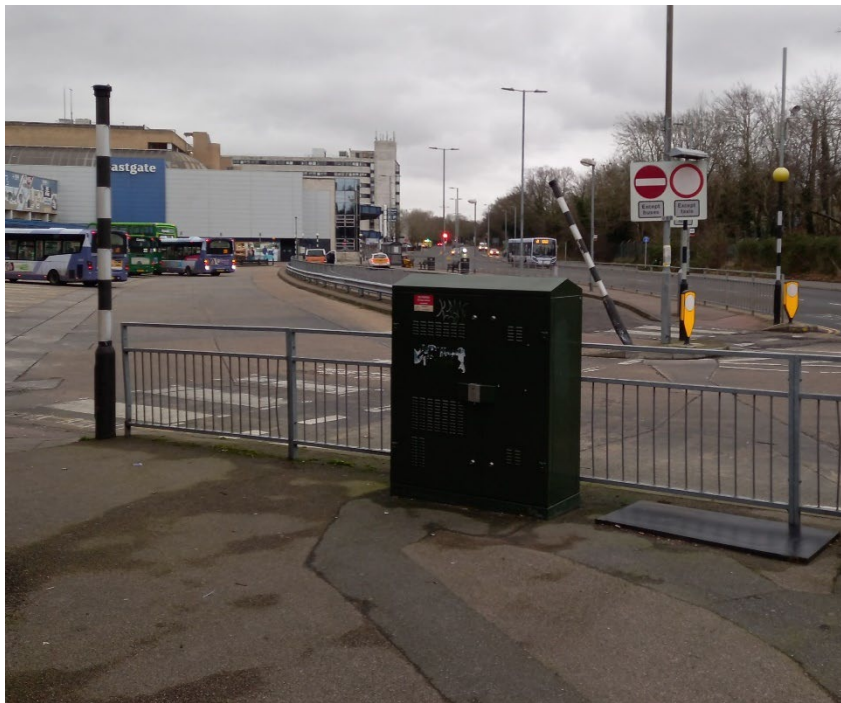
Summary: Risk of collisions and injury to pedestrians.

During the Stage 3-4 site visit, it was noted that the controlled crossing at each end of the Bus Station have been damaged and have beacon globes missing (see RSA 3-4 Image 5). There is concern that in low light conditions approaching drivers may not be aware of the presence of the crossing or pedestrians on the crossing. This may lead to collisions between pedestrians and road users resulting in injury.

RSA 3-4 Image 4 – Damaged pole and globes at crossing

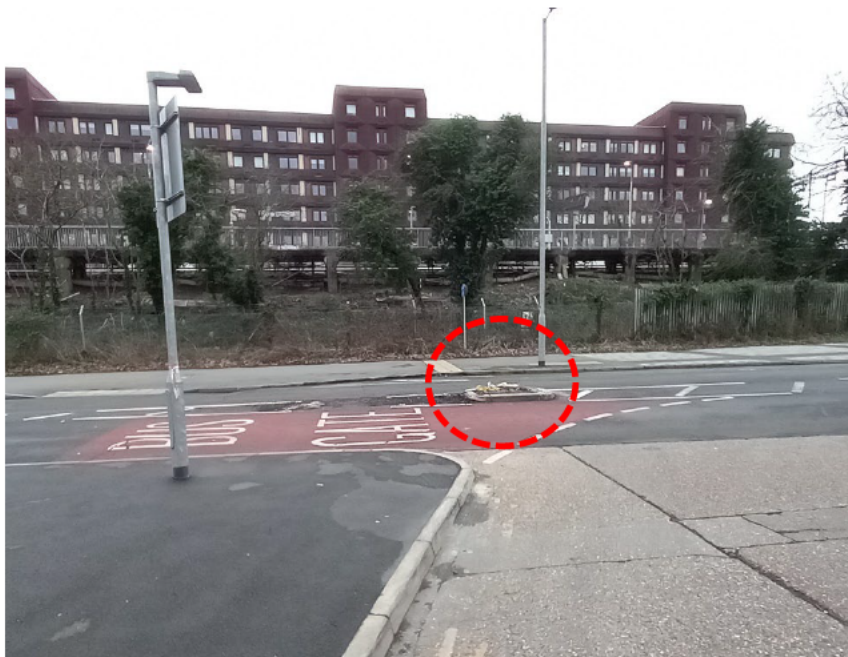
RSA 3-4 Image 5 – Damaged/removed traffic sign assembly on Southernhay at Bus Gate.

Agree : Signs to be removed
