Inspection_Batch_Photos

USRN13801554

Inspection Batch Inspection Route NameArea 16 Monthly Driven

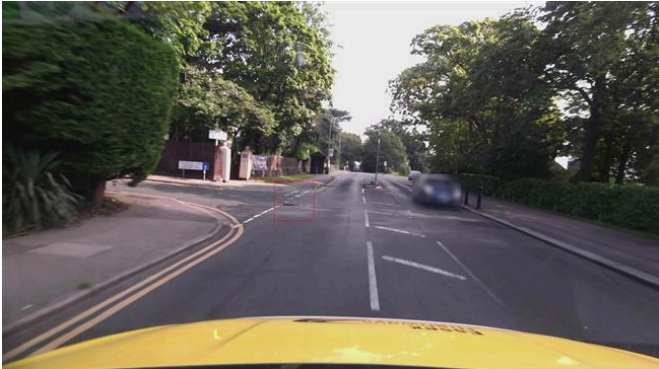
DescriptionRANSA 4 = 1 x 4. Misaligned/rocking RS gully

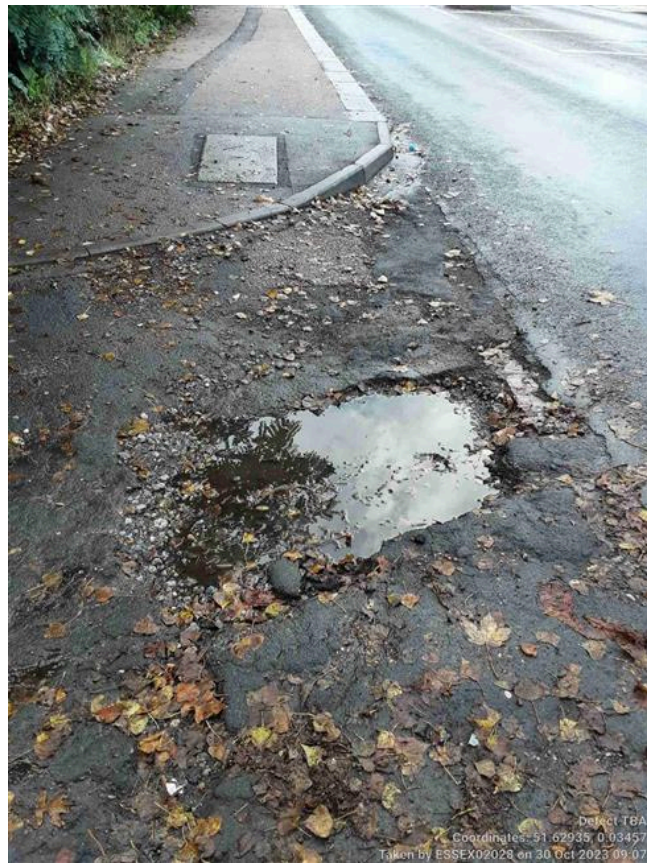
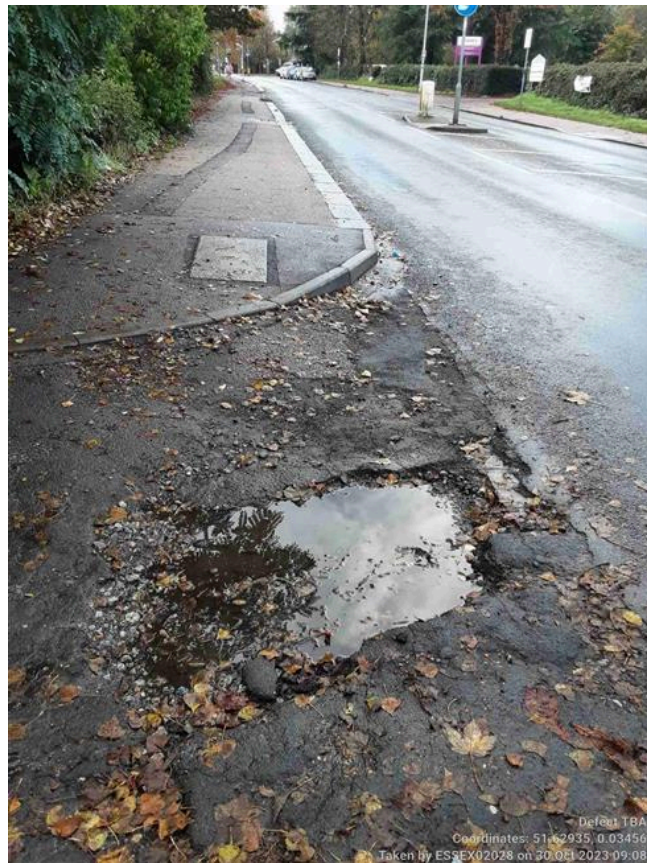
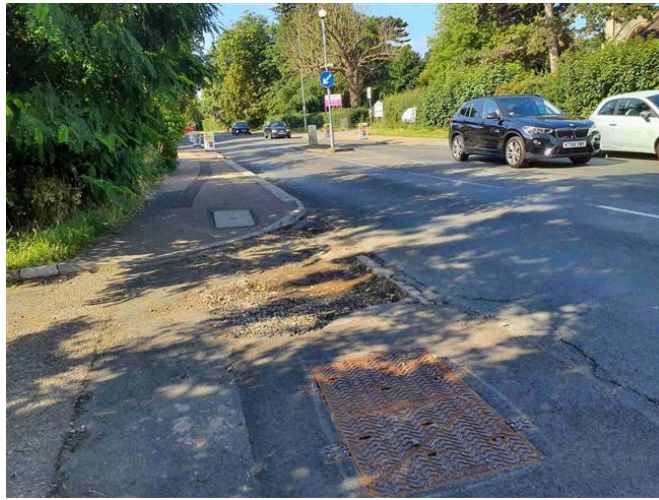
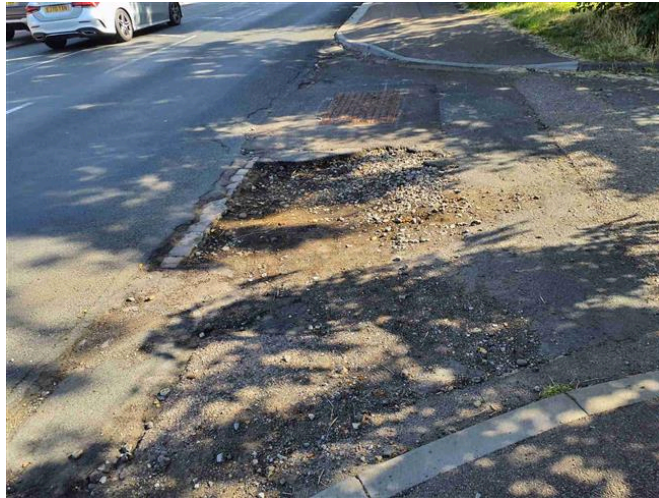
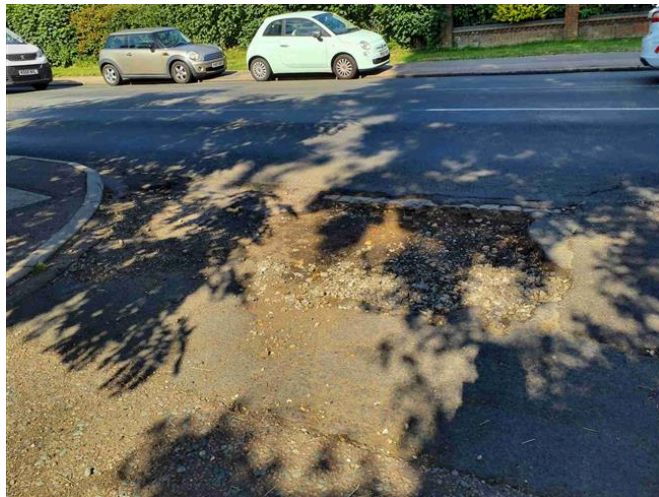
DescriptionRa 9=3x3. 1.4m x 1.4m x 70mm in places cwph

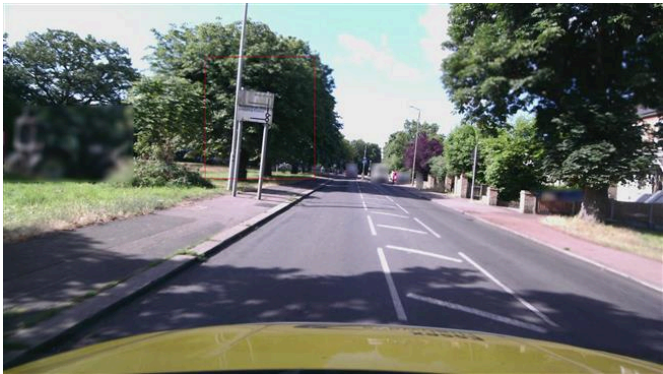
RANSA 4 = 1 x 4, Route Information sign dirty
Opp 84
HW: Street S3
3813123
13801554

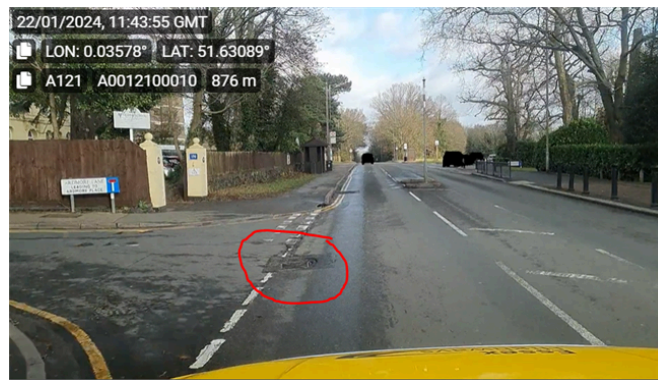
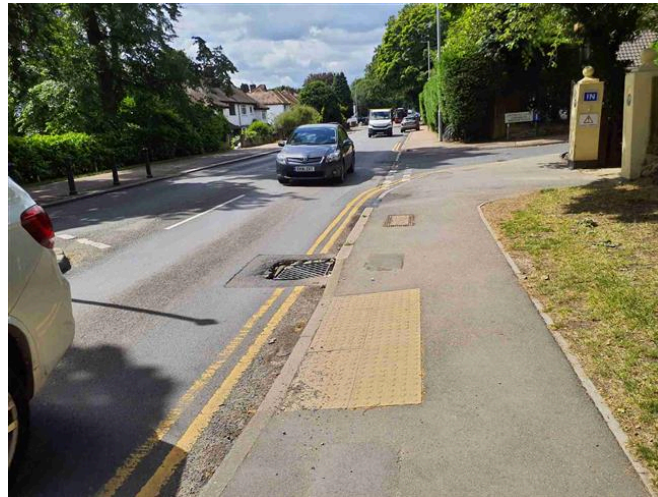
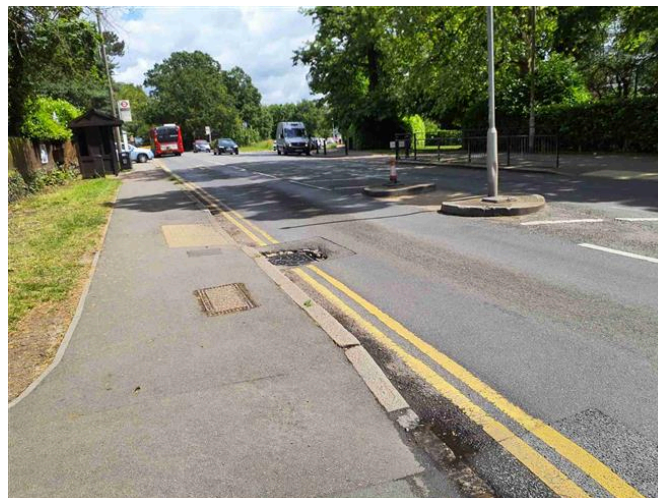
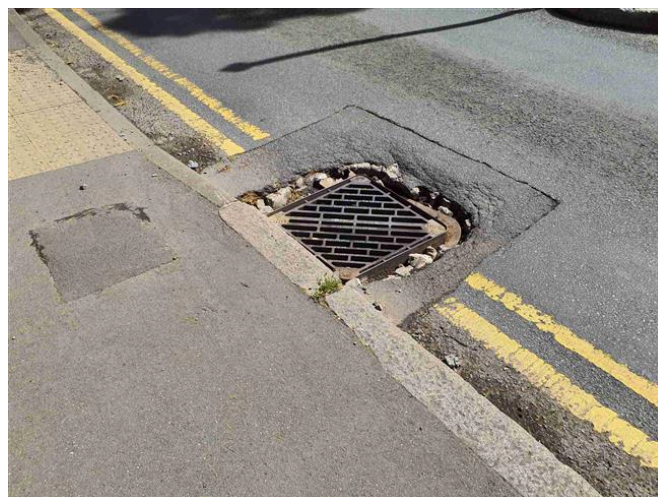
Description RANSA 12=3x4. Misaligned/rocking RS gully
Location LON: 0.03579°, LAT: 51.63091°, J/w Ardmore Lane
Priority Name HW: Street S2 PR1/2
Defect Number 3800039
Site Code 13801554
Documents

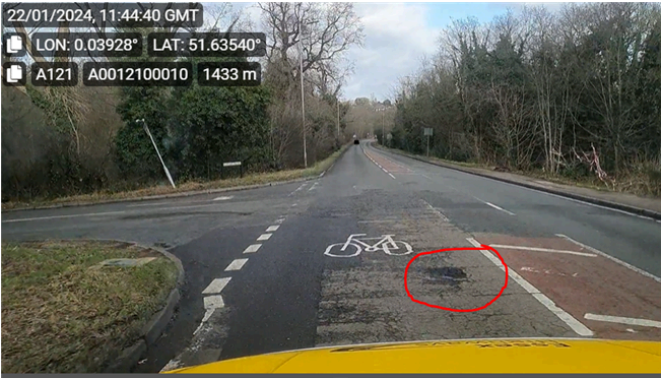
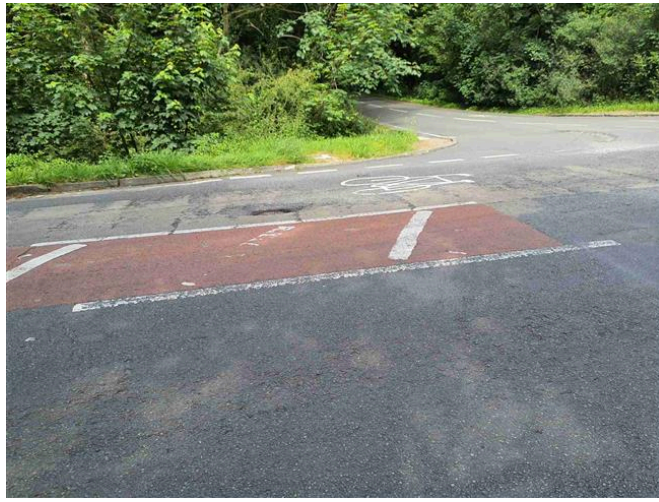
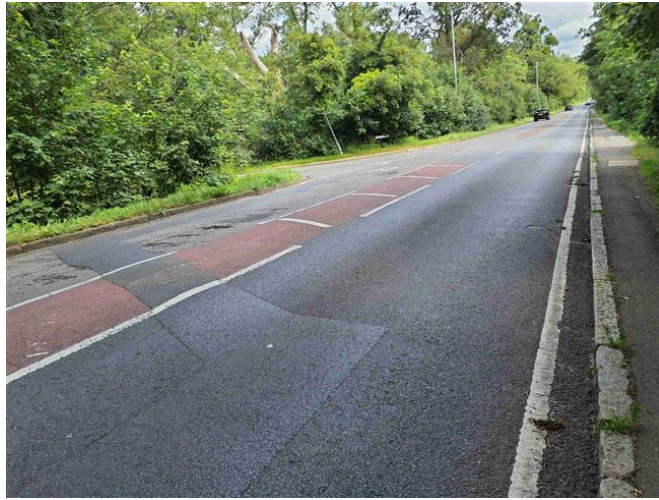
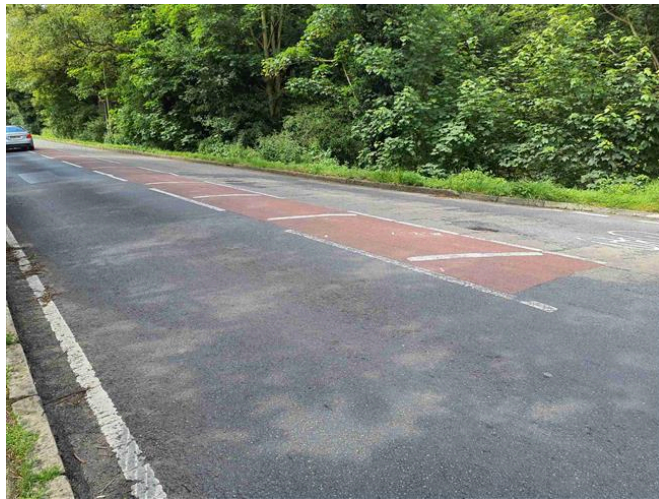
RA 12=3x4. C/w defect/p/h >0.6m x >0.5m x >80mm
LON: 0.03928° , LAT: 51.63540° , J/w Manor Road
HW: Street S2 PR1/2
3800036
13801554

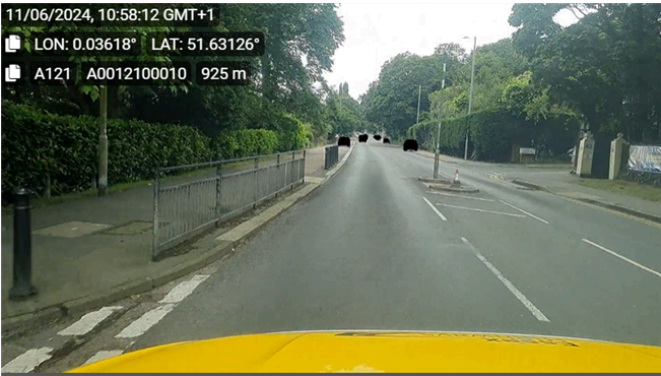
RANSA 4=4x1. Missing K/I Bollards and globe from column

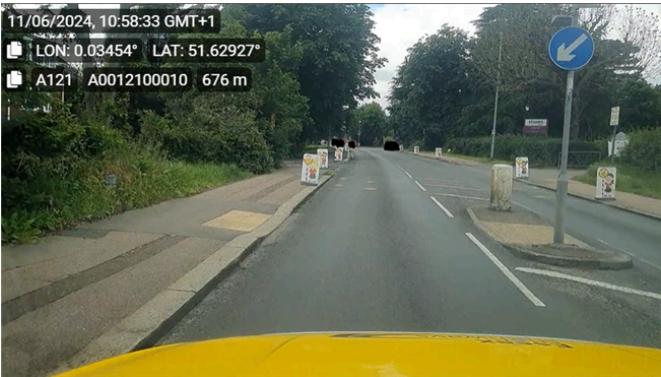
RANSA 4=4x1. Missing K/I Bollard and globe from column

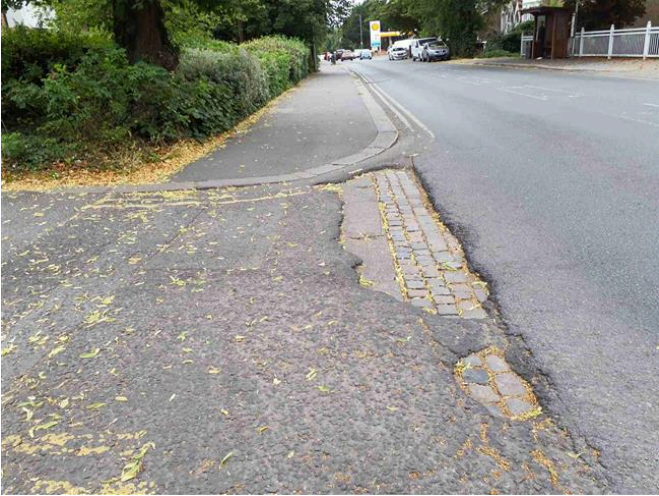
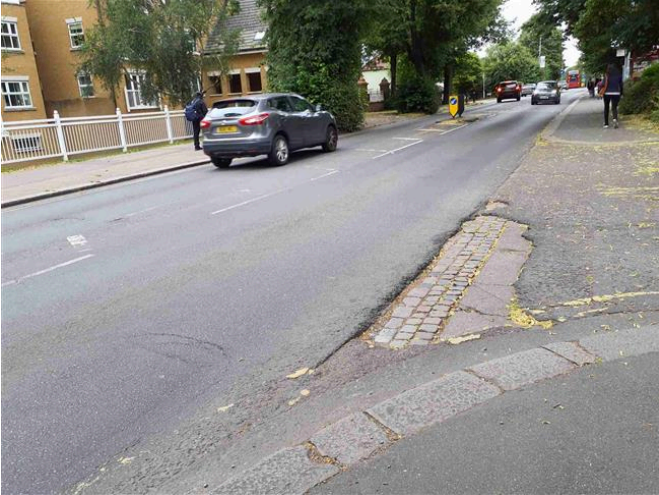
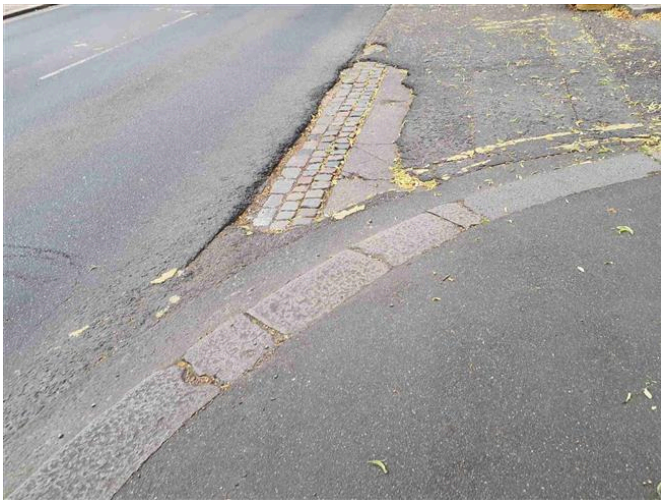
RA 9=3x3. F/w defect/erosion approx 2m x 1m x 50mm in places
O/s Toby Carvery by exit
HW: Street S2 PR1/2
3814114
13801554

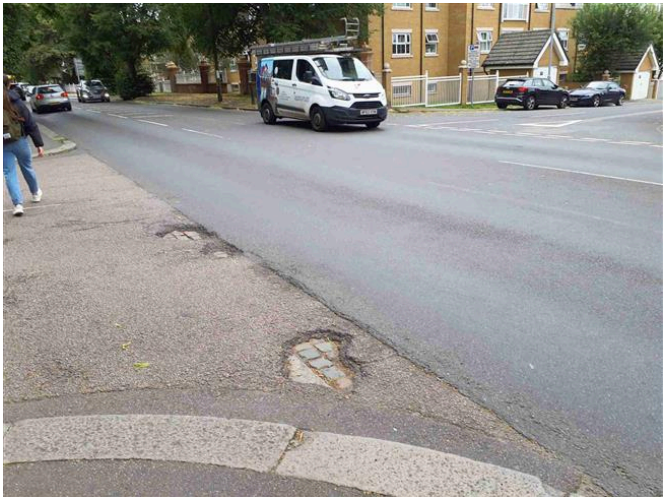
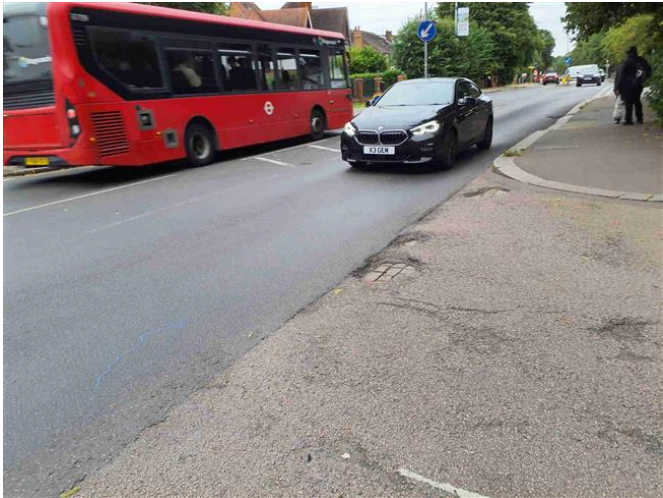
RA 4=2x2. F/w defect/p/h approx 0.4m x 0.3m x 40mm in places---Possibly unadopted
At Entrance to Toby Carvery
HW: Street S3
3814119
13801554

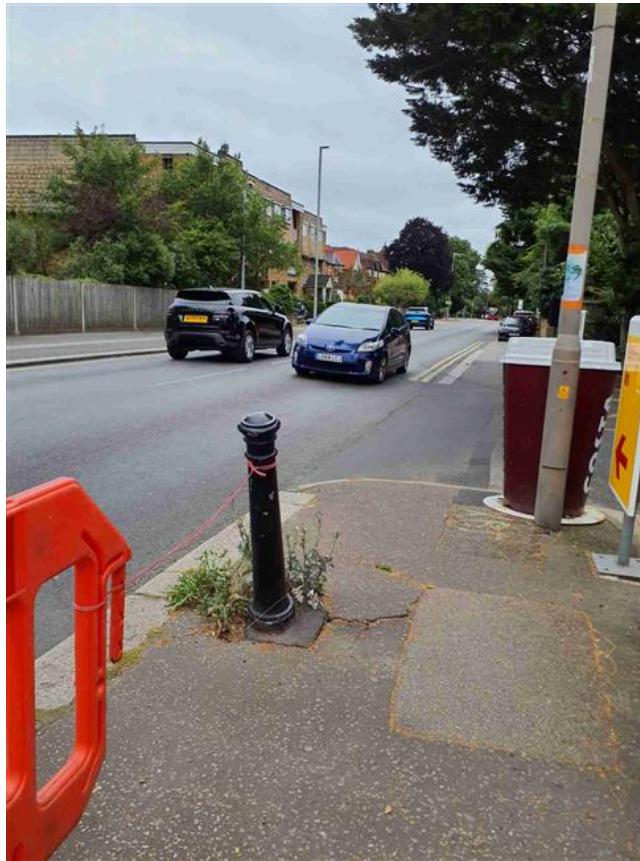
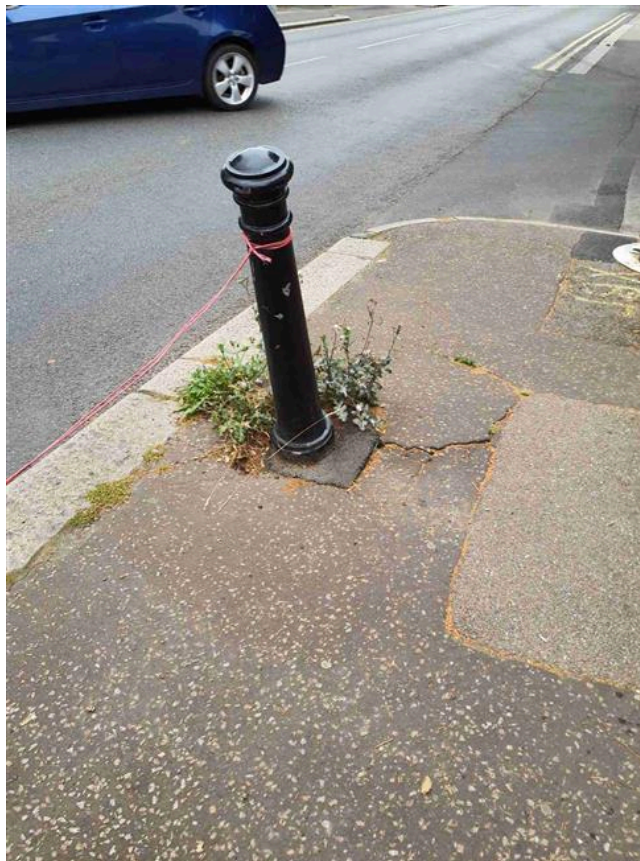
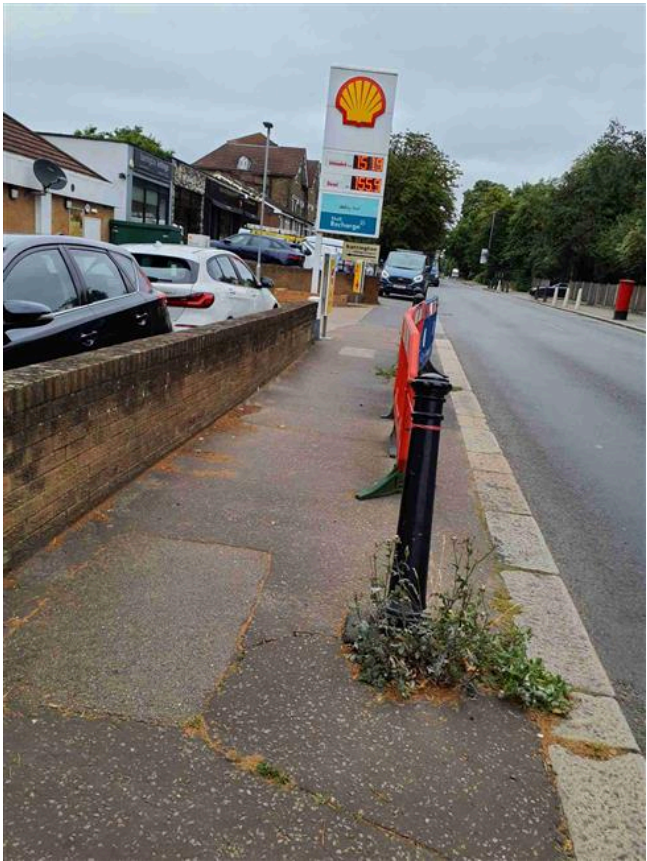
RA 6=2x3. F/w defect/heave to bollard surround approx 1m x 0.5m x 30mm in places
O/s Shell Garage by bollard
HW: Street S3
3814050
13801554

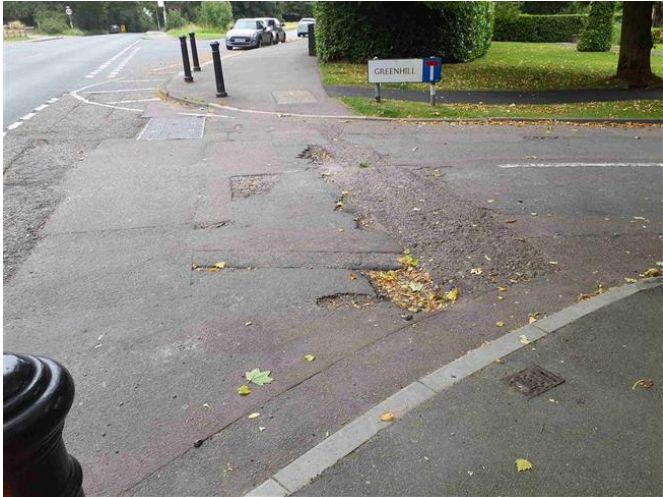
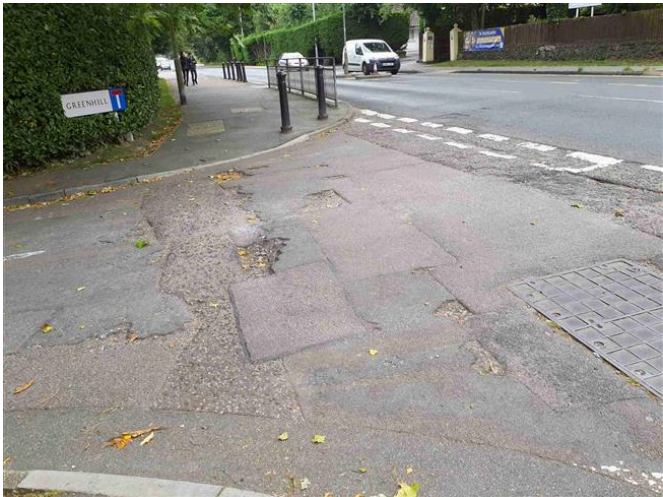
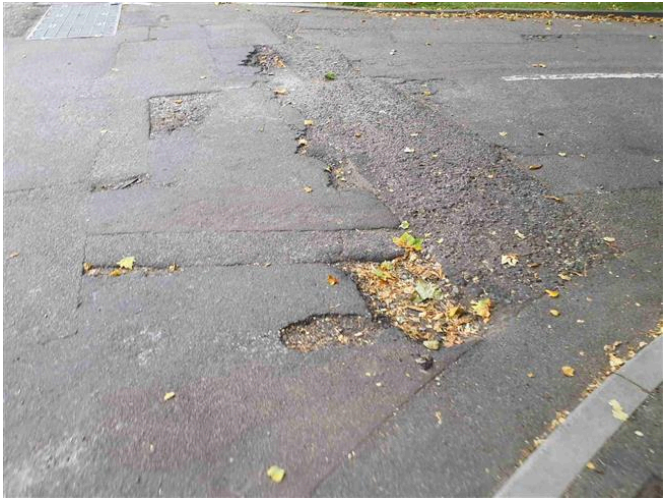
RA 9=3x3. C/w defect/erosion approx 2m x 0.4m x 50mm in places
J/w Greenhill adj pram xing
HW: Street S2 PR1/2
3814143
13801554

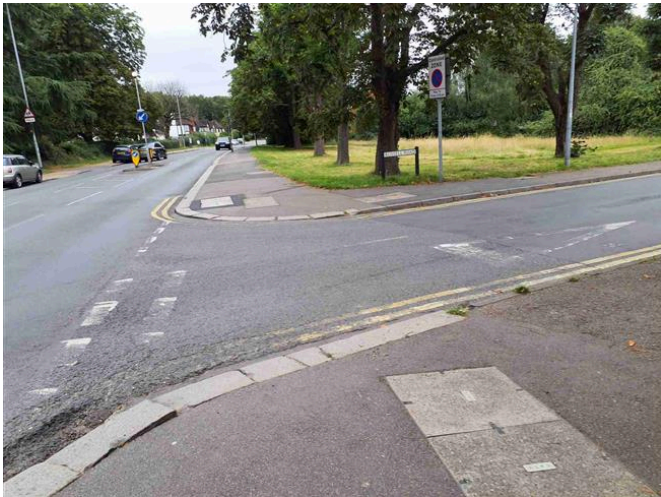
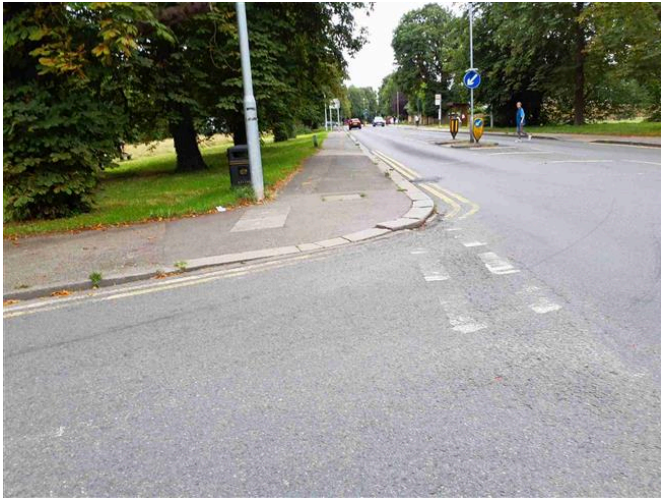
RA 9=3x3. 2no Misaligned/loose granite kerbs x 60mm

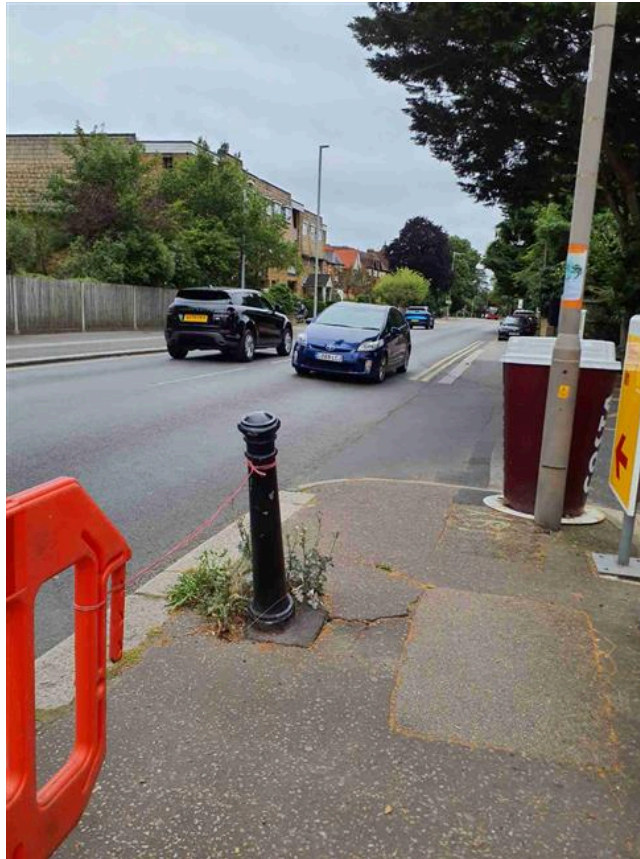
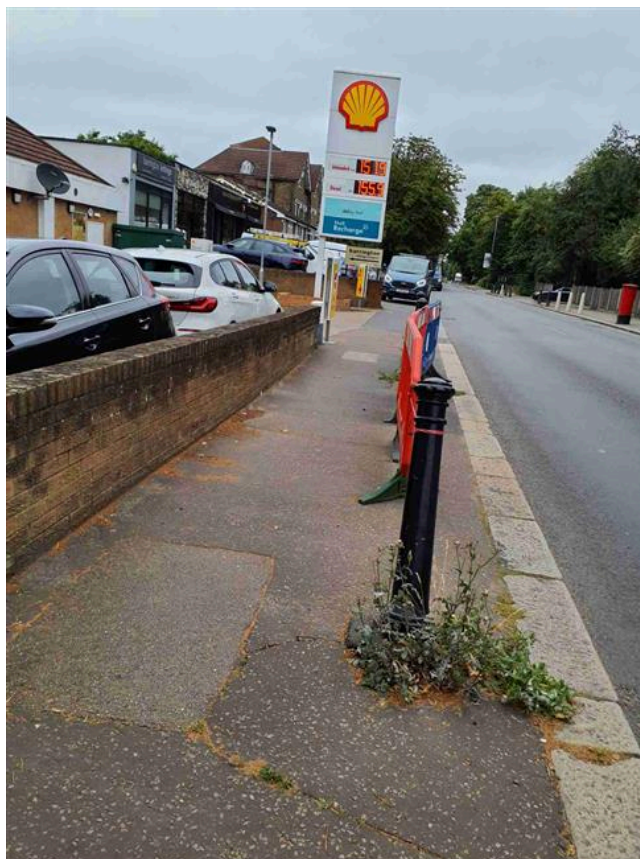
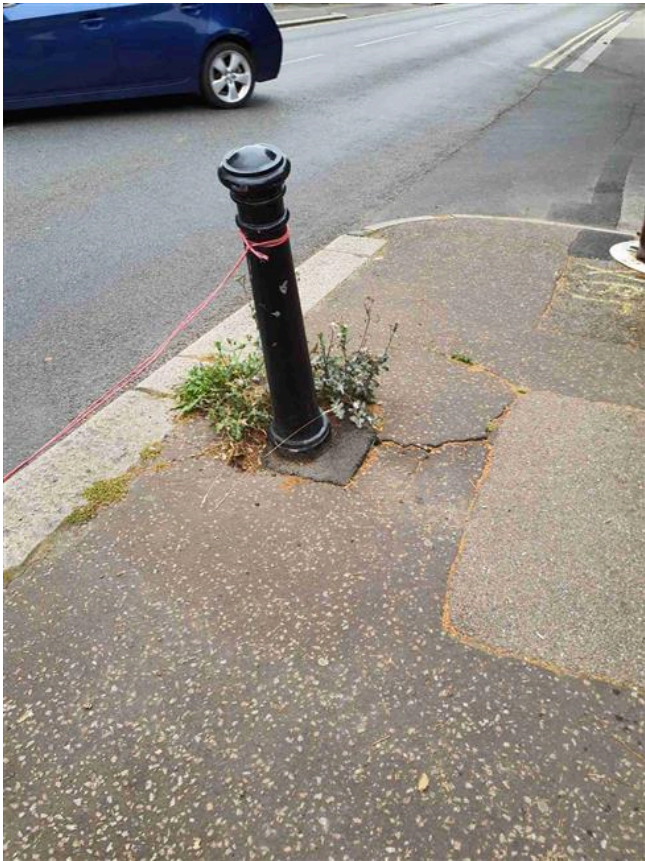
Description	RA 4=4x1. Bollard damaged/leaning
Location	O/s Shell Garage
Priority Name	HW: Street S3
Defect Number	3814049
Site Code	13801554
Documents

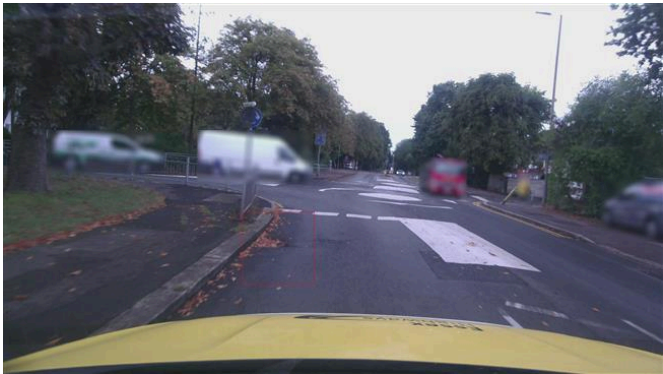
Description RANSA 6 = 2 x 3. Misaligned RS gully x 60mm
Location LON: 0.0331398, LAT: 51.6271362, J/w Palmerston Road
Priority Name HW: Street S3
Defect Number 3830363
Site Code 13801554
Documents

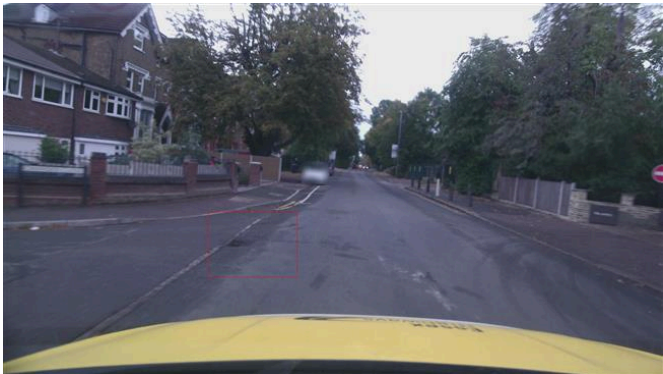
Description RANSA 4=2x2. C/w defect/depression 0.6m x 0.4m x 60mm
Location LON: 0.0313555, LAT: 51.6248589, J/w Chandos Close
Priority Name HW: Street S3
Defect Number 3830394
Site Code 13801554
Documents

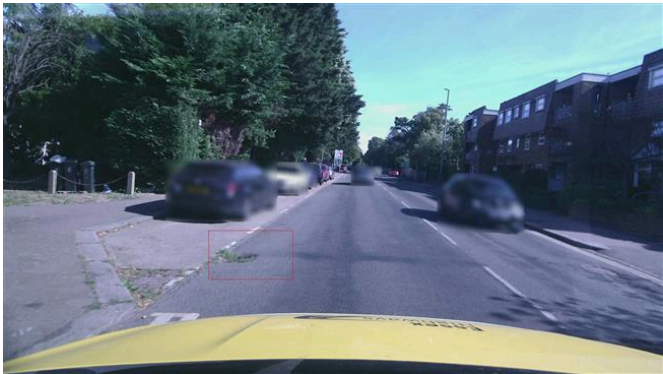
RANSA 6 = 2 x 3. Misaligned RS gully x 60mm
LON: 0.0306465, LAT: 51.623848, Opp 5 by parking bays
HW: Street S3
3823595
13801554

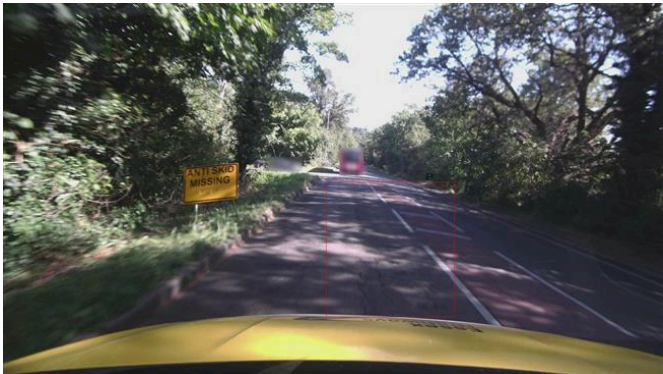
RANSA 4 = 1 x 4. C/w defect/rutting >4m x >0.8m x >50mm
LON: 0.0390942, LAT: 51.6352081, 30m before Manor Rload
HW: Street S3
3823639
13801554

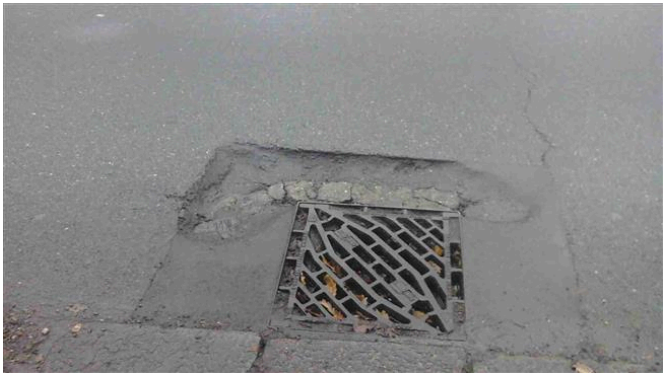
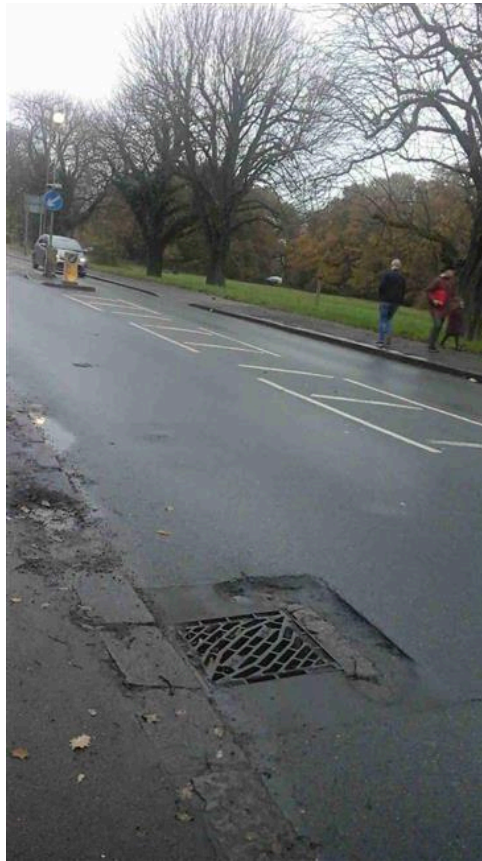
Ra 8=2x4. Cway ph to gully 1.4 x 0.4 x 70mm.
Os no 74.
HW: Street S2 PR1/2
3823612
13801554

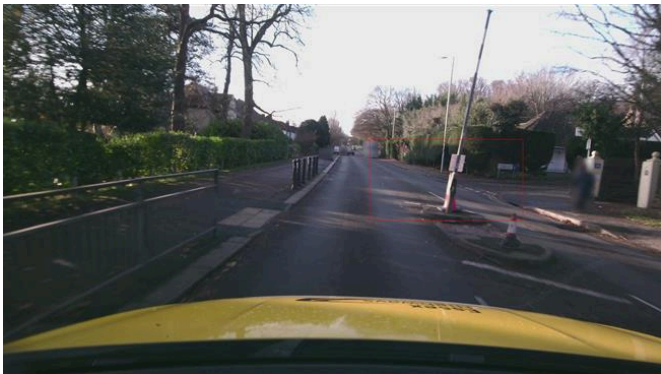
RANSA 4 = 4 x 1. Post RB02 door damaged----Phoned through to street lighting@14:15

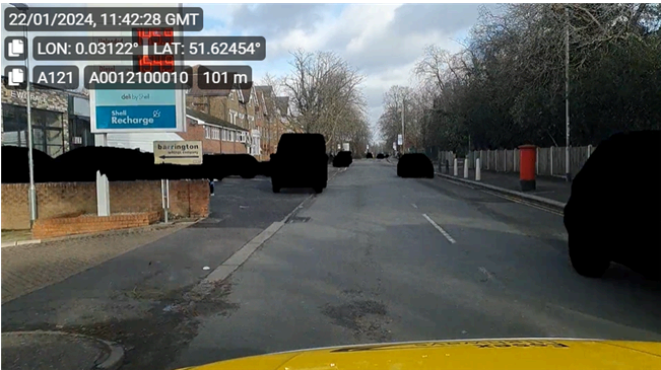
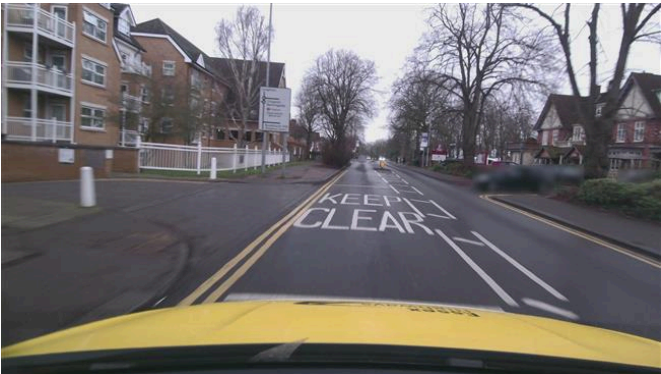
Description RESOLVED RANSA 4=1x4. Worn/faded white centre markings hatchings and arrows
Location LON: 0.03122°, LAT: 51.62454°, From Shell Garage to Palmerston Road
Priority Name HW: Street S3
Defect Number 3869927
Site Code 13801554
Documents

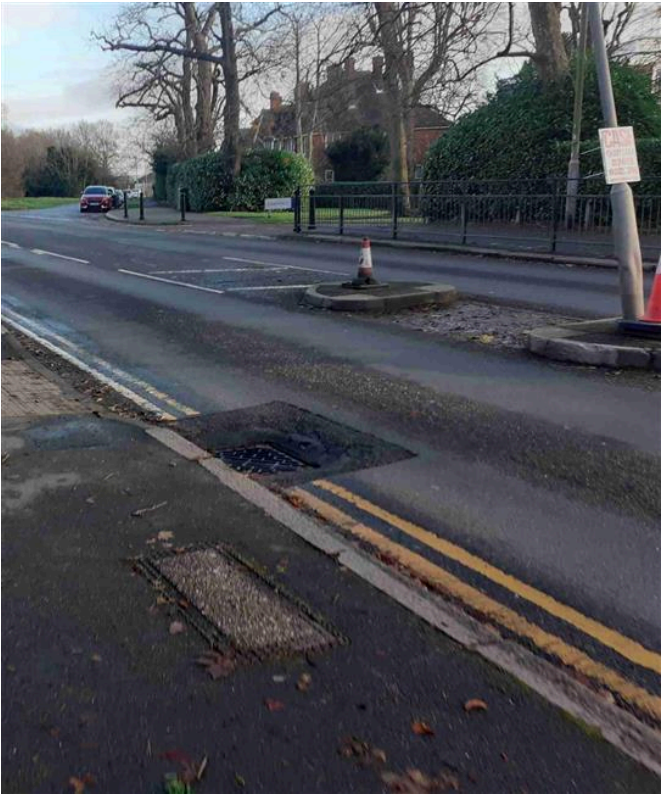
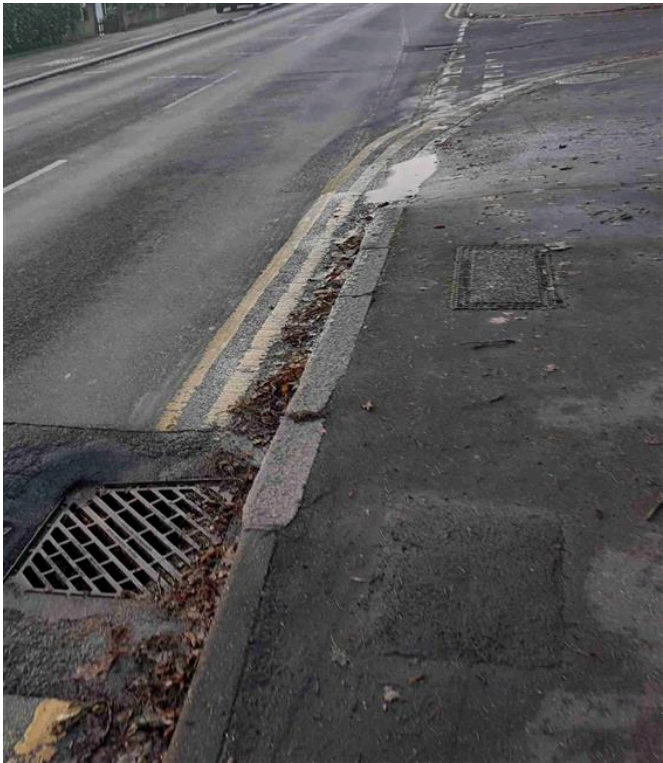
RA 12=3x4. Misaligned/rocking RS Gully x 80mm
Adj Ardmore Lane by School
HW: Street S2 PR1/2
3869890
13801554

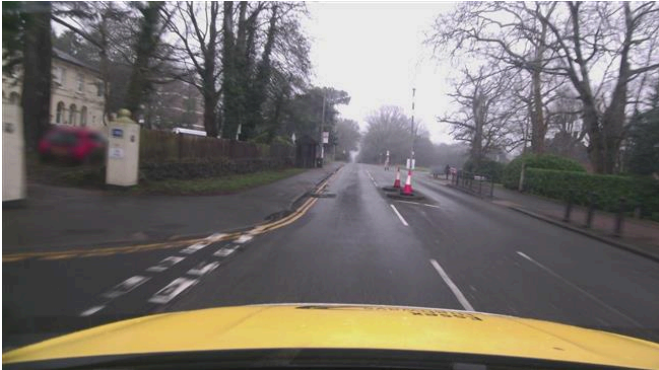
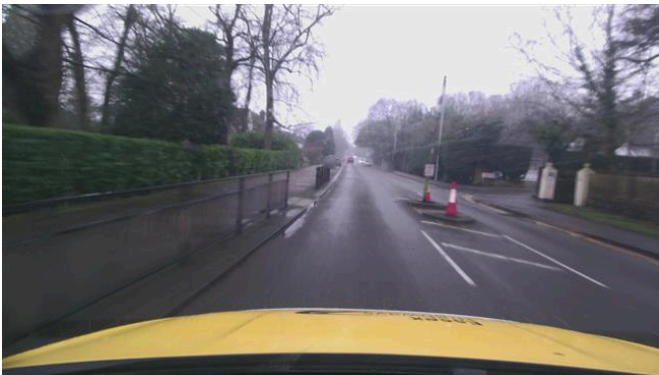
Description RANSA 12=3x4. Misaligned RS gully x 80mm
Location O/s 130, Braeside School
Priority Name HW: Street S2 PR1/2
Defect Number 3874282
Site Code 13801554
Documents

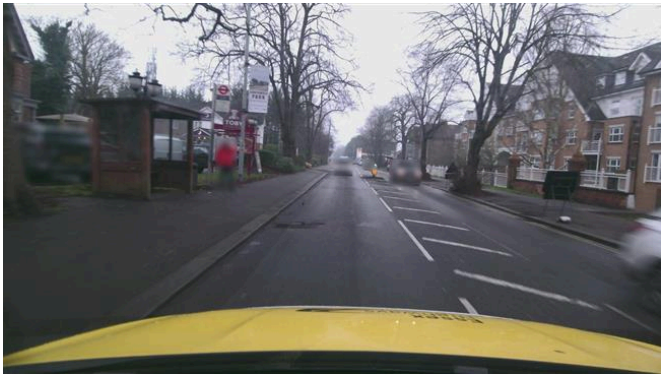
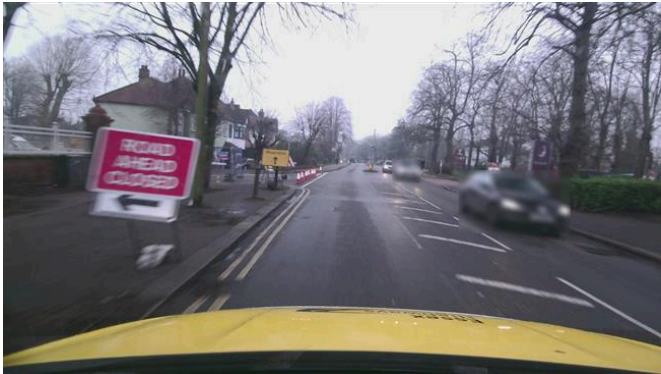
Description	RANSA 8=2x4. C/w p/h to s/c 0.2m x 0.6m x 70mm
Location	O/s Toby Carvery
Priority Name	HW: Street S2 PR1/2
Defect Number	3874277
Site Code	13801554
Documents

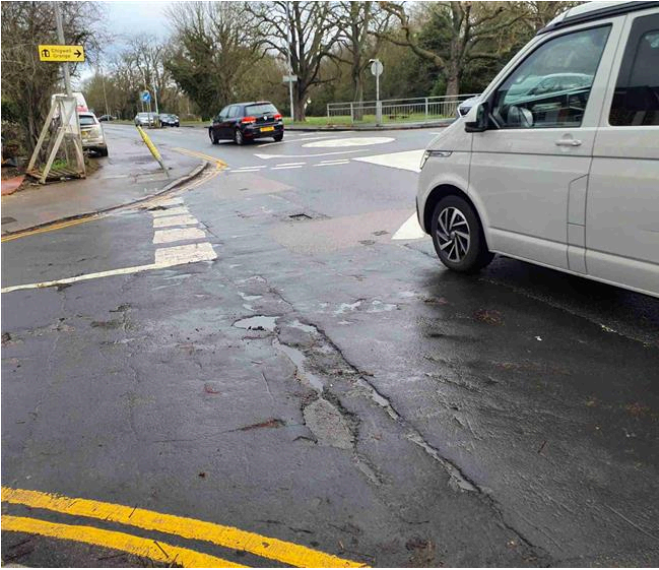
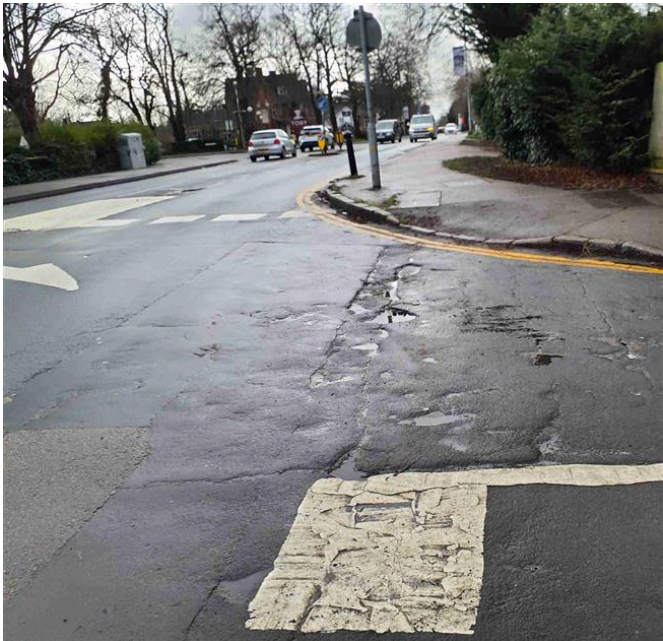
RA 6=2x3. C/w p/h 0.2m x 0.4m x 40mm NSMM
J/w Devon Close at pram xing
HW: Street S3
3870837
13801554

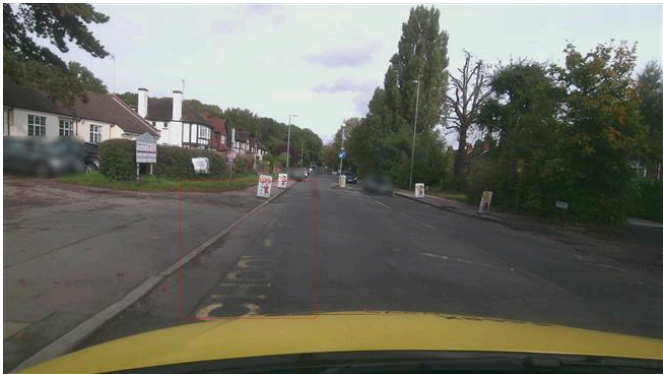
DescriptionRANSA 4 = 1 x 4, 50 % missing. keep clear school markings faded
LocationLON: 0.0341482, LAT: 51.628952; DETAILS: os st johns centenary hall
Priority NameHW: Street S3
Defect Number3846054
Site Code13801554
Documents

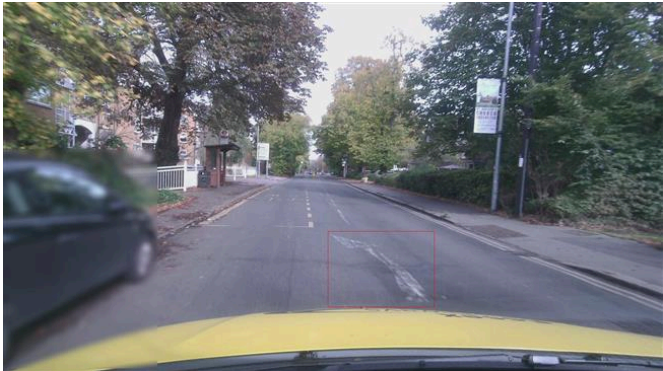
DescriptionRANSA 4 = 1 x 4, 60 % missing. keep left arrow faded
LocationLON: 0.0316231, LAT: 51.625248; DETAILS: opp hotel
Priority NameHW: Street S3
Defect Number3846052
Site Code13801554
Documents

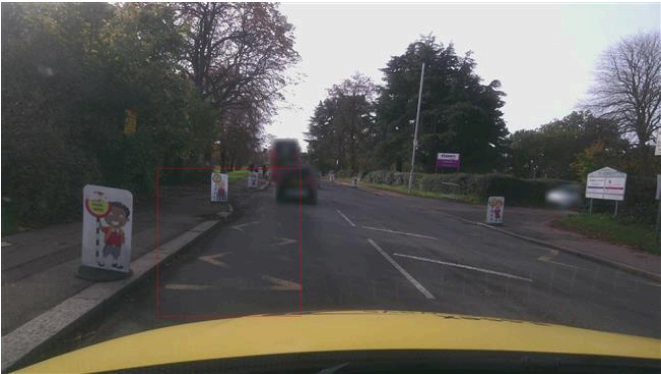
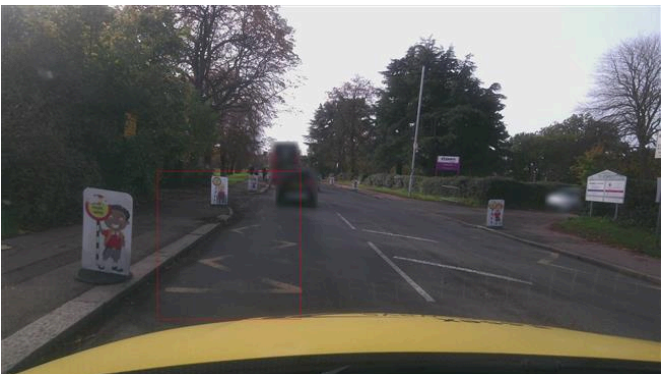
RANSA 4 = 1 x 4, 70 % missing. school keep clear markings faded
LON: 0.0344121, LAT: 51.6291504; DETAILS: opp St John's Centenary Hall
HW: Street S3
3846002
13801554
