Enquiry_Trace

Enquiry Number 2770719
Enquiry Classification Description fault reports
Enquiry Subject Name footway defects
Enquiry Subject Type Of Service Description Maintenance
Description Title=More than 2cm,resident fell on footpath
Address **MEMBER ENQUIRIES** between the BP garage and the bathstore
Central Site Address NETHER MAYNE
Central Site Notes
 SMO3 - Basildon // South Area // added as NSG update 7_7_2004; TRB // for further history see USRN 2002563, 2002063, 2000901
Central Site Area Description Basildon
Central Site Ward Name Basildon Westley Heights
Enquiry Customer Links

Defectdefect Number 3724126
Defectlogged Date 11 Jul 2023 11:45
Defect Defect Type Name HW: footway defect
Defect Description

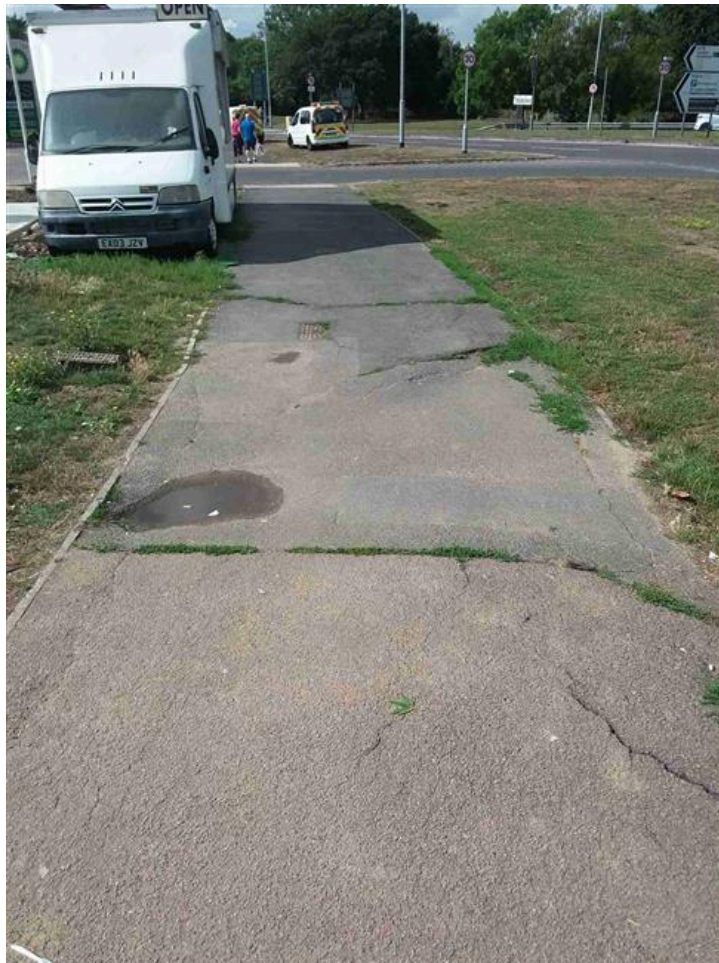
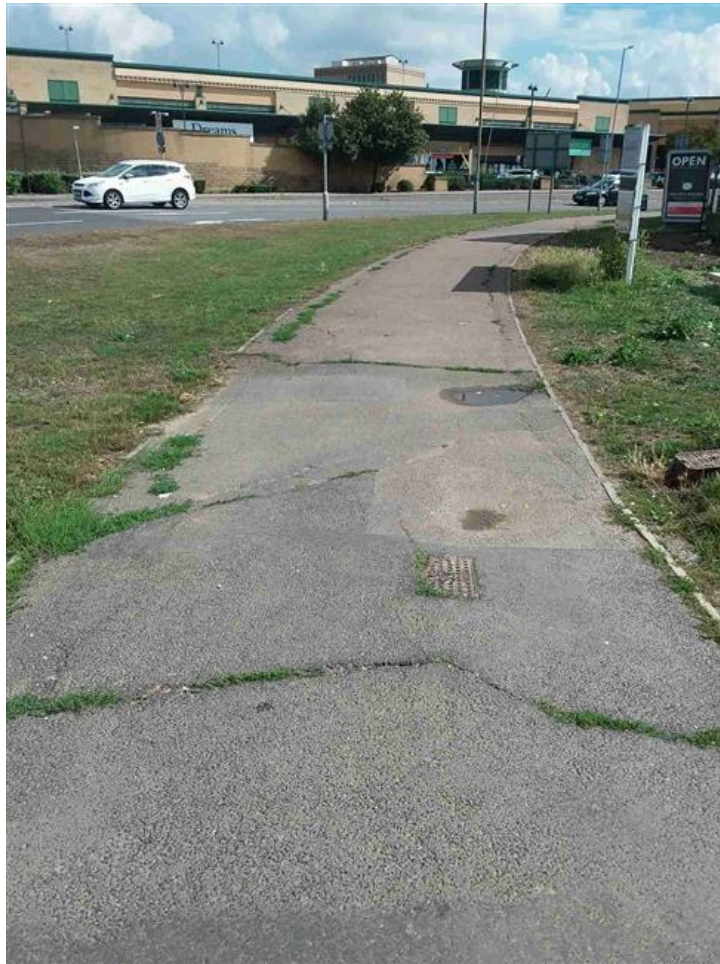
Defect Location Rear L/c 12, adj electric vehicle chargers in BP garage
Supersededdefect Number 3495730
Supersededlogged Date 17 Aug 2020 10:38
Superseded Defect Type Name HW: footway defect
Superseded Description RA 6 = 2 x 3 Depression in tarmac Footway Patch 5.0 x 2.5 x 150mm at its deepest point
Superseded Location Rear L/c 12
Superseded Supersedes Defect Number 3416275

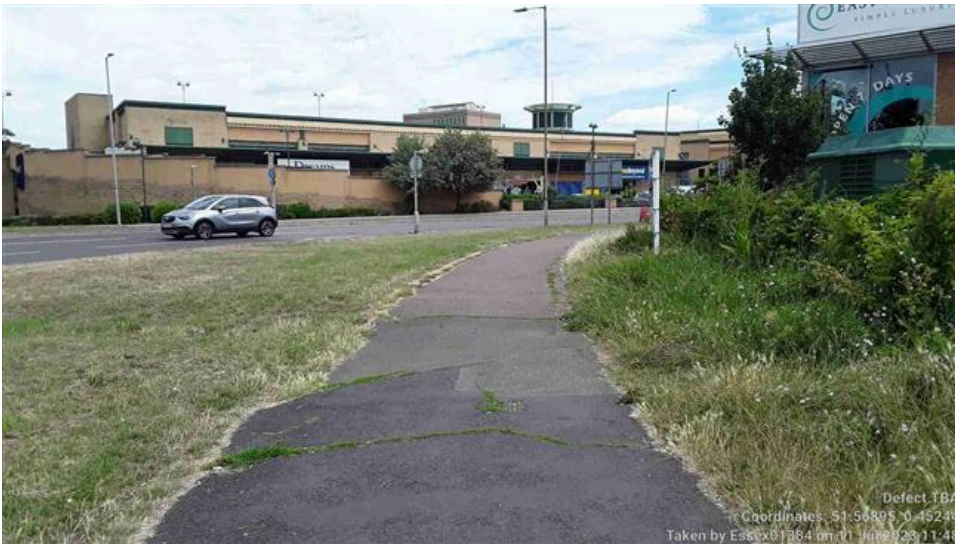
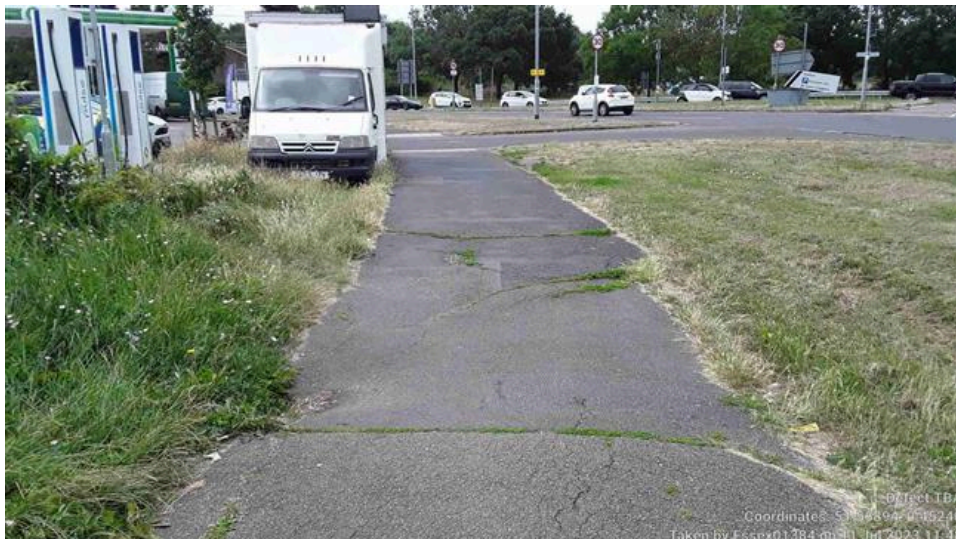
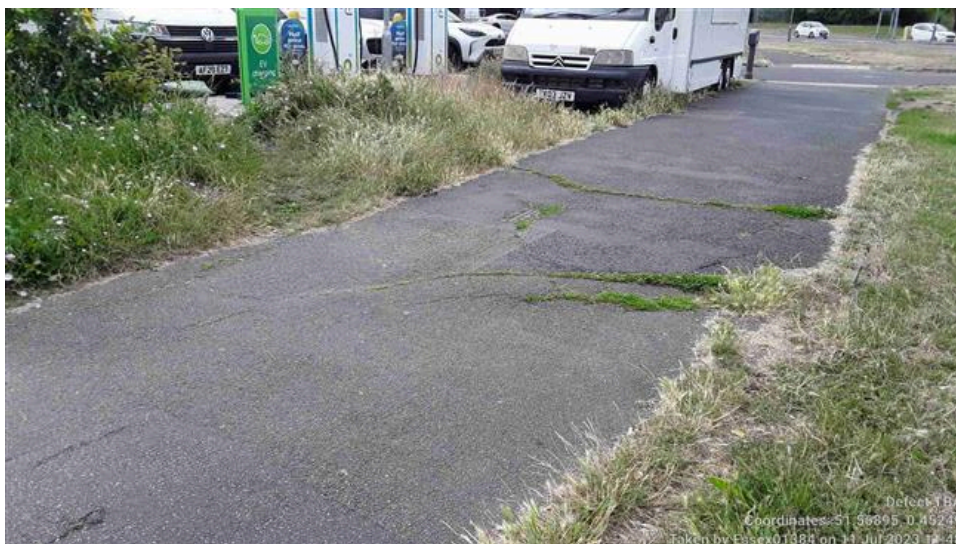
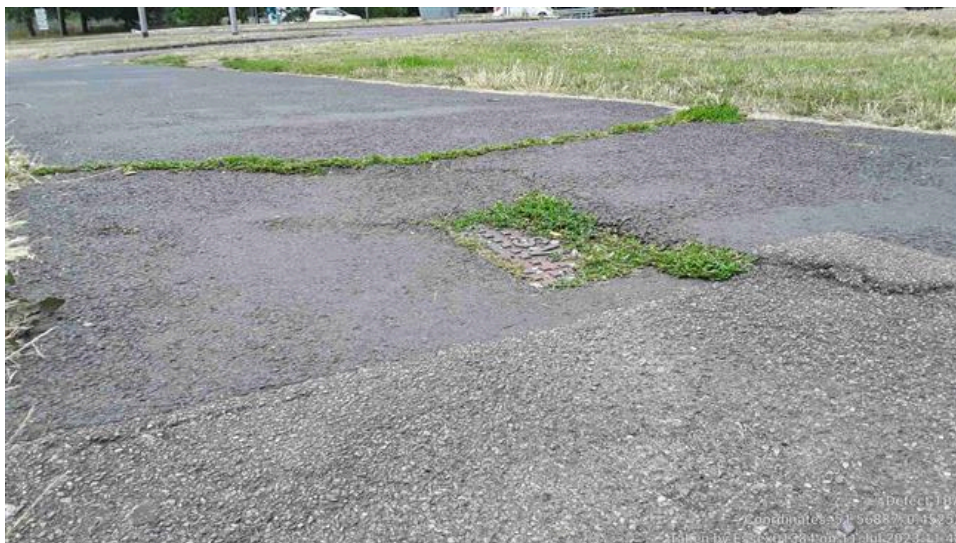
Ra6=2x3 fw cracked, sunken, uneven and undulating 5.0mx6.0mx 150mm at its deepest point, upstand against ESW SV cover is 40mm
