# General Inspection Report

**Structure Name:** GUTTERIDGE HALL BRIDGE

**Identifier:** 1515

**Inspection Date:** 30/11/2022

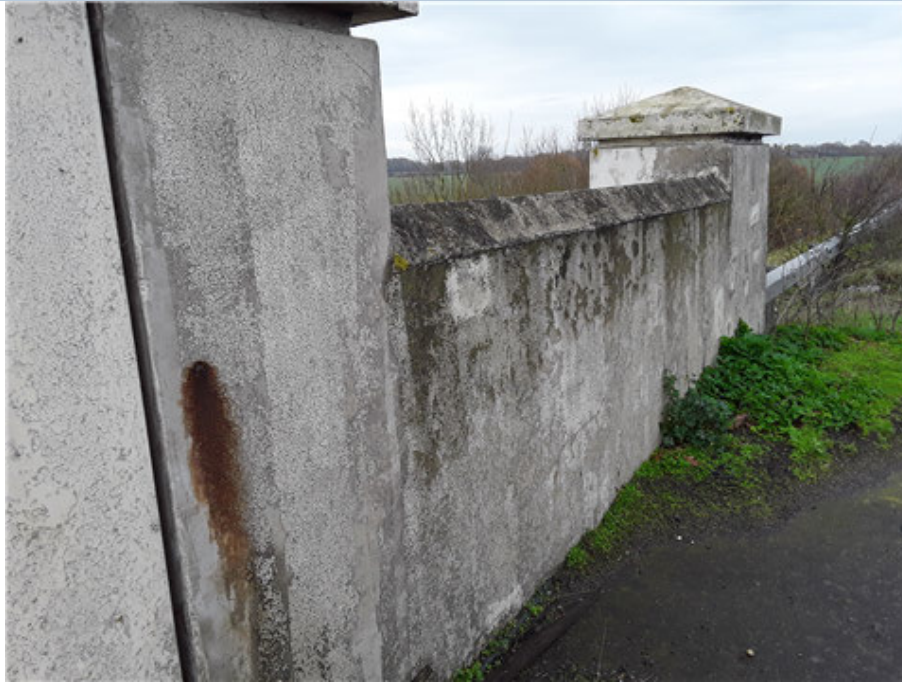
**Span 3 - West Pilasters**  
 Protective paint top coat failing.

Protective paint top coat chipped and flaking to wing walls and pilasters both sides. [none]

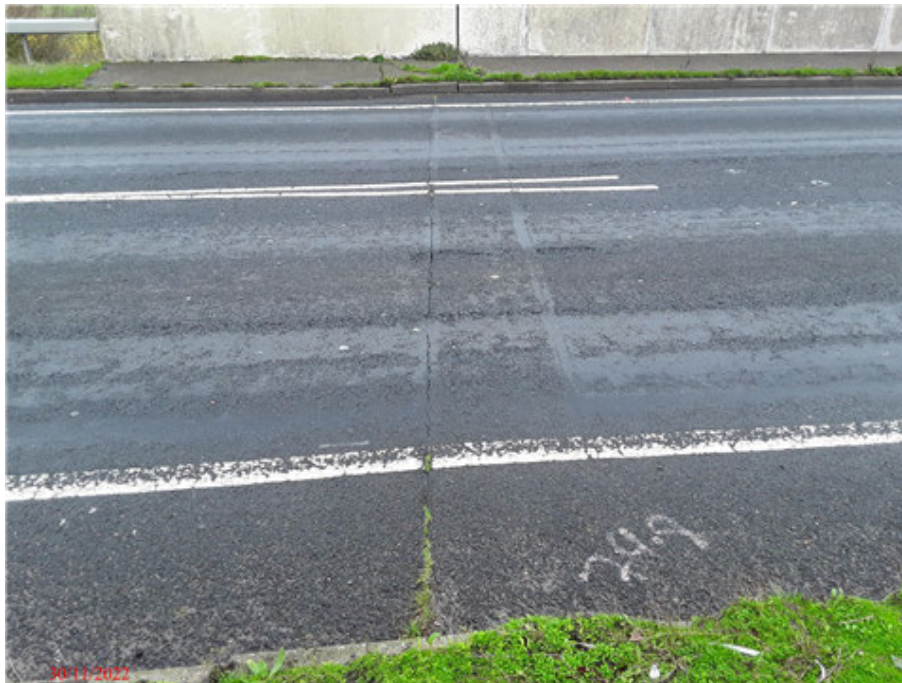
No	Element Name	Sev	Ext	Defect	Works	Priority	Cost £k
24	24/Carriageway surfacing	2	C	9.2	<input type="checkbox"/>	L	
<b>Comment</b>							
Carriageway surface cracked along APJ edges across both lanes with minor wear patch to west side northbound lane.							
<b>Remedial Works</b>							
[none]

**Span 3 - West Carriageway**  
 Cracks to APJ edges

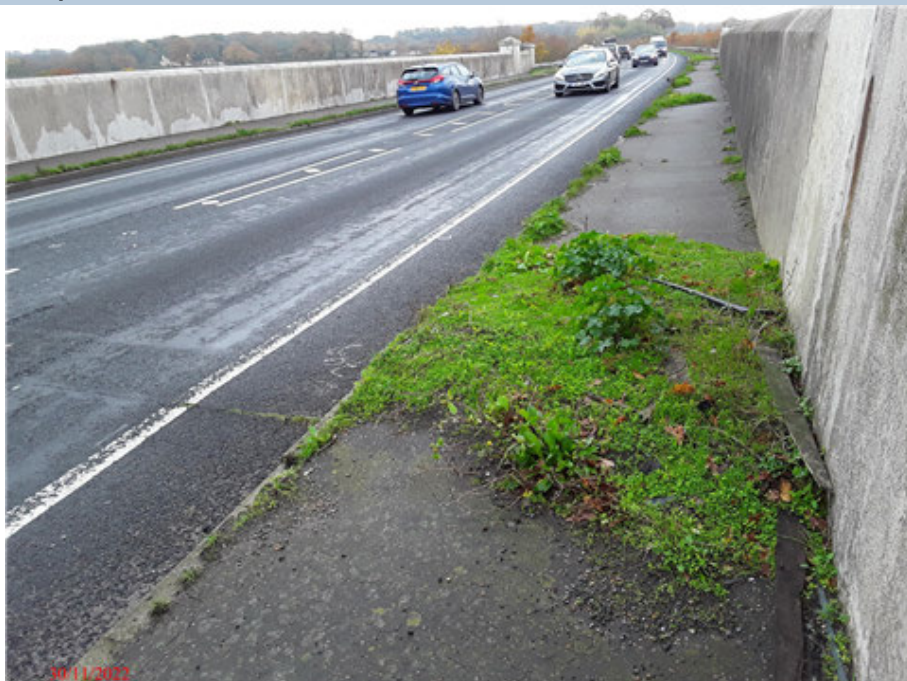
**Span 3 - West Footway**  
 Vegetation build up to footway front edge and joints.

Comment	Remedial Works
Large soil and Vegetation buildup above APJ on both footways. Vegetation growing to front and back of both footways.	Remove Vegetation

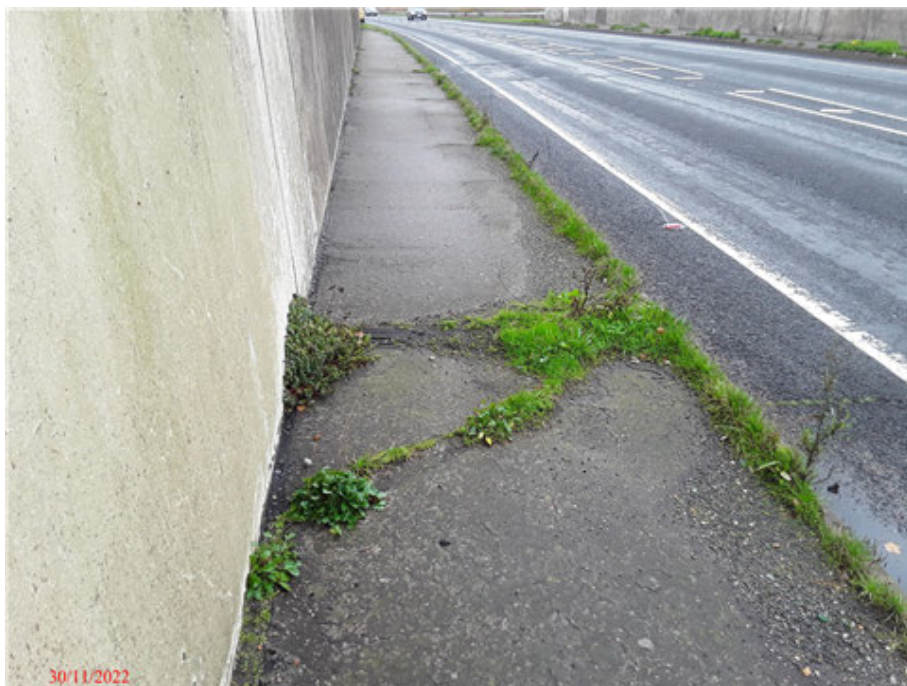
No	Element Name	Sev	Ext	Defect	Works	Priority	Cost £k
25	25/Fway/verge/fbrdge surfacing	2	B	9.2	<input type="checkbox"/>	L	
<b>Comment</b>							
North east footway cracked and sunk adjacent APJ							
<b>Remedial Works</b>							
[none]

**Span 3 - East Footway**  
 Footway cracked and sunk.

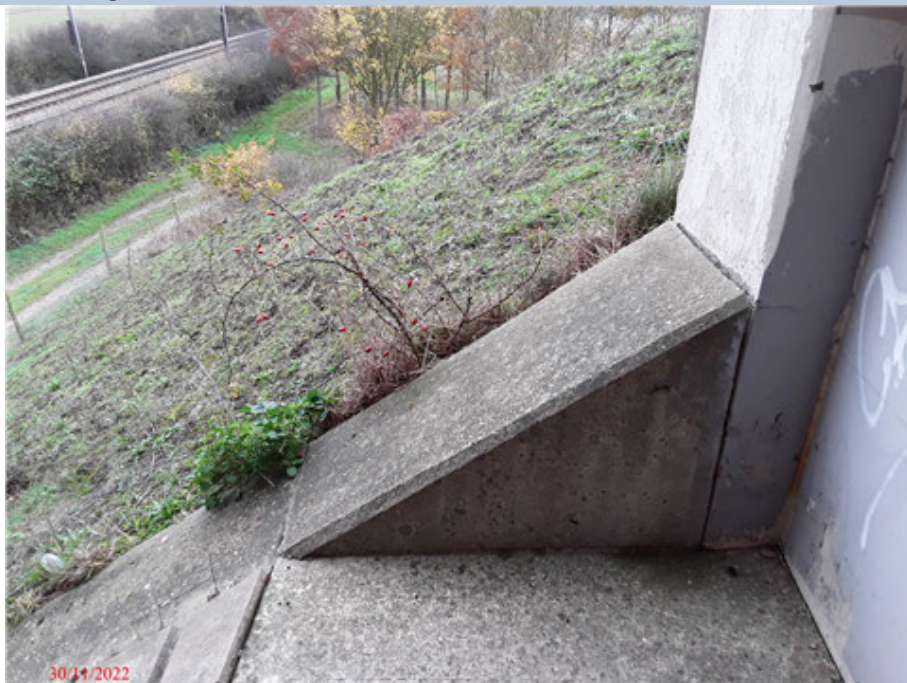
**Span 3 - North West Buttress**  
 Separation of 15mm to pilaster

Comment	Remedial Works
Minor rotation of concrete stop ends at top corners of revetment both sides, separation of 15mm from adjacent pilaster.	[none]

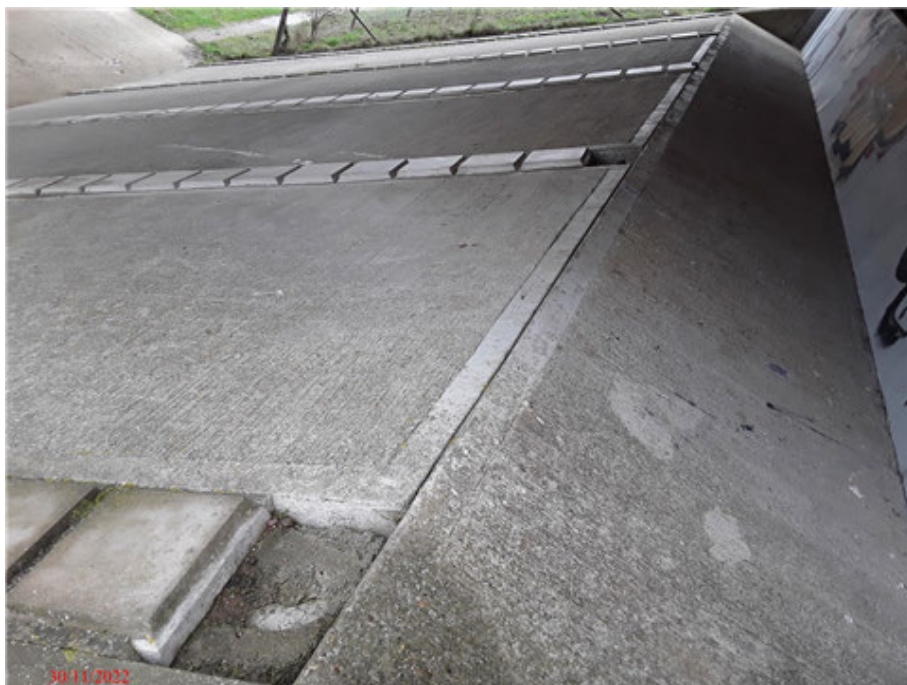
No	Element Name	Sev	Ext	Defect	Works	Priority	Cost £k
30	30/Revetment/batter paving	2	B	3.6	<input type="checkbox"/>	L	
<b>Comment</b>							
3no. missing revetment pavers missing from top upper line and 1no. chipped on top upper line.							
<b>Remedial Works</b>							
[none]

**Span 3 - North East Revetment**  
 Missing revetment pavers

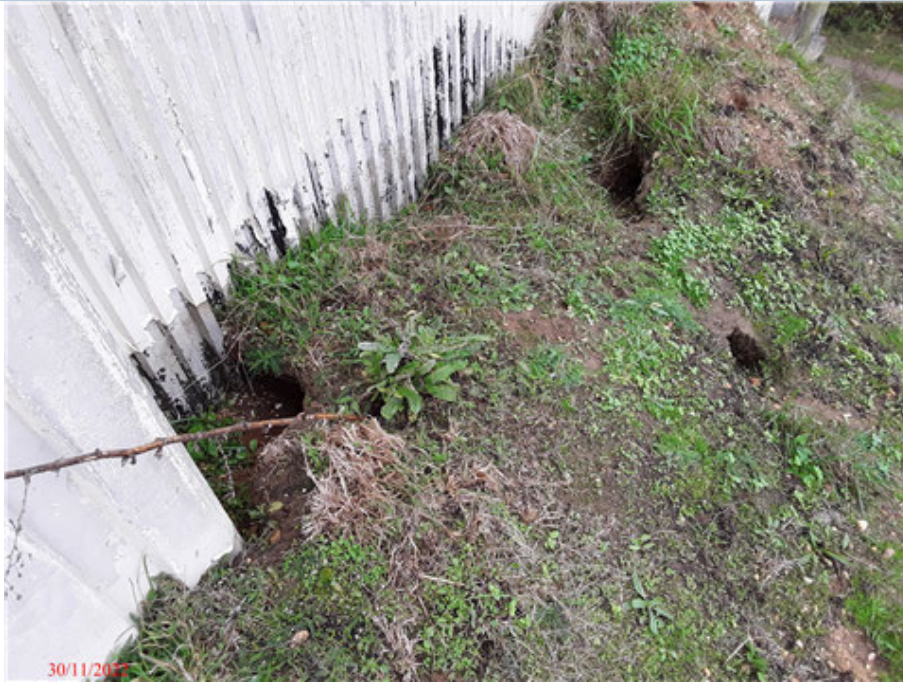
No	Element Name	Sev	Ext	Defect	Works	Priority	Cost £k
33	33/Embankments	2	B	11.1	<input type="checkbox"/>	L	
<b>Comment</b>							
Deep animal hole adjacent to wingwall at top of north east and north west embankments.							
<b>Remedial Works</b>							
[none]

**Span 3 - North West Embankment**  
 Animal habitat undermining elements.

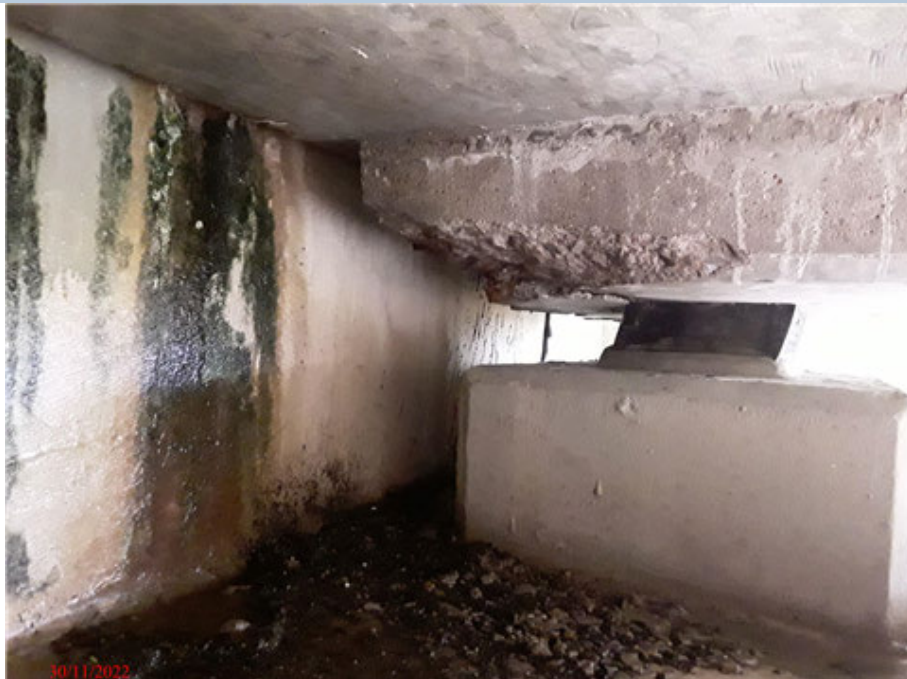
**Span 1 - South West Deck**  
 Concrete spalling deck underside.

Comment	Remedial Works
Moderate concrete spall to far end of south west edge beam, exposing corroded rebar, very close above bearing.	[none]

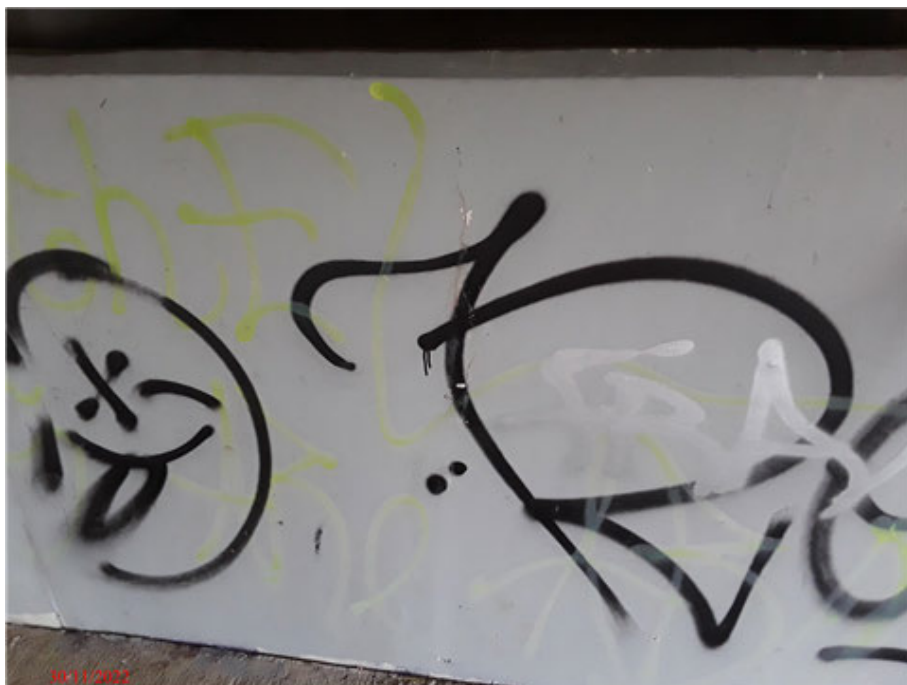
**Comment**  
 Minor vertical hairline crack full height 4m in from the west side.

**Span 1 - South West Abutment**  
 Vertical hairline crack

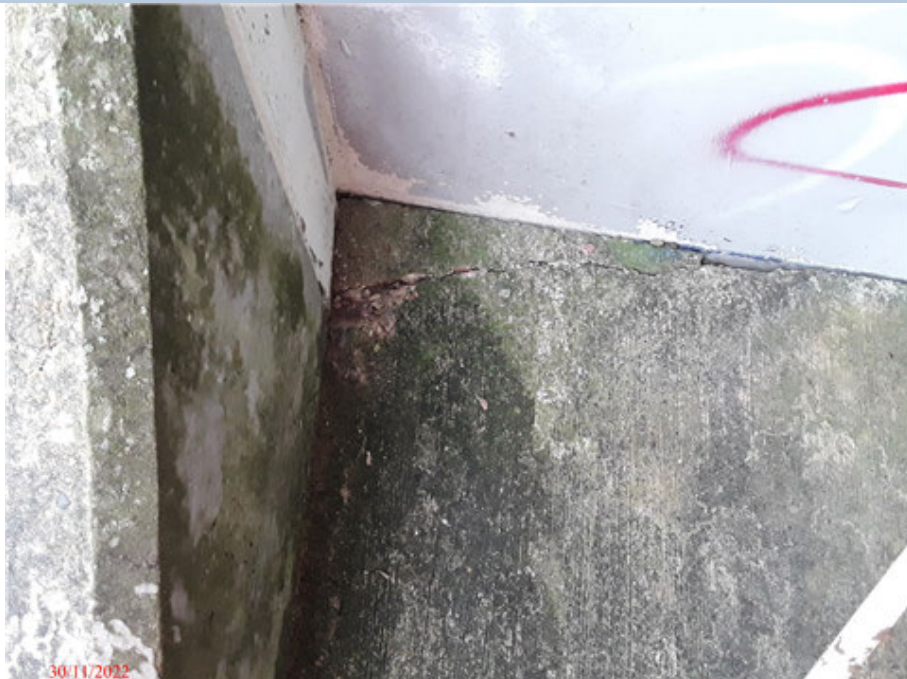
**Span 1 - South East Abutment**  
 Concrete crack

Comment	Remedial Works
Concrete crack to abutment shelf back edge in south east corner adjacent buttress	[none]

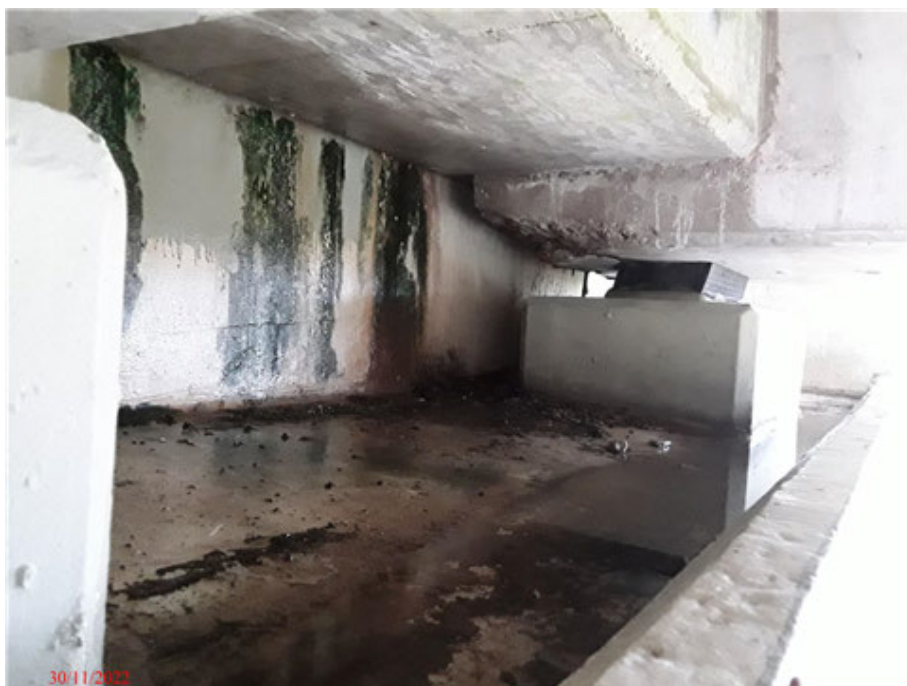
No	Element Name	Sev	Ext	Defect	Works	Priority	Cost £k
14	14/Bearing plinth/shelf	2	B	7.2	<input type="checkbox"/>	M	
<b>Comment</b>							
Pooling at south west end and south east of bearing shelf due to silt / debris blocking drainage path. It was noted that the south east weep holes were dripping water into the bearing shelf.							
<b>Remedial Works</b>							
[none]

**Span 1 - South West Bearing Shelf**  
 Water pooling on bearing shelf.

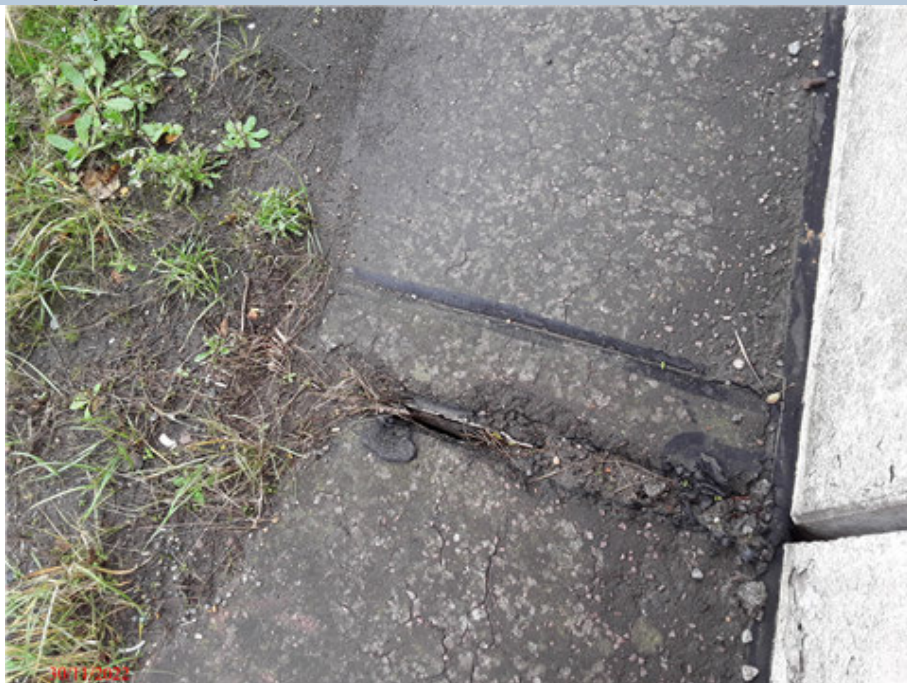
**Span 1 - East Footway APJ**  
 APJ south edge open.

Comment	Remedial Works
Water ingress through APJ at south west and south east (Most probably through footway) causing staining to east abutment and pooling at south west bearing shelf. Could also contribute to further spalling to end of south west edge beam.	[none]

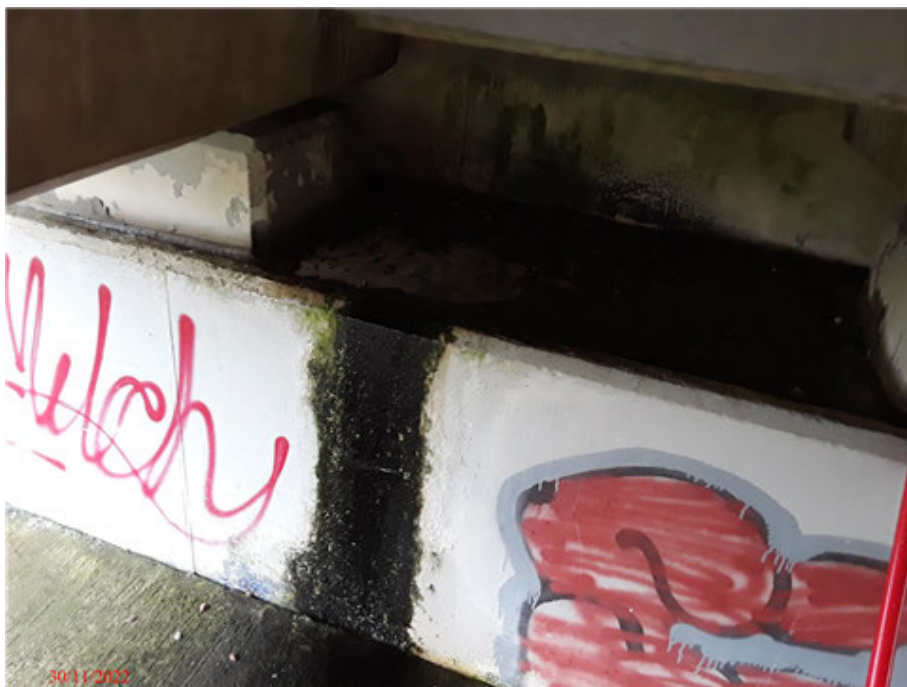
No	Element Name	Sev	Ext	Defect	Works	Priority	Cost £k
18	18/Movement/expansion joints	3	B	10.12	<input type="checkbox"/>	H	
<b>Comment</b>							
Water ingress through APJ at south west and south east (Most probably through footway) causing staining to east abutment and pooling at south west bearing shelf. Could also contribute to further spalling to end of south west edge beam.							
<b>Remedial Works</b>							
[none]

**Span 1 - South East Abutment**  
 Staining to elements

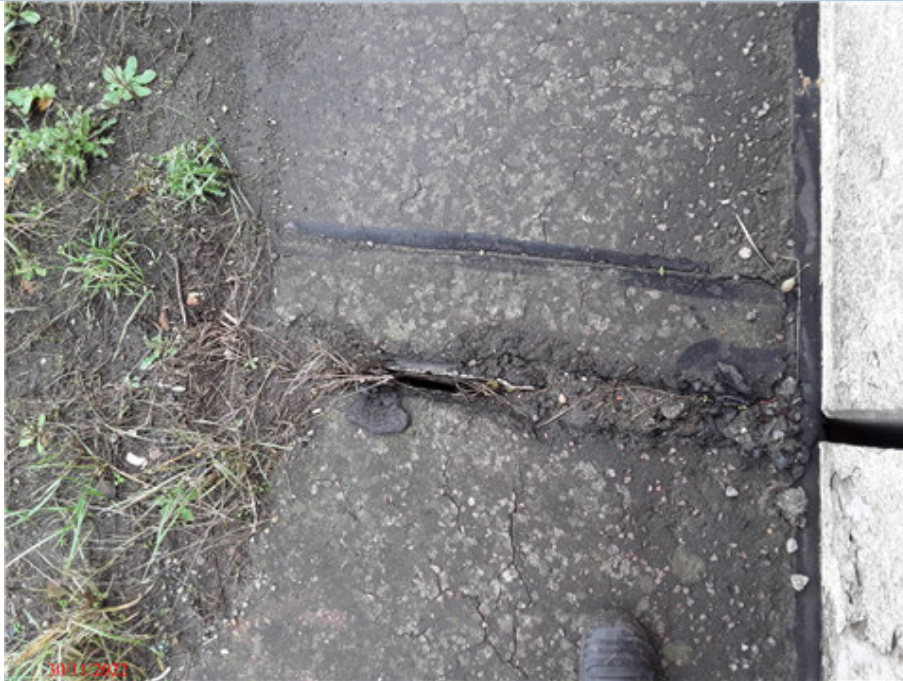
No	Element Name	Sev	Ext	Defect	Works	Priority	Cost £k
18	18/Movement/expansion joints	3	C	10.1	<input checked="" type="checkbox"/>	H	8
<b>Comment</b>							
APJ has debonded from east side of carriageway and missing joint sealant on east footway.							
<b>Remedial Works</b>							
Replace joints

**Span 1 - East Footway APJ**  
 Sealant debonded and missing

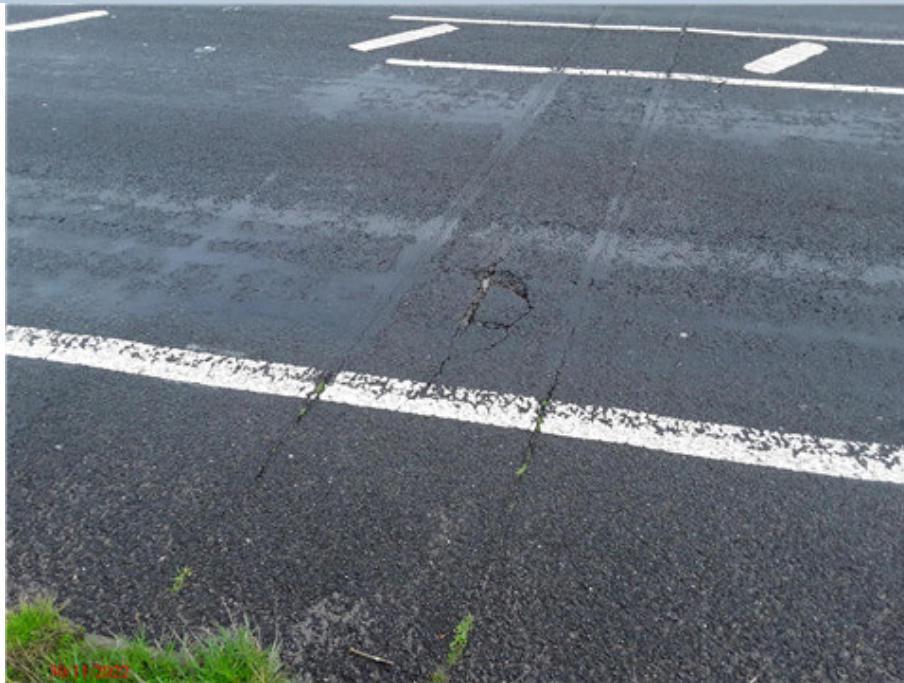
**Span 1 - West Carriageway Surfacing**  
 Asphalt breaking up in APJ

Comment	Remedial Works
Carriageway cracked and eroded in centre of joint to the west side in APJ surfacing on northbound carriageway. Carriageway cracked along edges of APJ joint across both lanes.	[none]

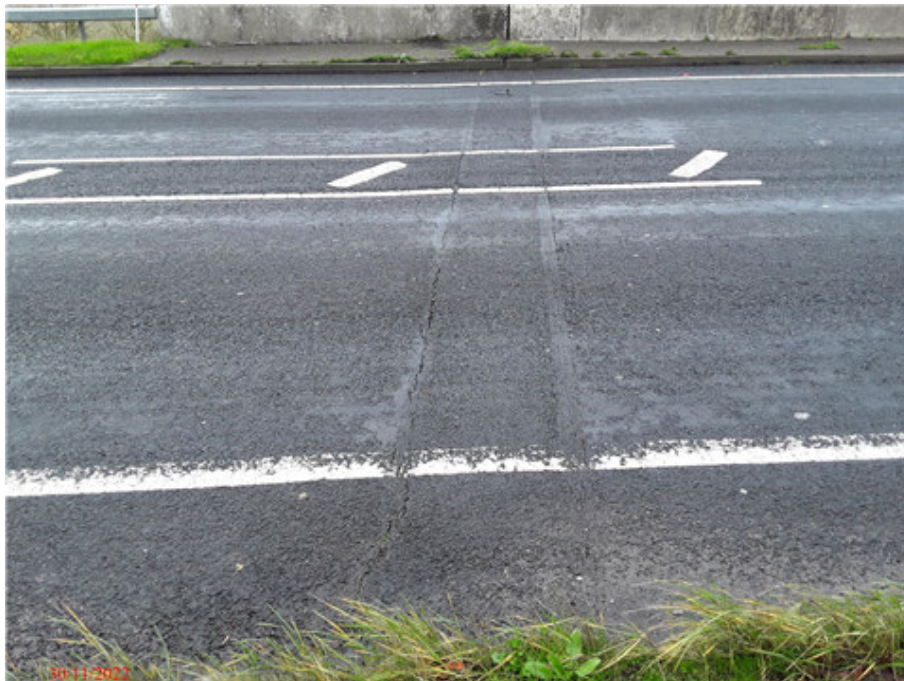
No	Element Name	Sev	Ext	Defect	Works	Priority	Cost £k
24	24/Carriageway surfacing	2	B	9.2	<input type="checkbox"/>	M	
<b>Comment</b>							
Carriageway cracked and eroded in centre of joint to the west side in APJ surfacing on northbound carriageway. Carriageway cracked along edges of APJ joint across both lanes.							
<b>Remedial Works</b>							
[none]

**Span 1 - East Carriageway**  
 Cracks along APJ edges across carriageway

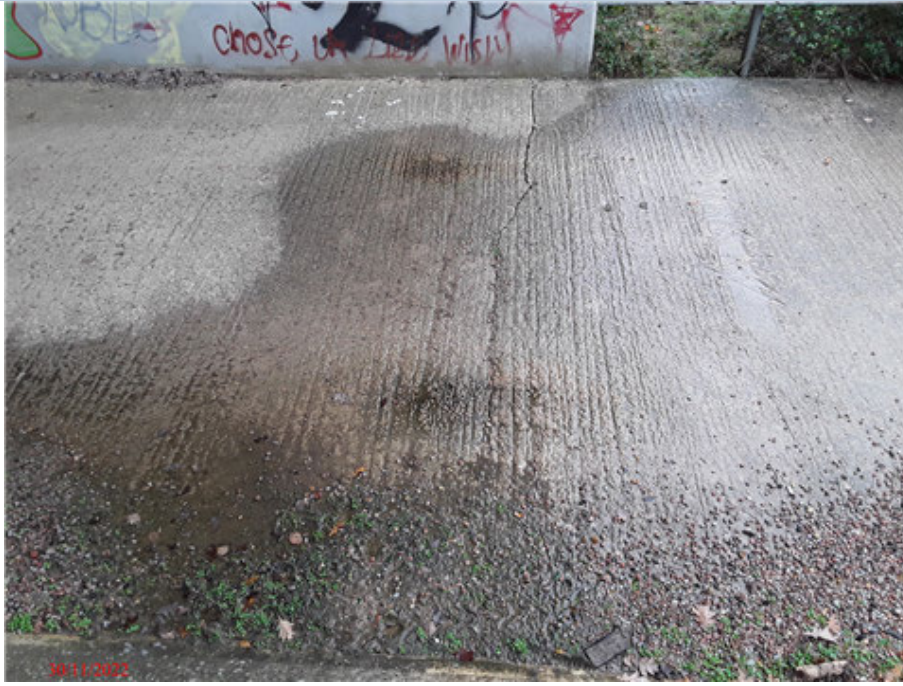
**Span 1 - South East Substructure Carriageway**  
 Concrete crack

Comment	Remedial Works
Lower substructure carriageway transverse crack across width open hairline (south side ) to 10mm (north side)	[none]

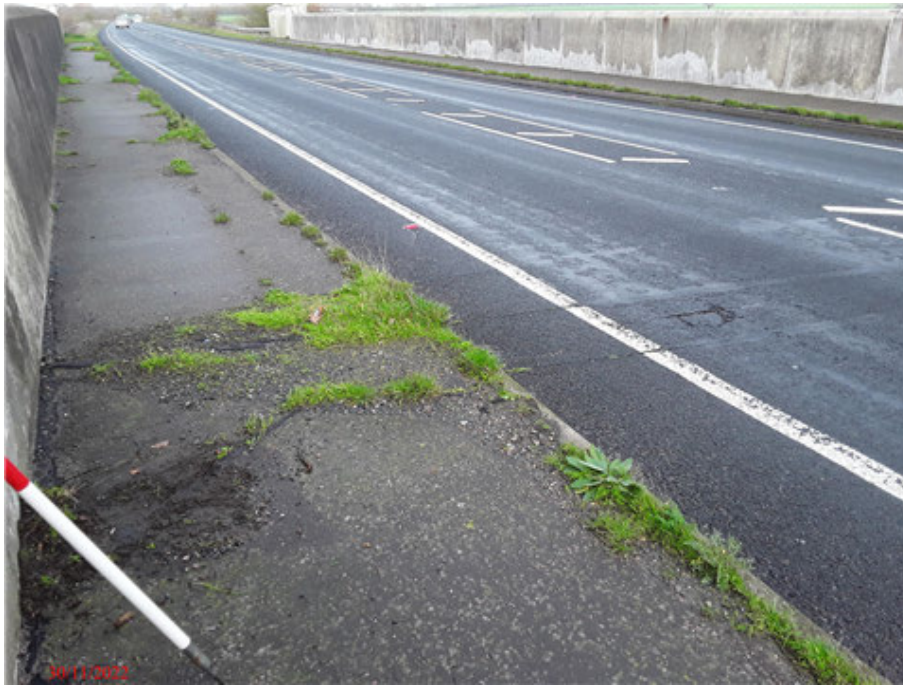
No	Element Name	Sev	Ext	Defect	Works	Priority	Cost £k
25	25/Fway/verge/fbrdge surfacing	3	C	5.1	<input checked="" type="checkbox"/>	H	0.4
<b>Comment</b>							
Soil and vegetation build up level with APJ on east and west footway (probable contributor to water ingress). Grass growing to front of both footways.							
<b>Remedial Works</b>							
Remove Vegetation

**Span 1 - South West Footway**  
 Vegetation build up around APJ on footway.

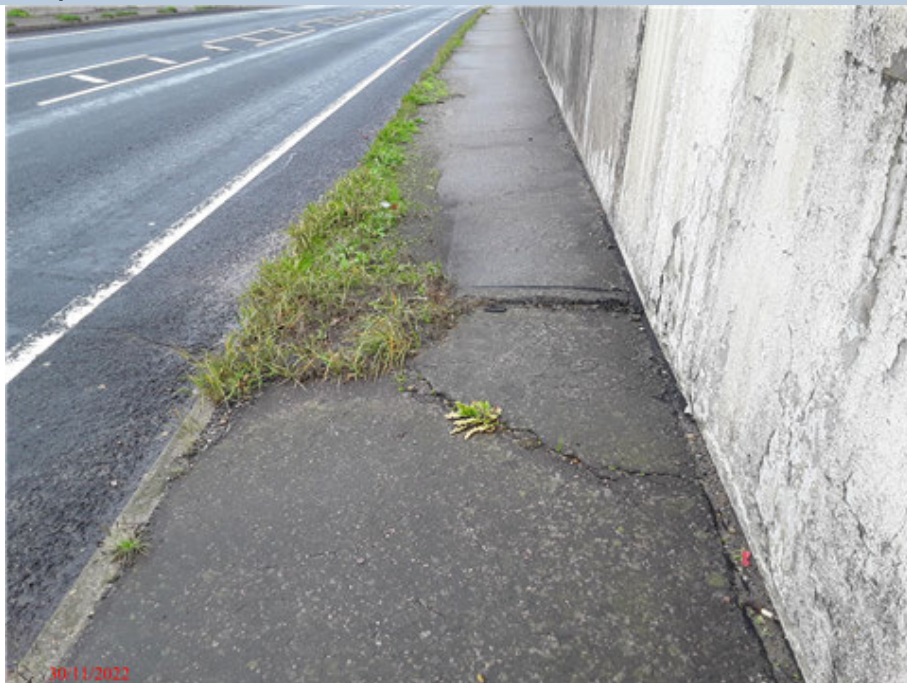
**Span 1 - East Footway**  
 Footway cracked and sunk

Comment	Remedial Works
East footway cracked and sunk adjacent to AJP. Minor multiple transverse cracks to east footway.	[none]

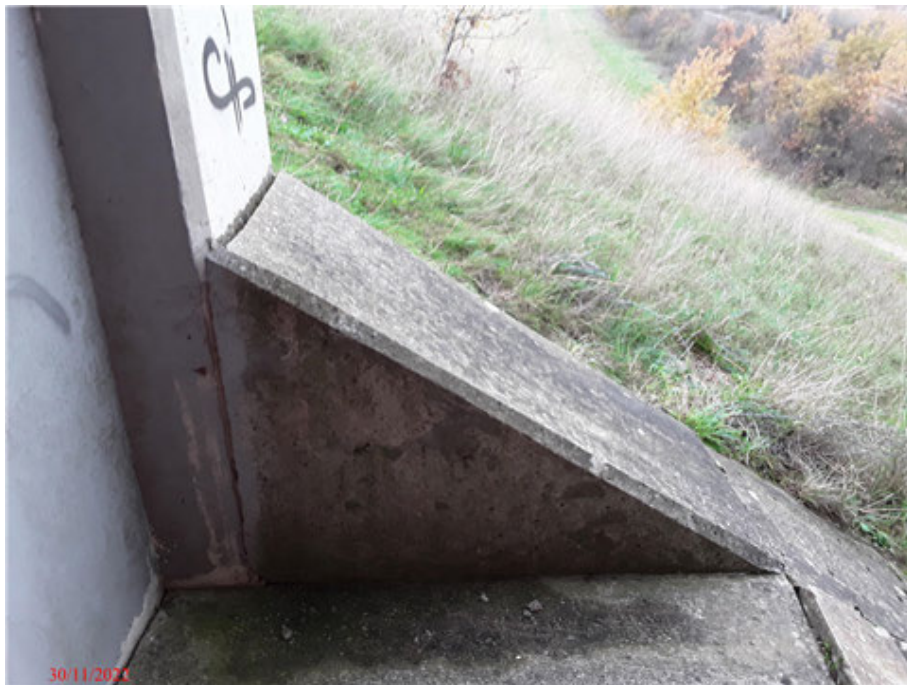
No	Element Name	Sev	Ext	Defect	Works	Priority	Cost £k
30	30/Revetment/batter paving	2	B	6.4	<input type="checkbox"/>	M	
<b>Comment</b>							
Minor rotation of concrete stop end buttresses at top corners of revetment both sides, separation of 20mm from adjacent pilaster.							
<b>Remedial Works</b>							
[none]

**Span 1 - West Buttress**  
 Minor rotation to buttress.

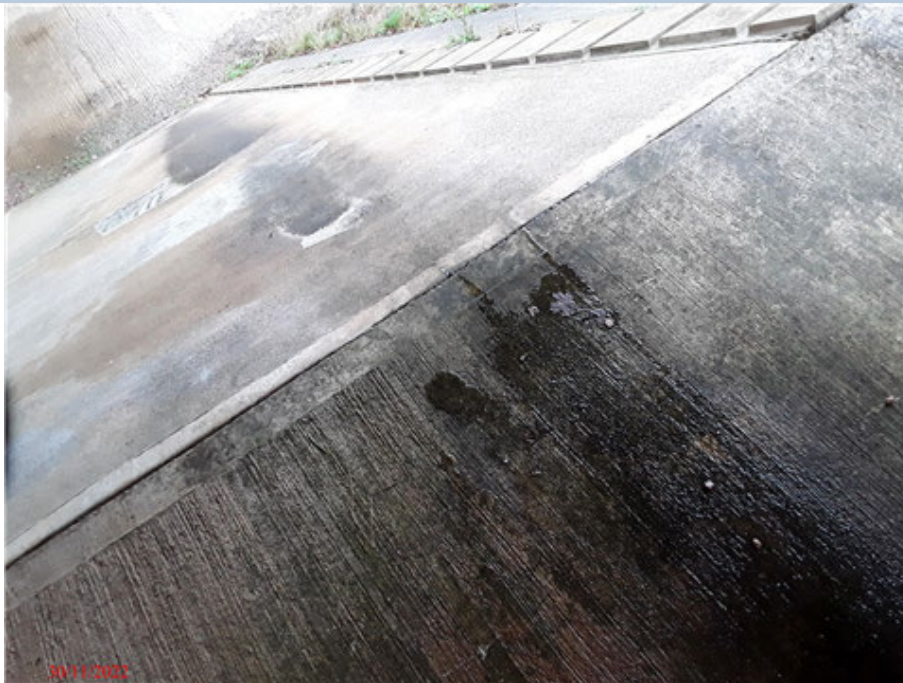
**Span 1 - East Substructure**  
 Staining from dripping weep holes.

Comment	Remedial Works
Weep holes dripping water and staining south bearing shelf, abutment and revetment.	[none]

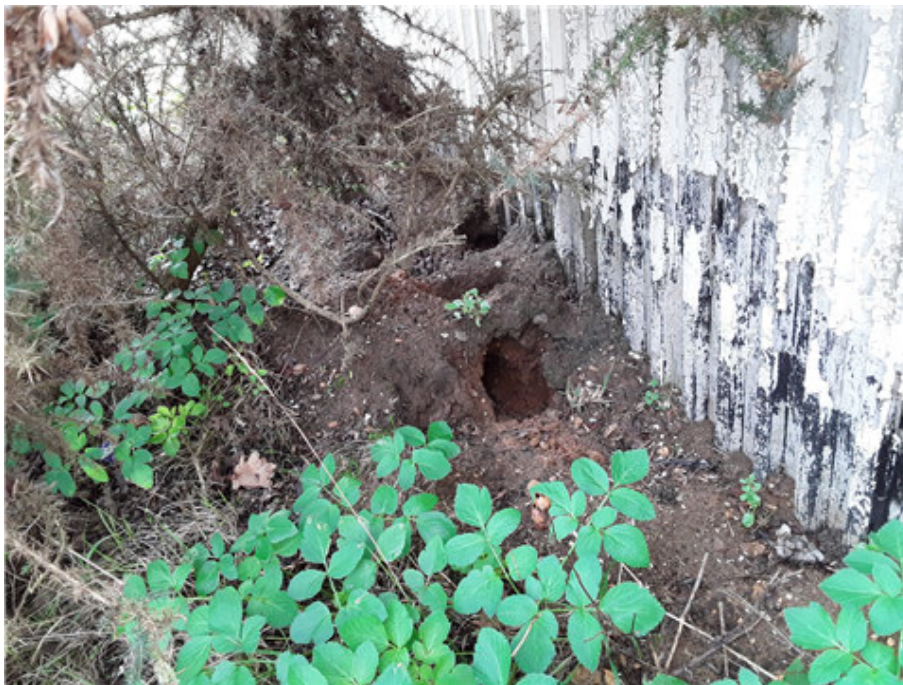
No	Element Name	Sev	Ext	Defect	Works	Priority	Cost £k
33	33/Embankments	3	B	11.1	<input type="checkbox"/>	L	
<b>Comment</b> Large/ deep rabbit (or other animal) holes at top of south west and south east embankment, directly next to wingwall.							
<b>Remedial Works</b> [none]

**Span 1 - South East Embankment**  
 Animal habitat undermining elements

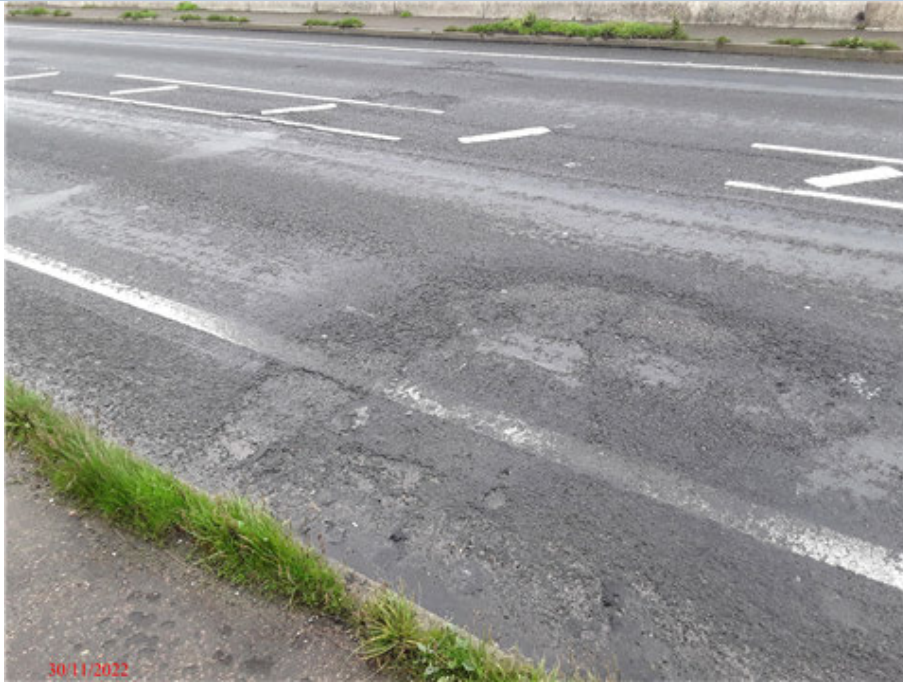
**Span 2 - East Carriageway**  
 Patches of carriageway erosion across both lanes.

Comment	Remedial Works
Carriageway wearing coarse top layer eroding in patches across both carriageway lanes.	[none]

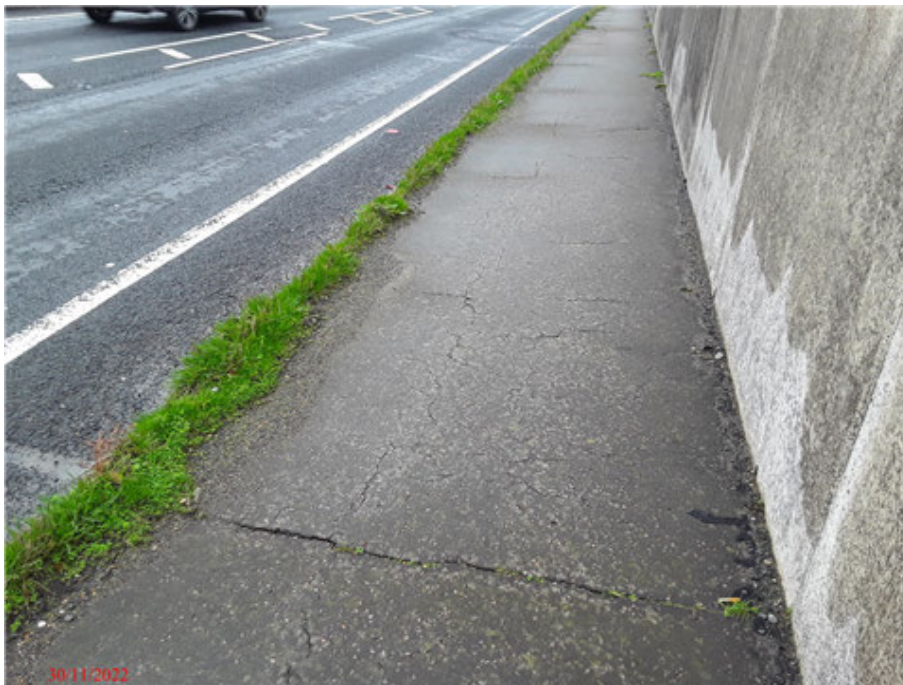
**Span 2 - East Footway**  
 Minor cracks to footway

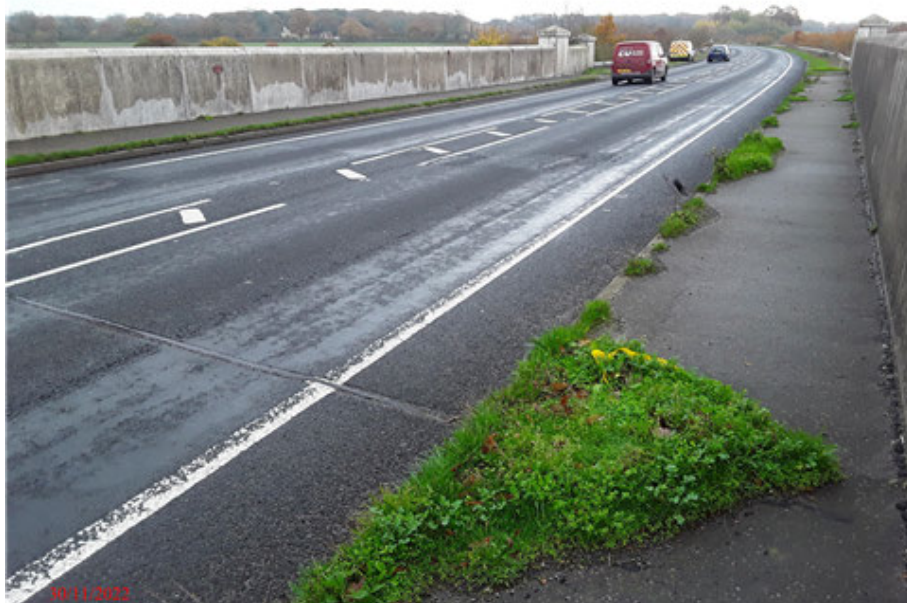
**Span 2 - West Footway**

Vegetation build up to footway front edge and joints.
