General Inspection Report

Structure Name: GUTTERIDGE HALL BRIDGE

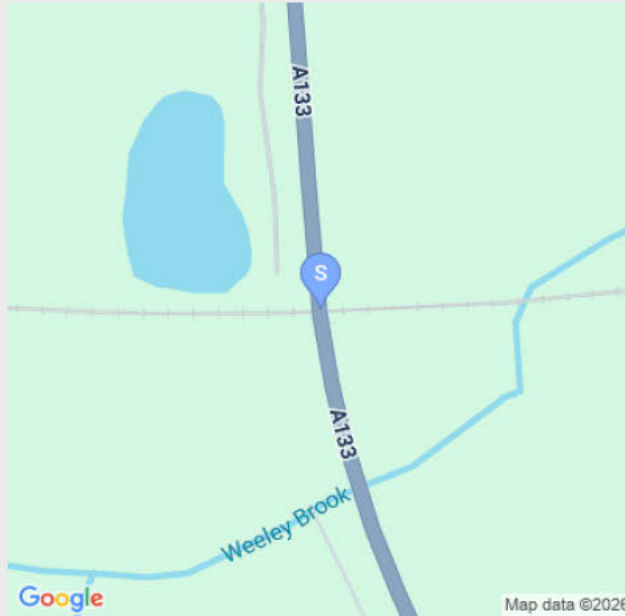
Summary Photographs:

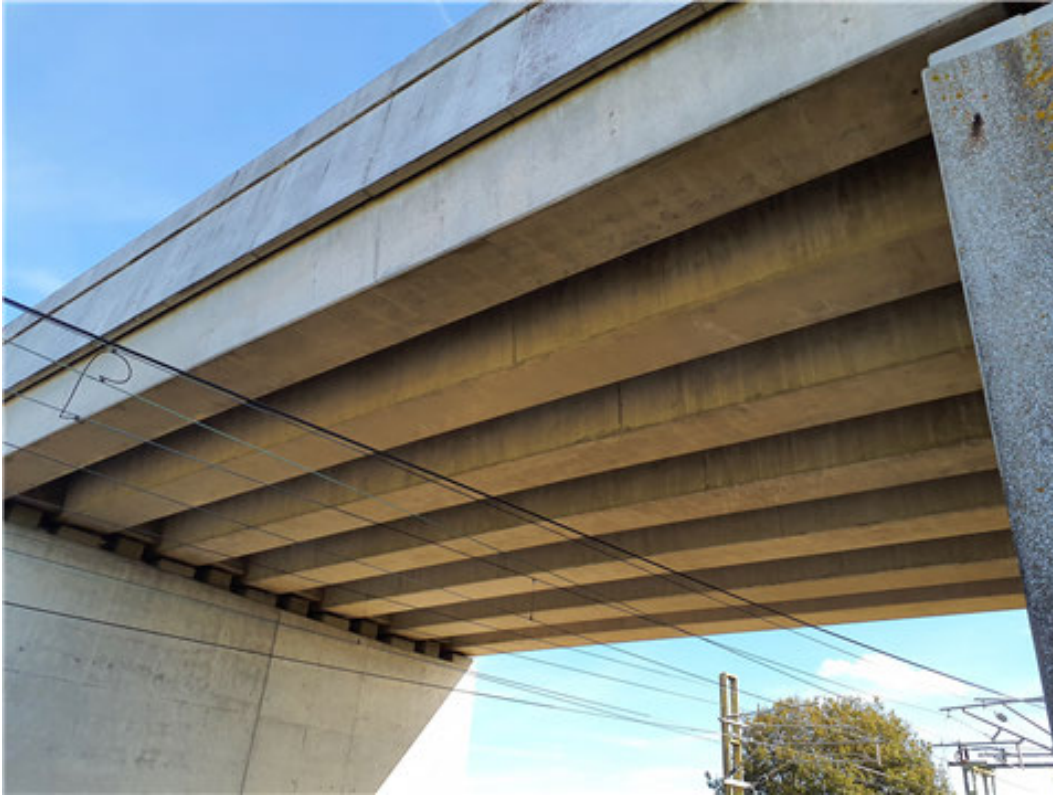
General Photograph 2
General view of the deck soffit of span 2.

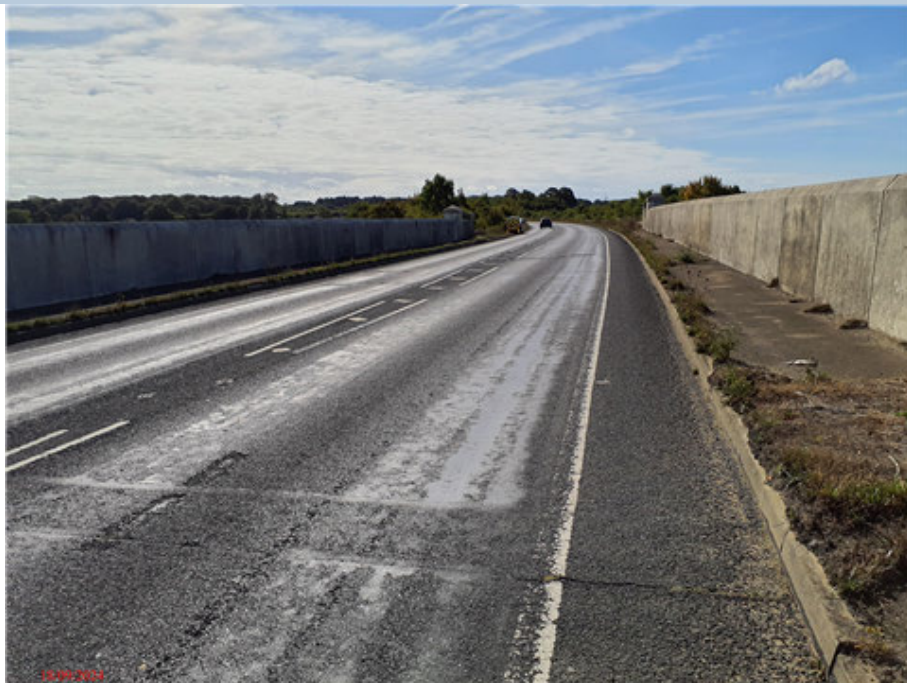
20240917_104238_1.jpg

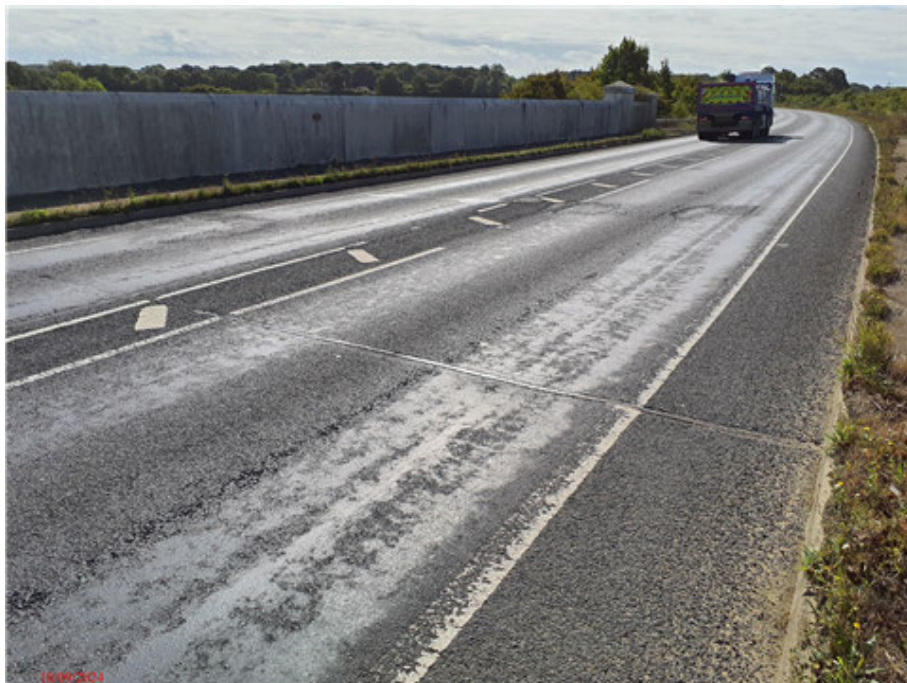
20240917_104321_3.jpg

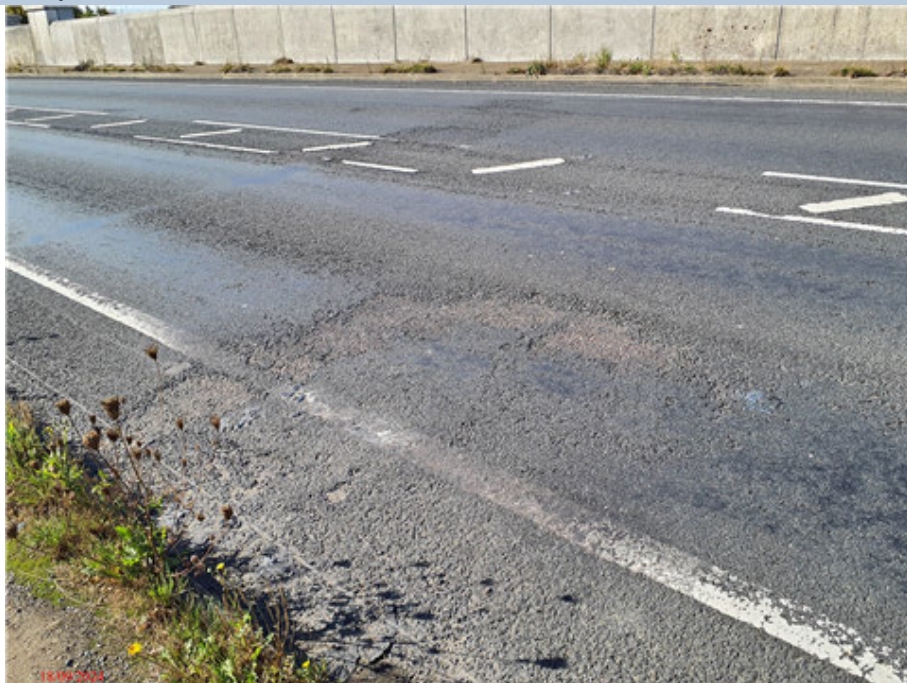
20240917_104139(0)_2.jpg

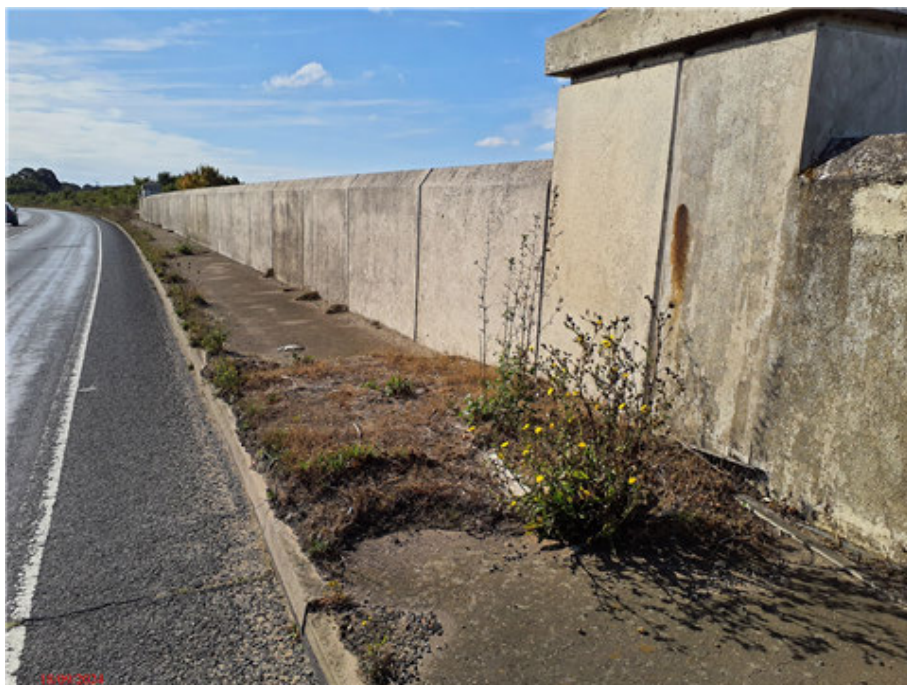
Comment	Remedial Works
Moderate wear and fretting to the carriageway surfacing over much of the span. This is not considered to warrant remedial works at present.	[none]

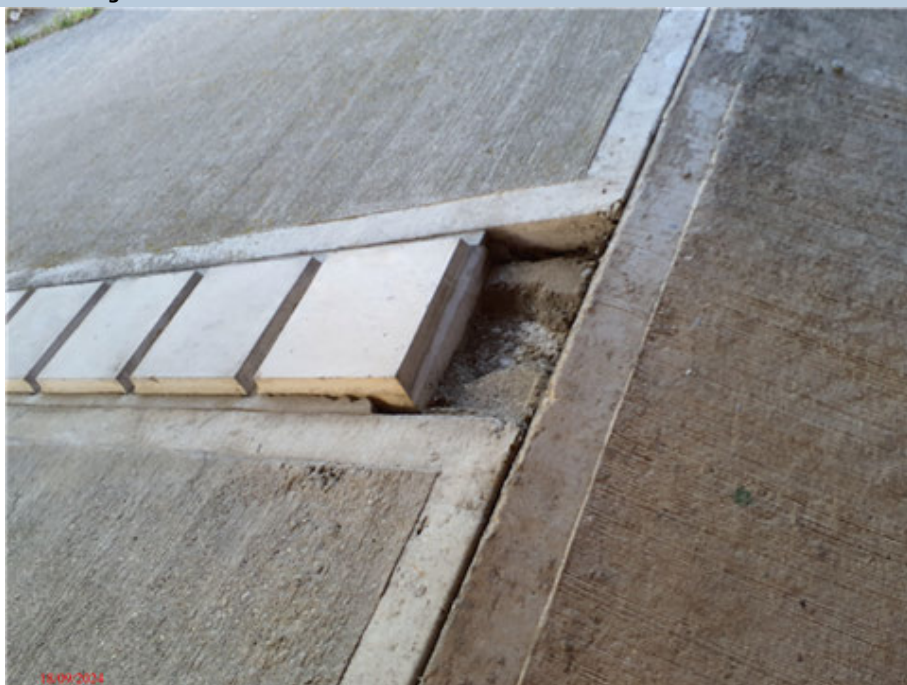
Other Bridge Elements

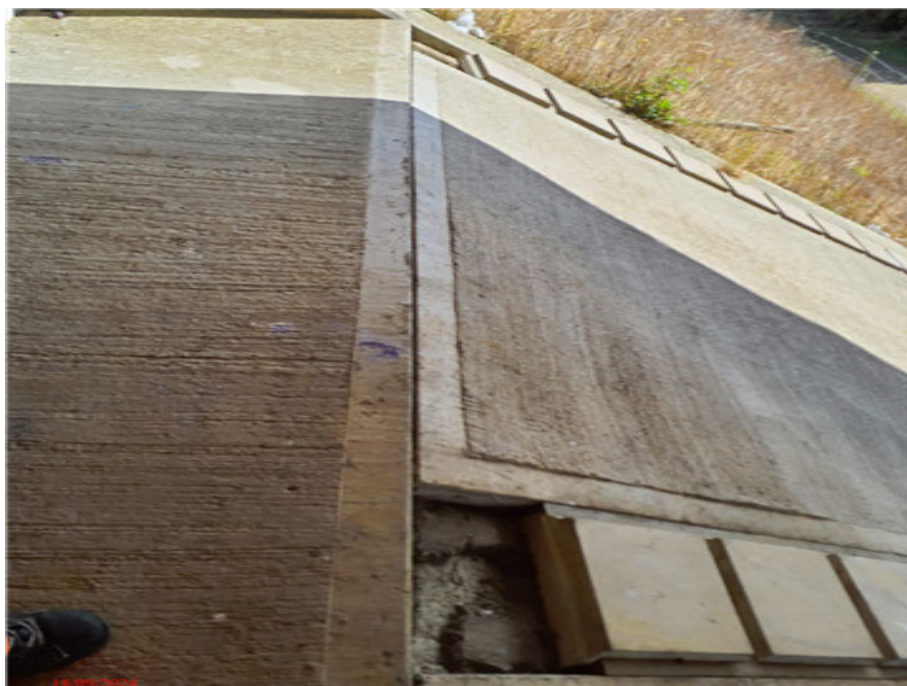
Repair the revetment as necessary.

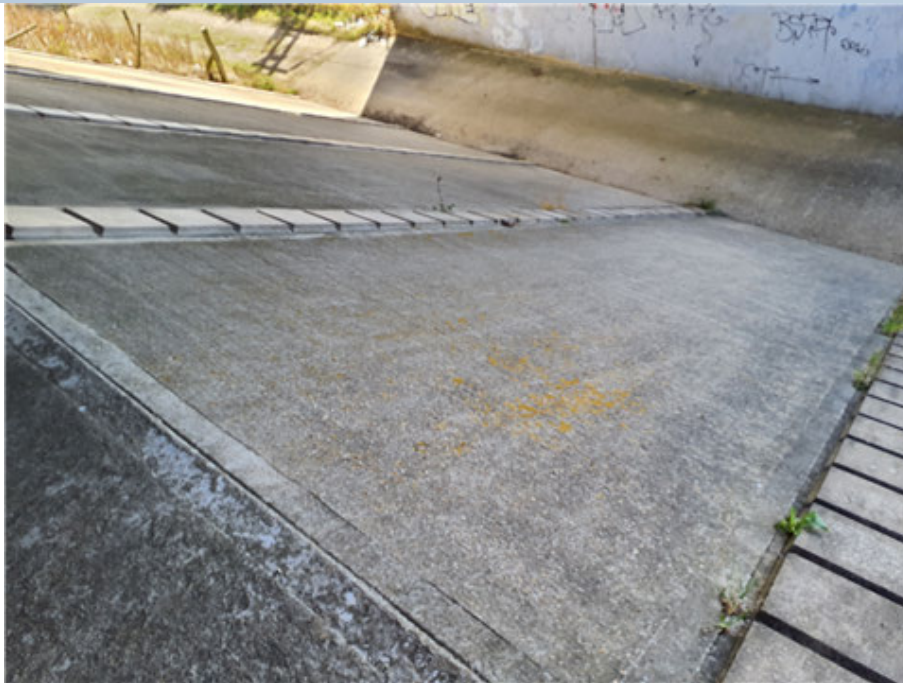
20240917_105943.jpg
 30 - 30/Revetment/batter paving

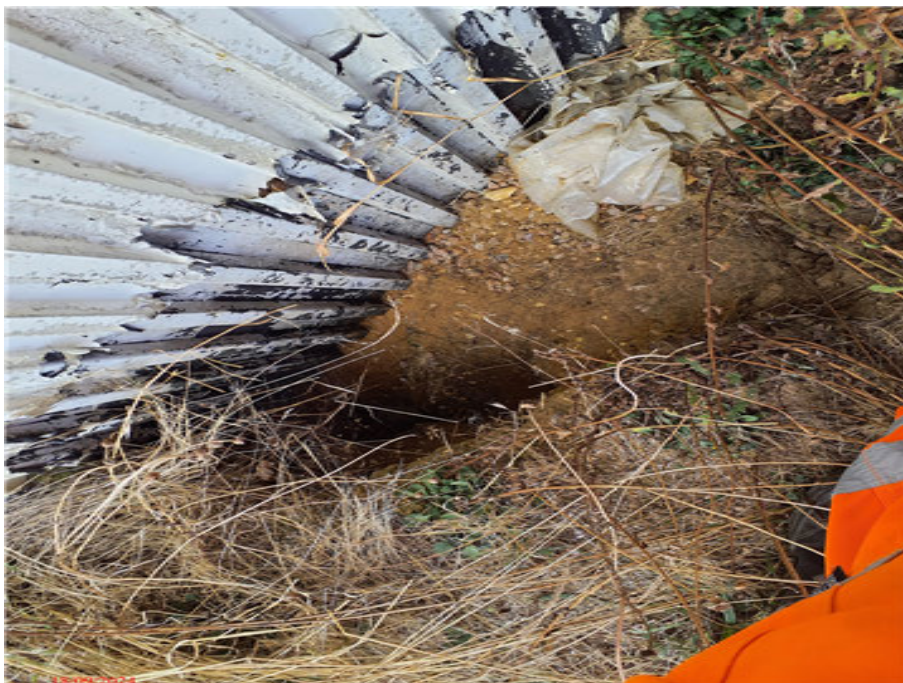
20240917_110347_1.jpg

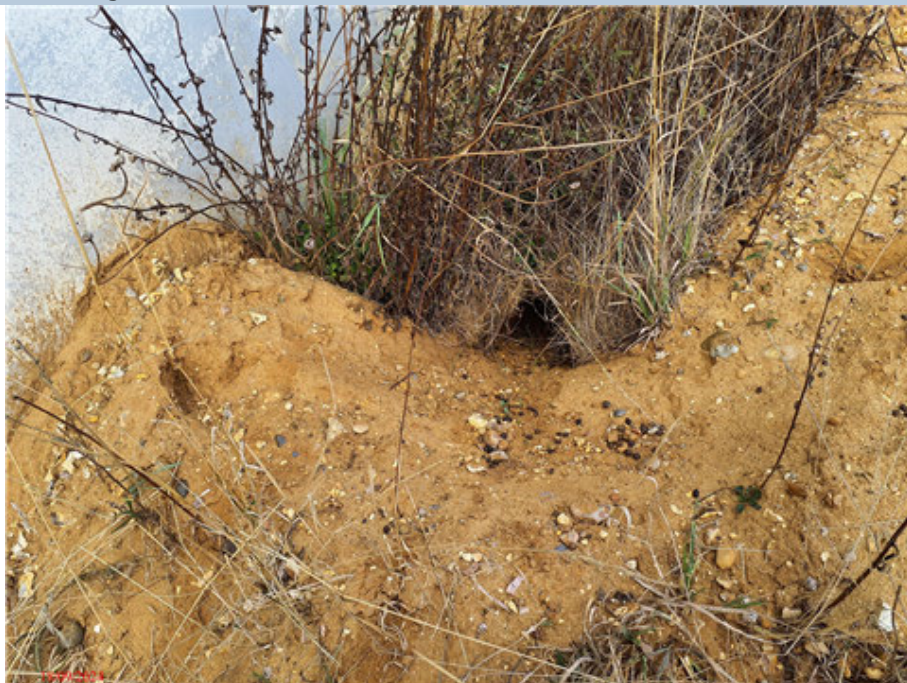
20240917_110329_1.jpg

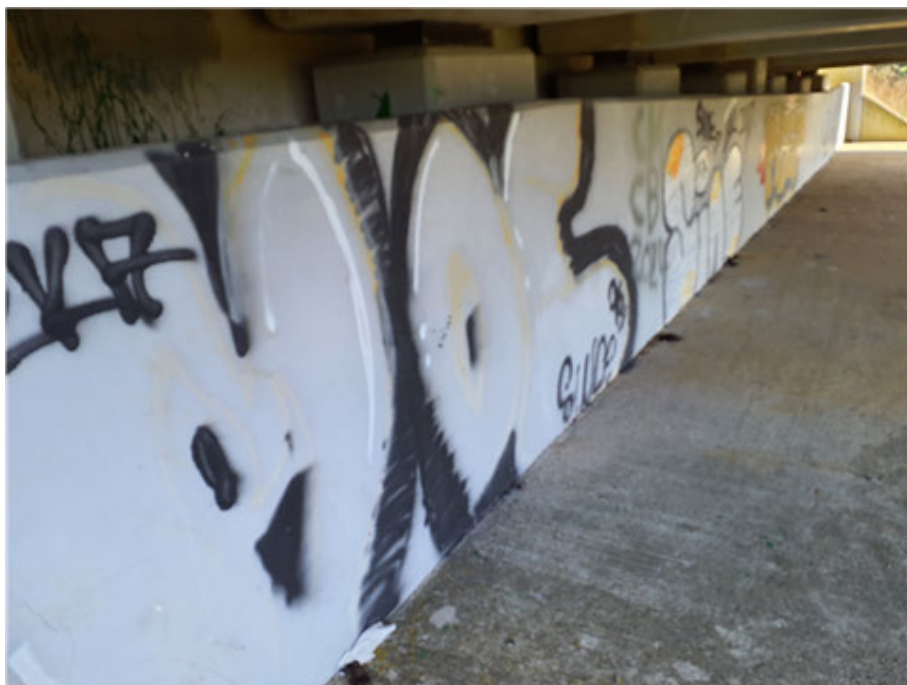
North abutment
 Non-offensive graffiti within view of the railway beneath span 2.

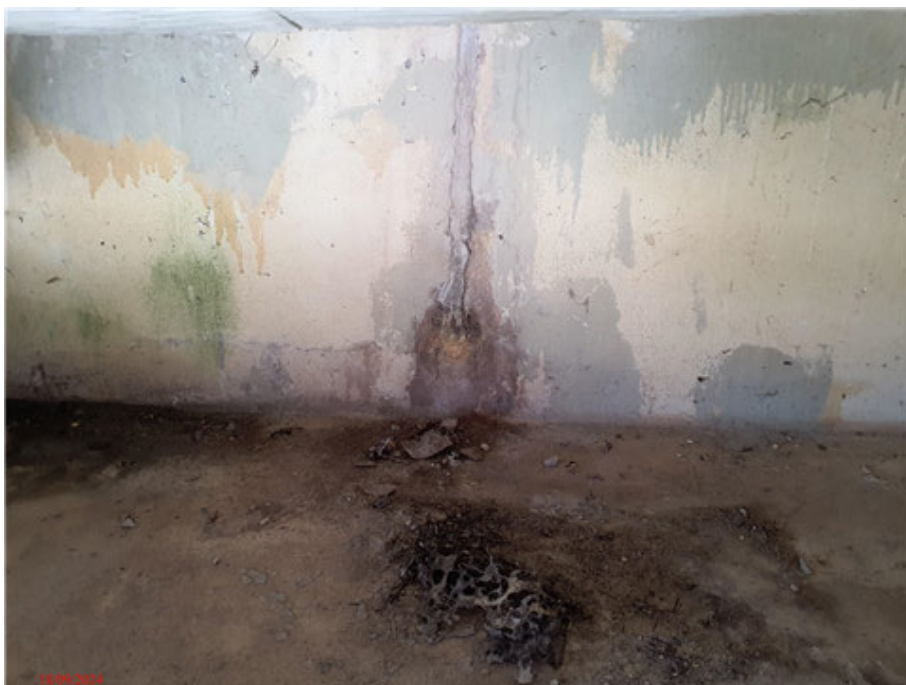
Repair the beam as necessary.

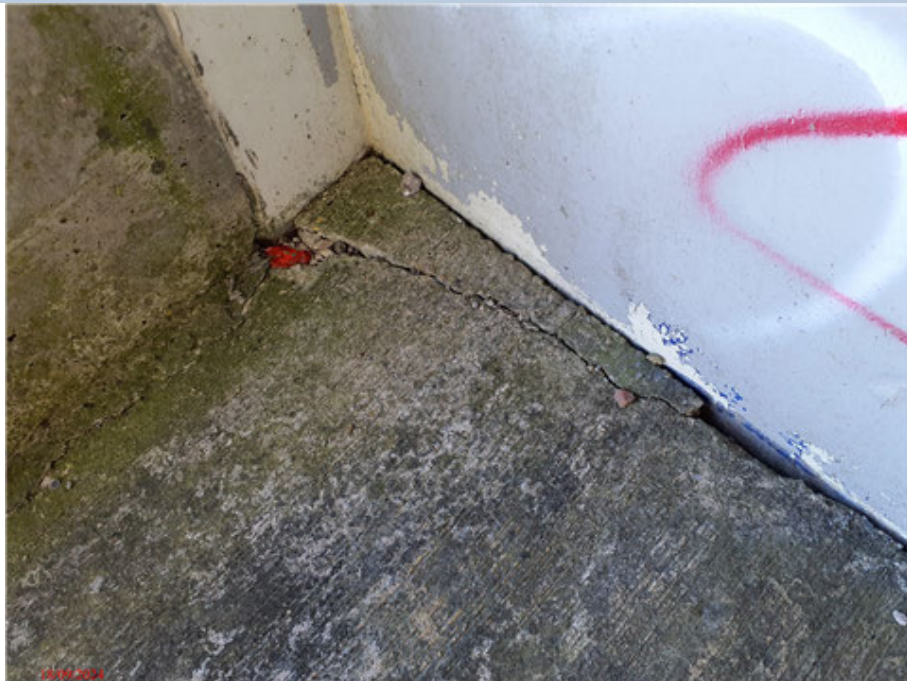
Load-bearing Substructure

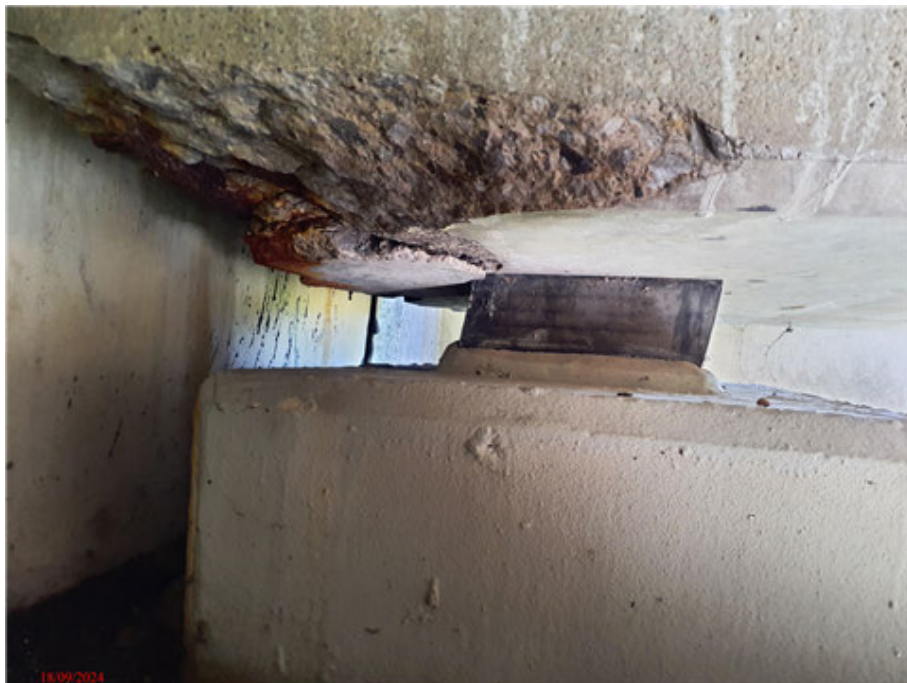
20240917_104559_1.jpg

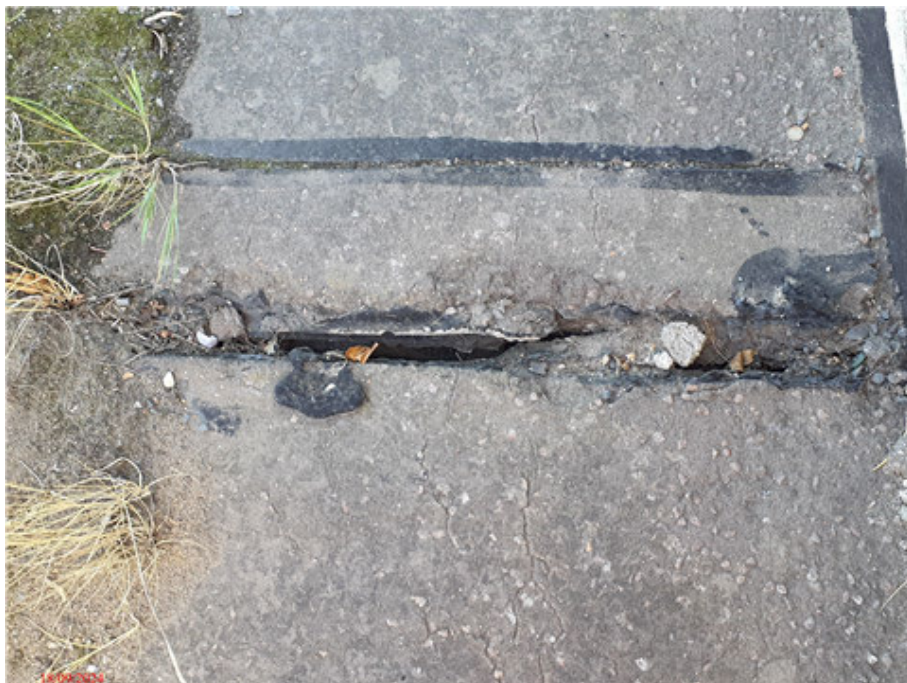
Comment	Remedial Works
Seepage showing down the south abutment at the east and west ends, possible due to cracks to the joints in the footway. This is not considered to warrant remedial works or further investigations at present.	[none]

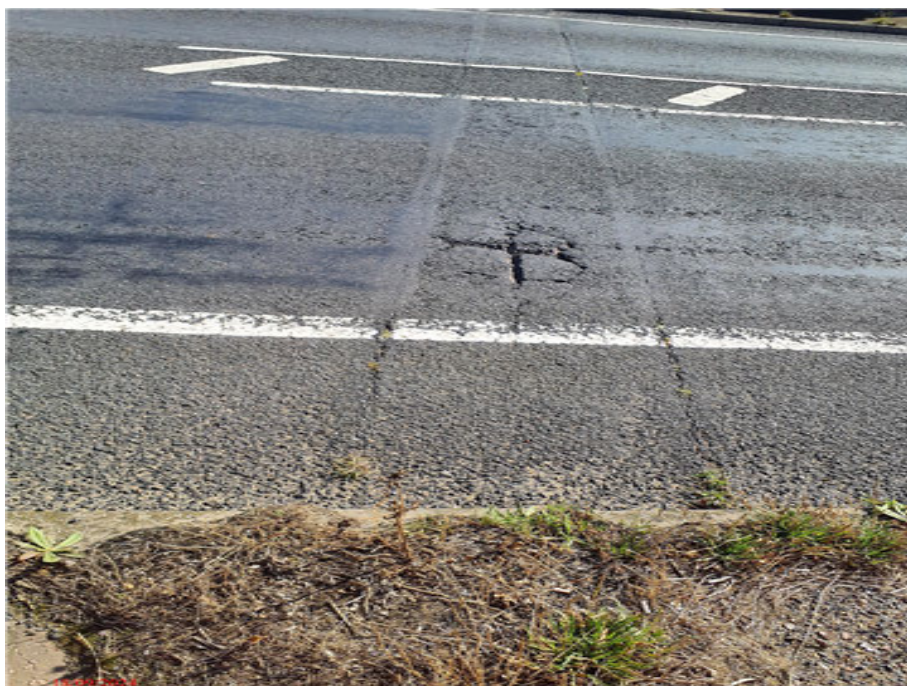
Clear vegetation from the footway joints and replace the debonded/missing joint sealant.

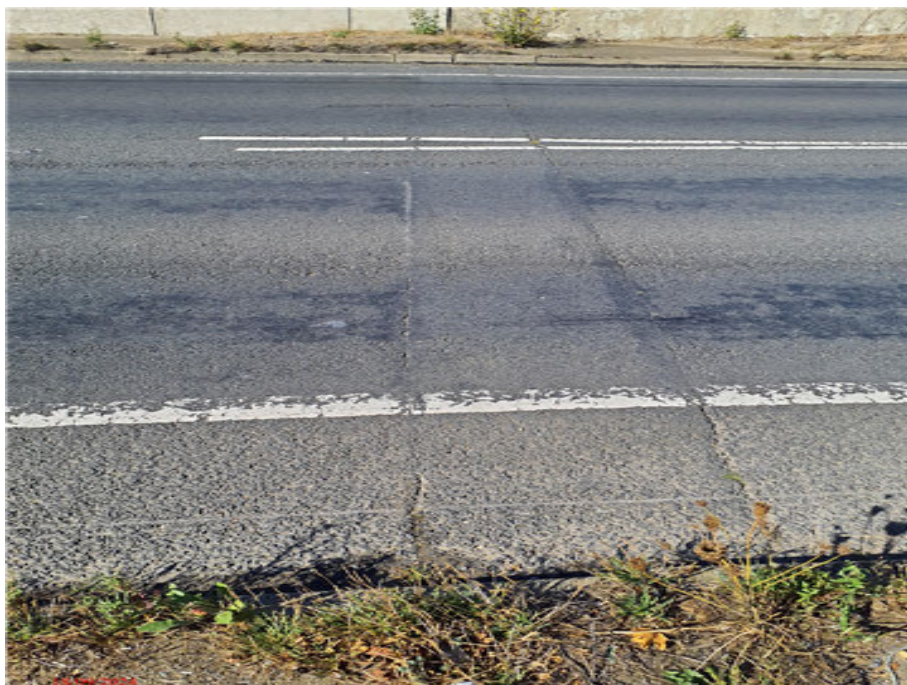
20240917_104158_1.jpg

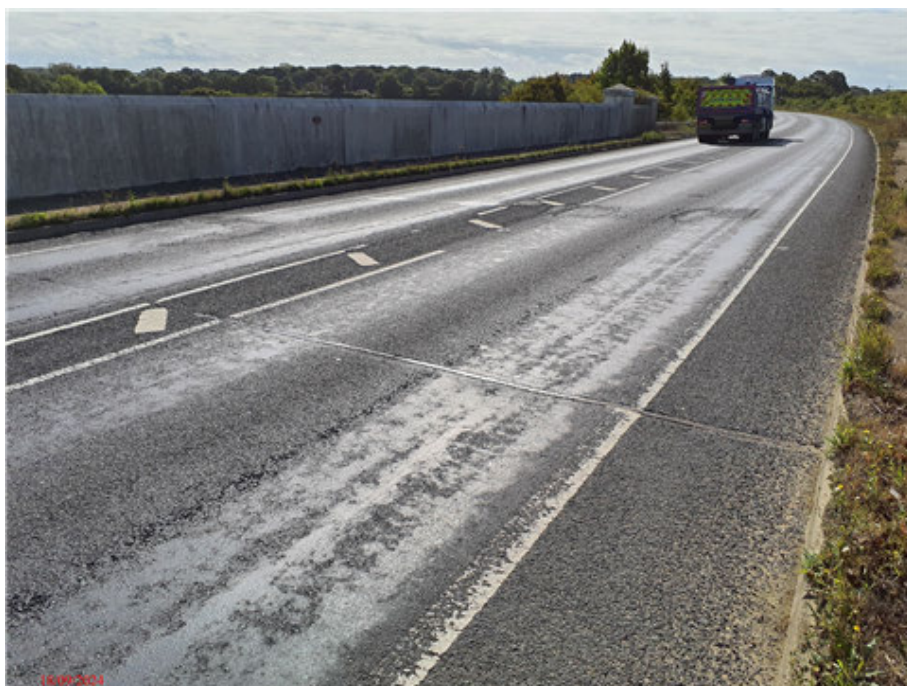
20240917_104321_1.jpg

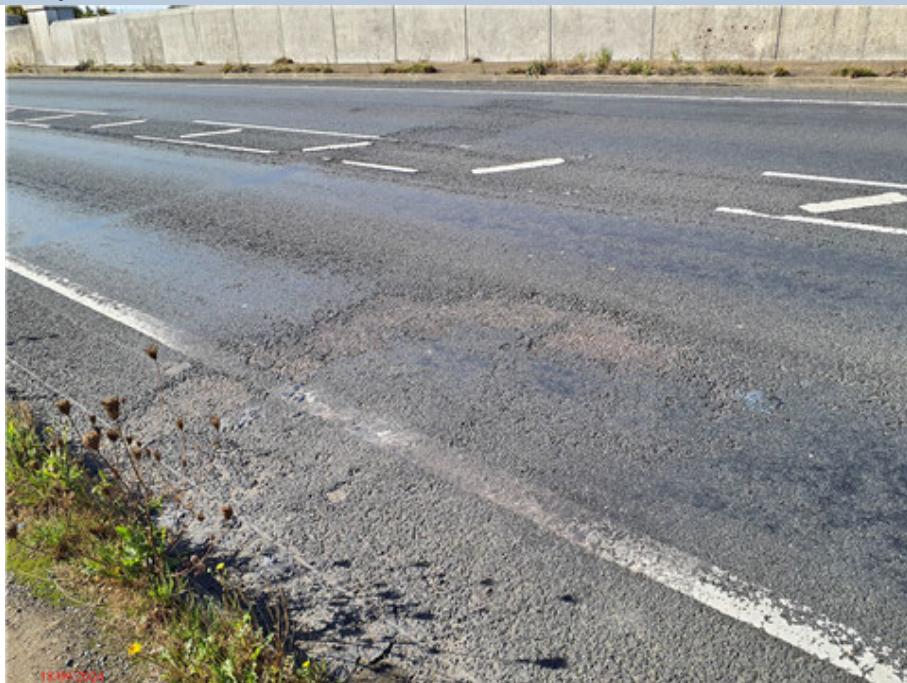
20240917_104139(0).jpg

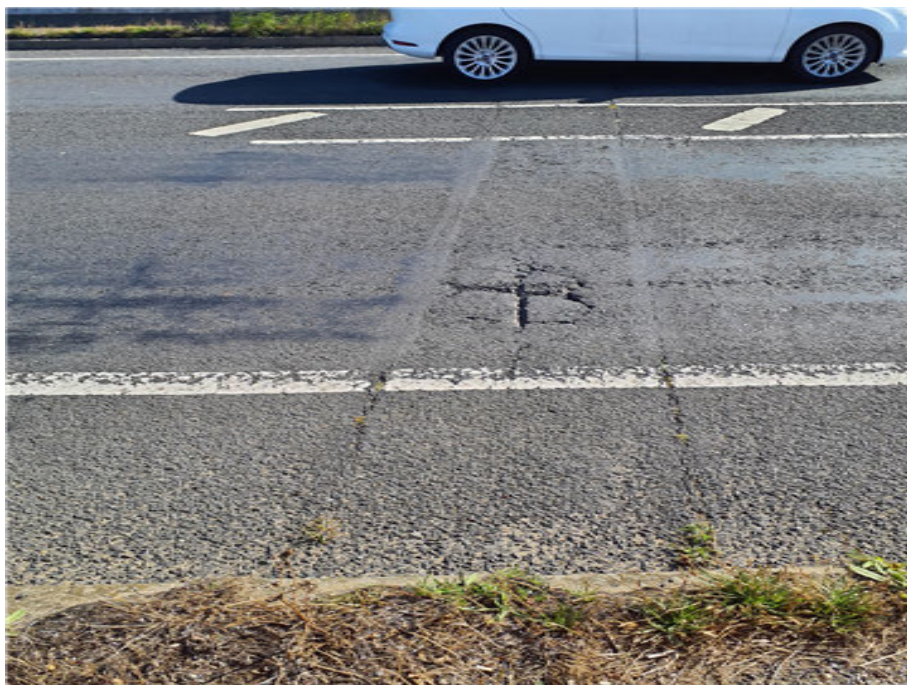
Eastern side of carriageway
 Cracking to surfacing over buried joint

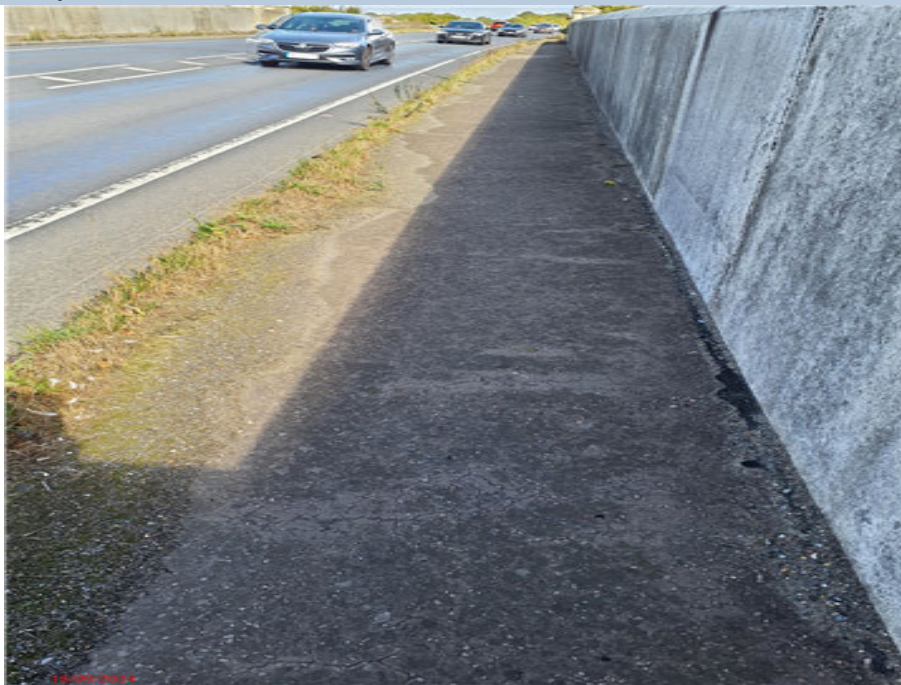
20240917_104040.jpg
 Vegetation growth to western kerb line

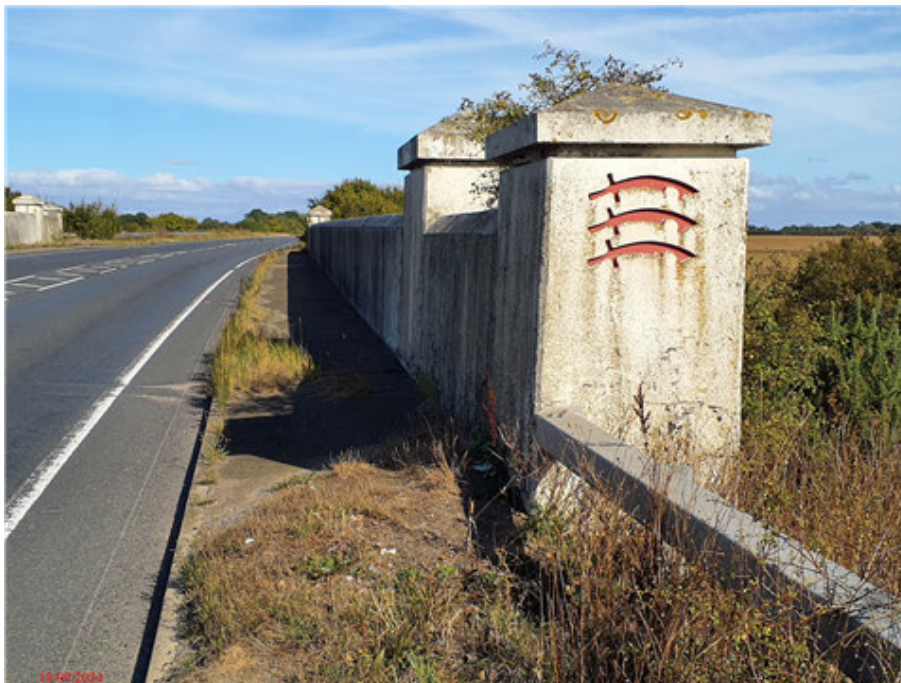
Comment	Remedial Works
Vegetation growing into cracks and kerb line to both footways at numerous locations over span.	Remove all vegetation from the footways and seal cracks as necessary.

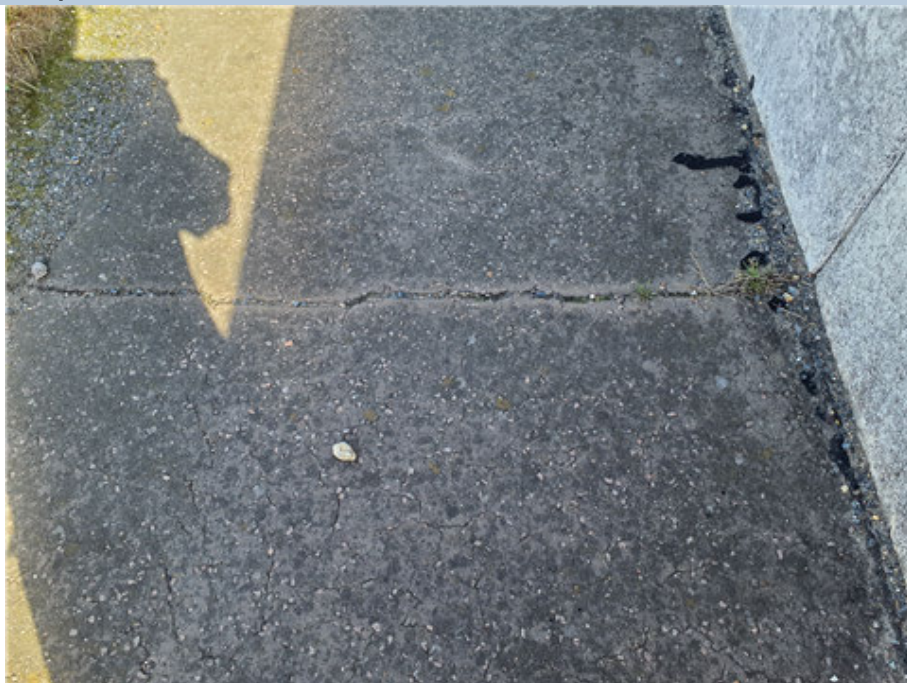
Easter footway
 Transverse crack and general crazing to footway.

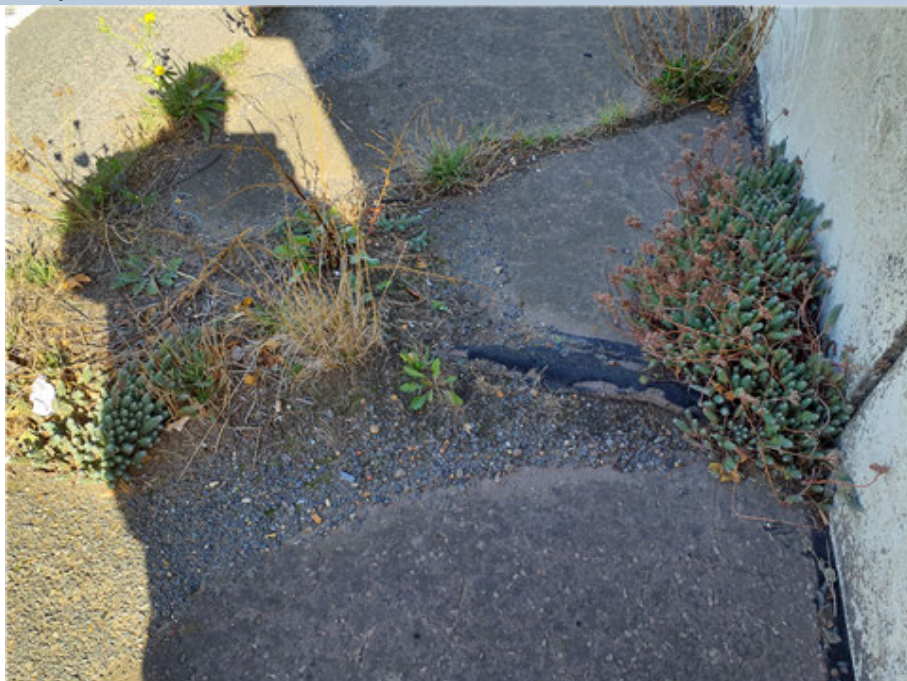
Eastern footway
 Transverse crack adjacent to deck joint with significant vegetation growth.

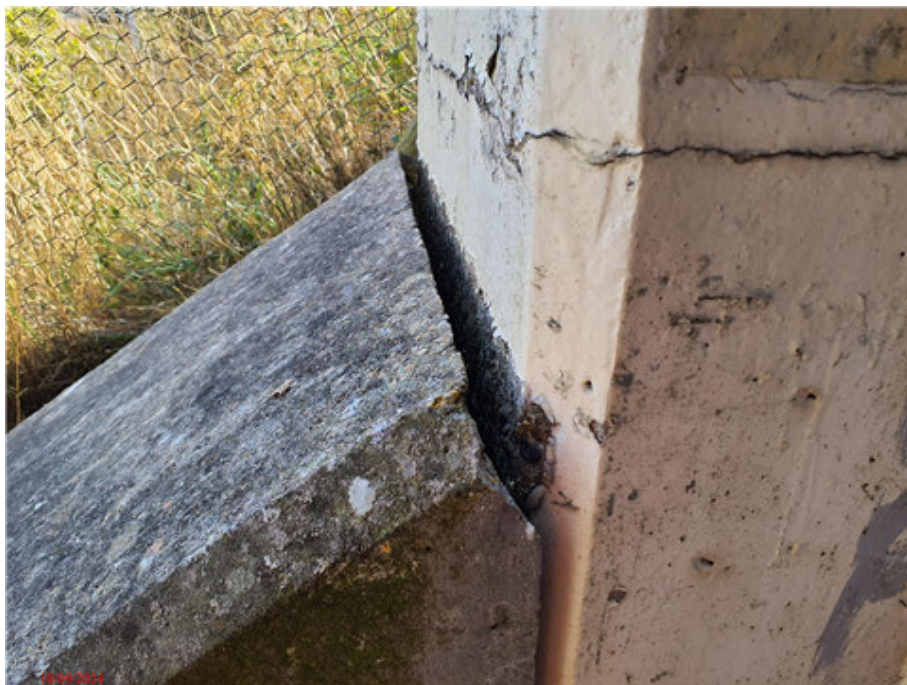
20240917_104759_1.jpg

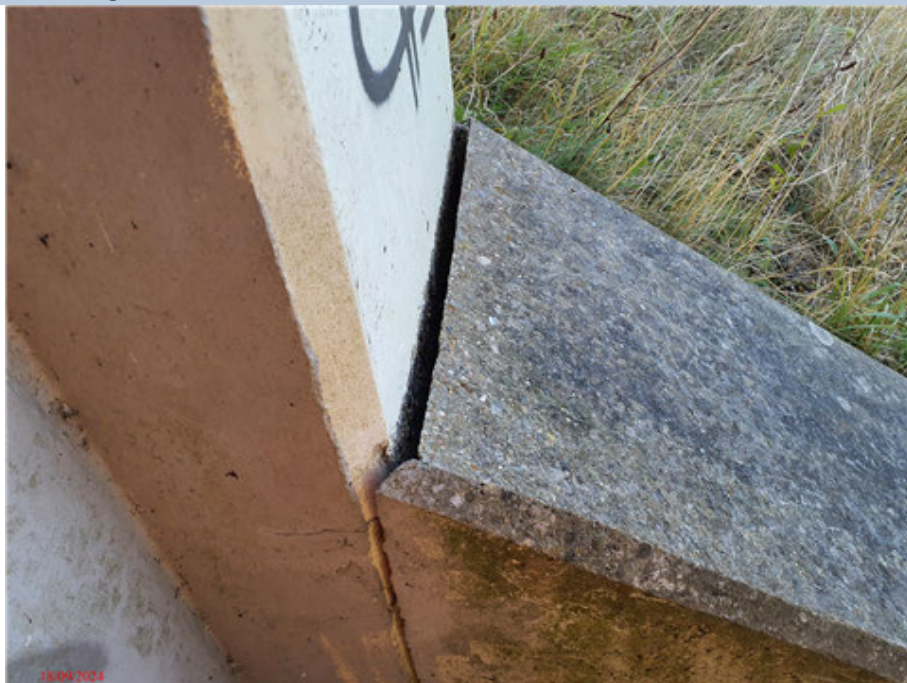
Other Bridge Elements

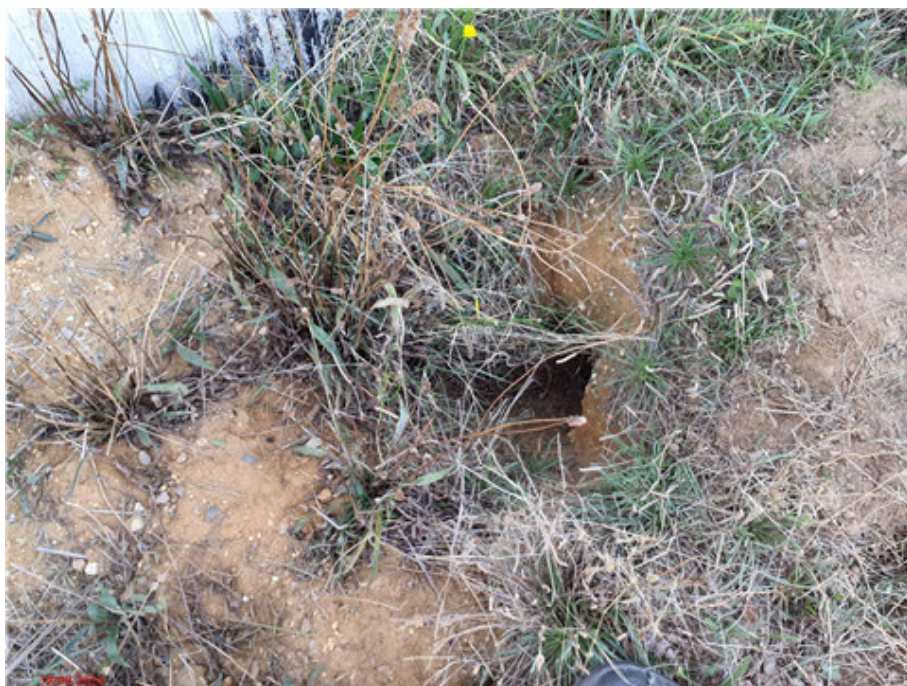
Comment	Remedial Works
Rotation of the east and west revetment buttresses have caused a gap of 20mm showing at the top.	Seal cracks to the revetment Buttresses.

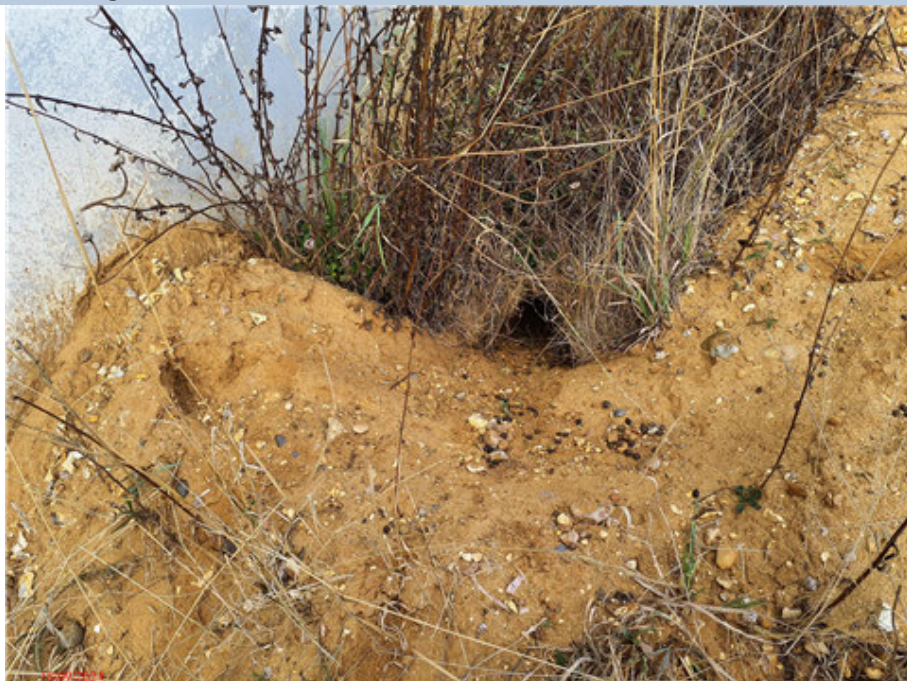
Other Bridge Elements

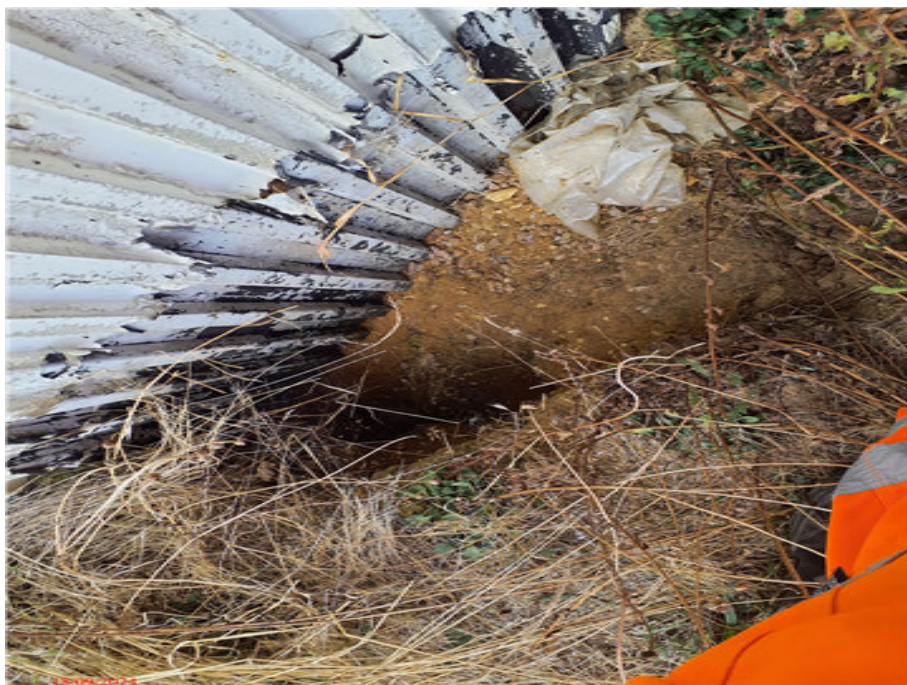
Comment	Remedial Works
Animal burrows to the S/E and S/W embankments. These are not considered to warrant remedial works at present.	[none]

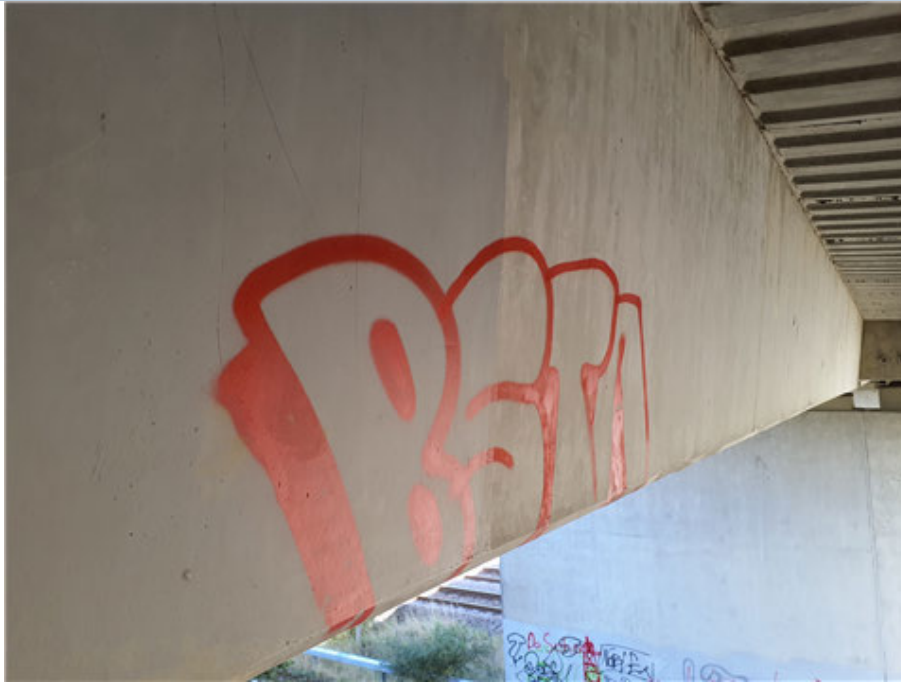
Main beam of span 1
 Area of non-offensive spray paint graffiti to main beam.

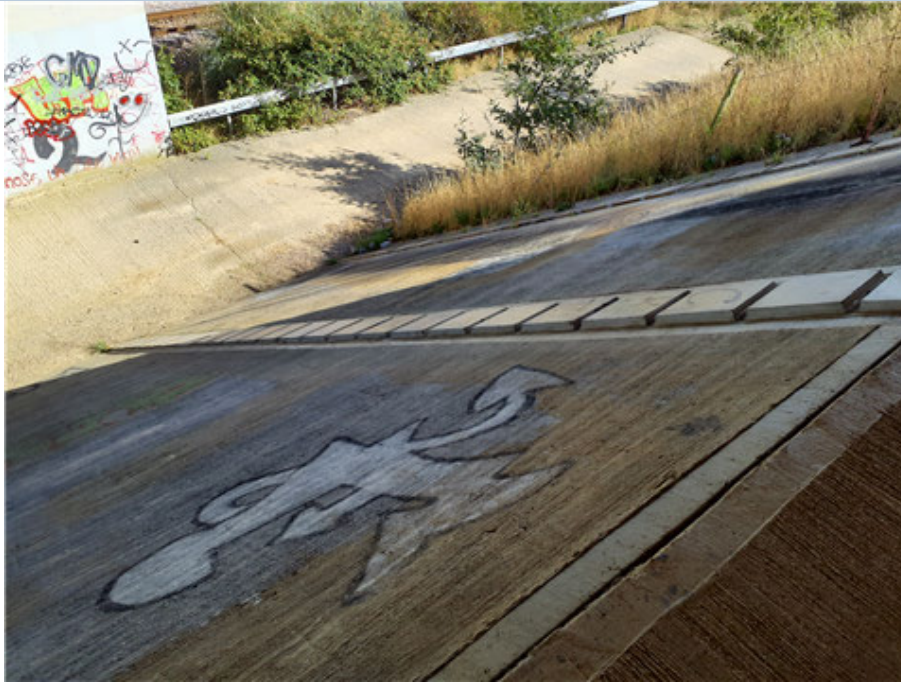
Revetment beneath span 1
 Non-offensive graffiti to the revetment

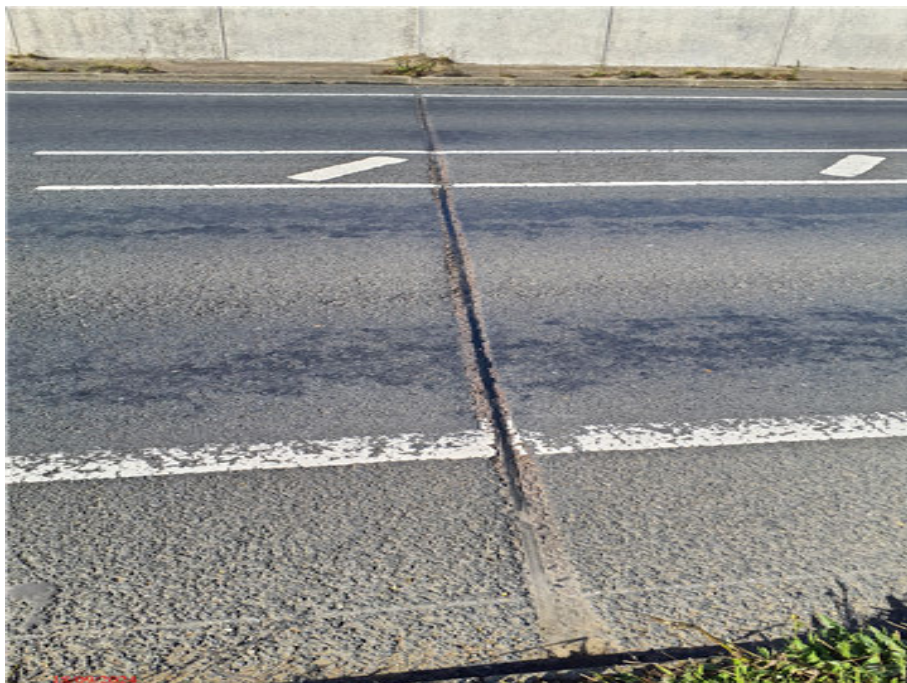
Seal joints as necessary.

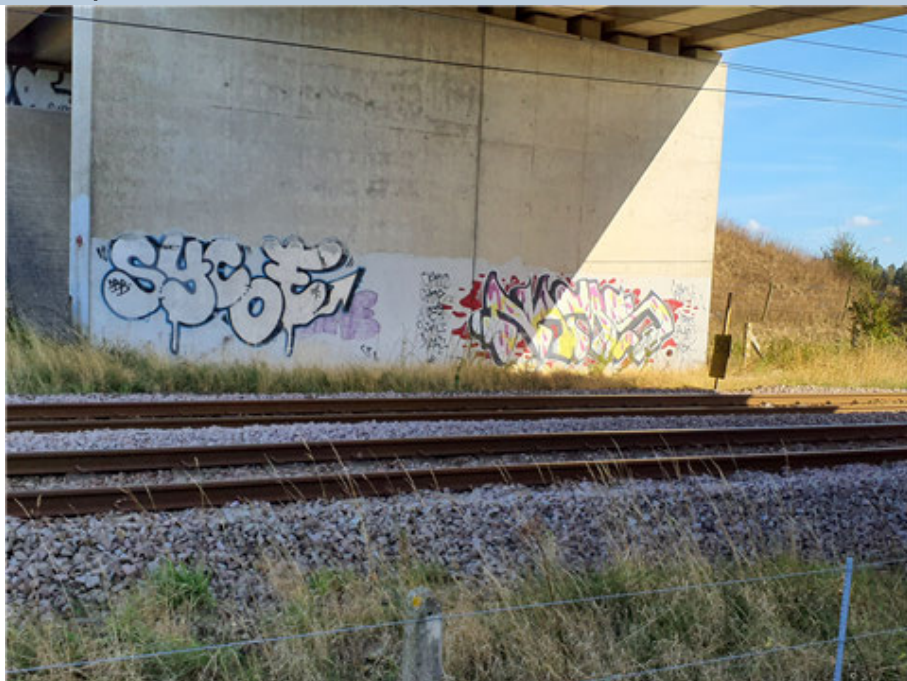
Substructure finish to pier 2
 Non-offensive graffiti within view of train line beneath span

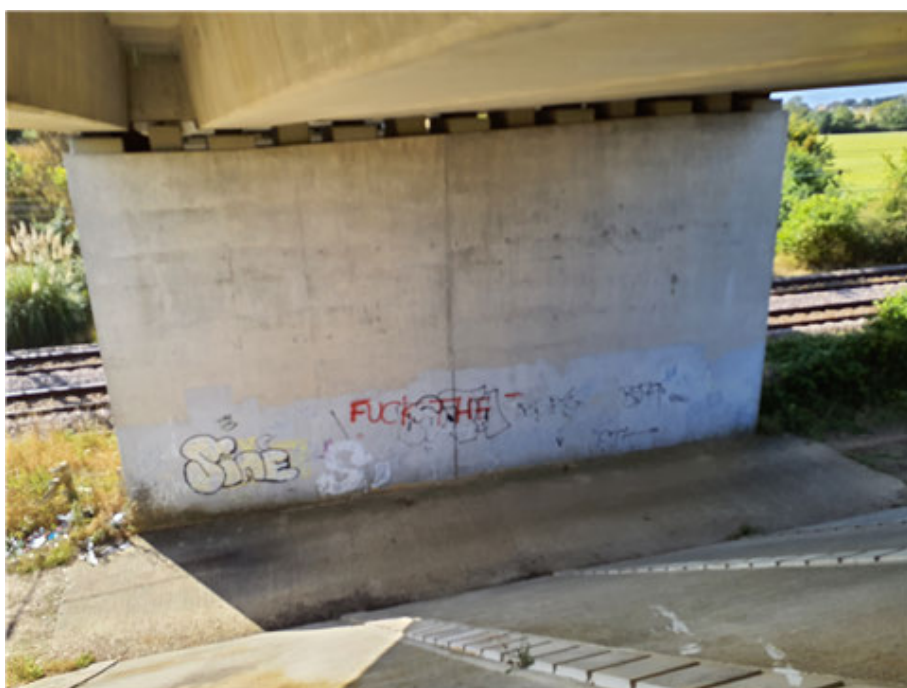
Substructure finish to pier 2
 Area of offensive graffiti out of view of general public.

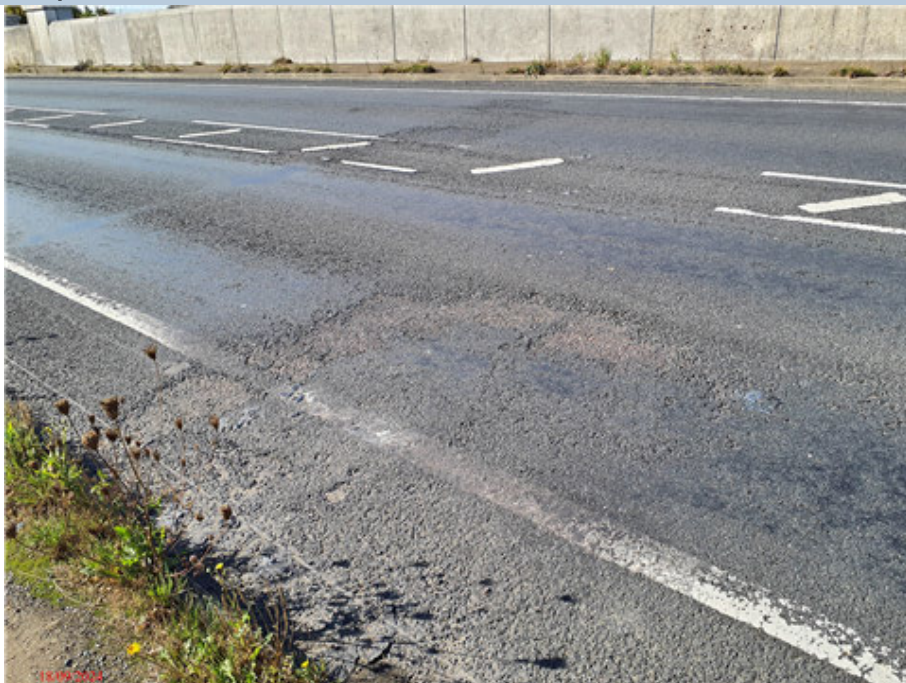
20240917_104139(0)_1.jpg
