General Inspection Report

Structure Name: GUTTERIDGE HALL BRIDGE

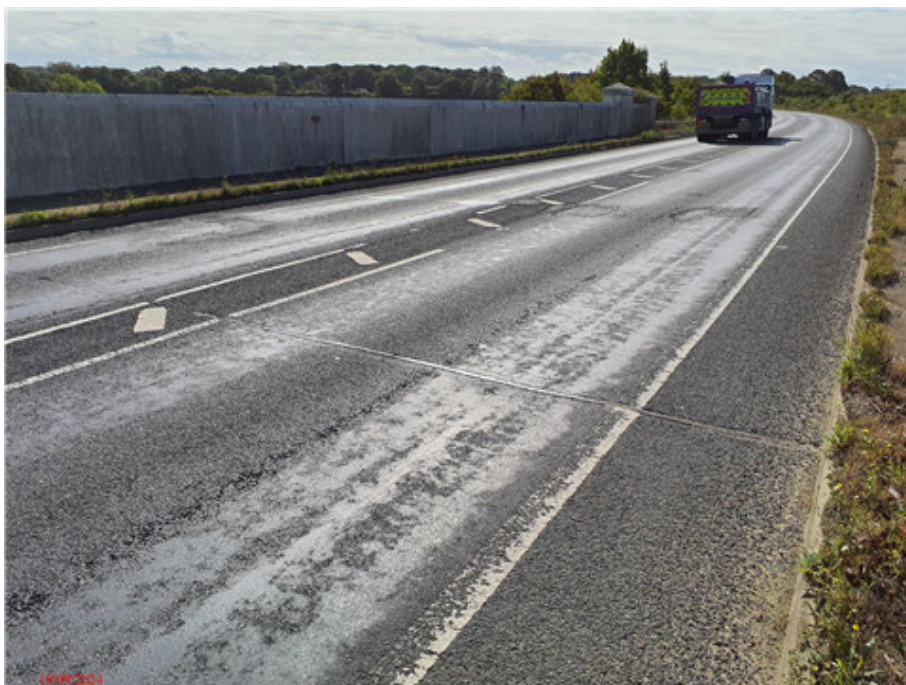
20240917_104321_2.jpg
