# **BASILDON TOWN CENTRE HIGHWAYS IMPROVEMENTS**

## **COMBINED STAGE 3 & 4 ROAD SAFETY AUDIT**

| Road Safety Audit Register Number: | 9286 |

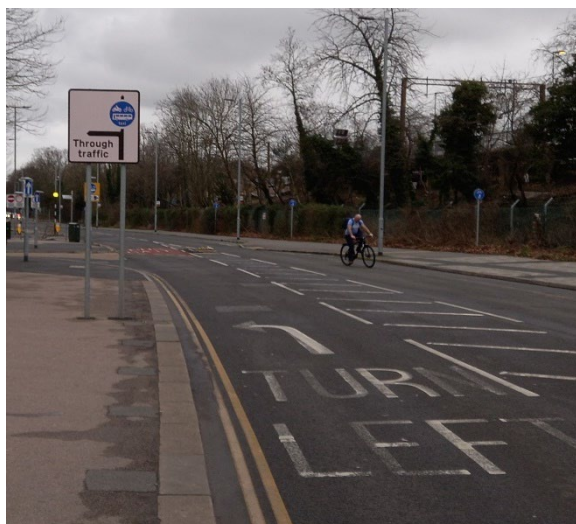
The eastbound approach to the bus-only link on Southernhay has an Advanced Directional Sign (ADS) and 'Turn Left' carriageway marking to inform eastbound road users of the route they should take. This issue is resolved.

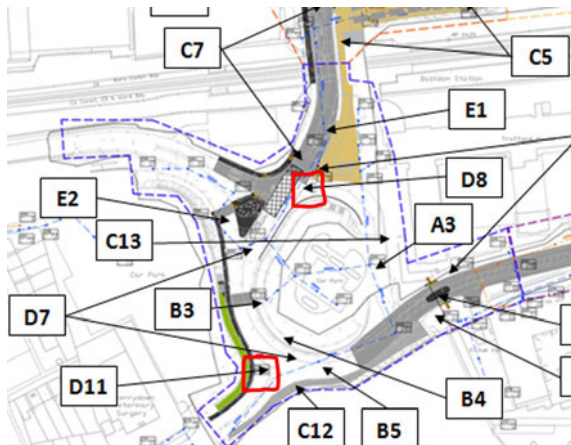
During the Stage 3-4 site visit it was noted that there are several 'Turn Left' regulatory signs and carriageway marking to direct road users. However, at the time of the site visit, the vehicle in the image below was observed turning right into Station Way. It is recommended that this issue is monitored and remedial / enforcement actions taken as appropriate.

It is recommended that measures are provided to prevent road users from turning right onto Station Way from Cherrydown Way.

Agree: The image shown above and the review at RSA3 are referring to a different location to the comments in RSA 1 location D11. The image above is at location D8. However, both locations have clear signage and physical measures implemented (kerb line changes) . Due to the width of the station way carriageway, it is impossible to stop cars (Taxis) from making right turns without a central median or barrier. The situation should be monitored and if instances persist, camera enforcement could be considered.

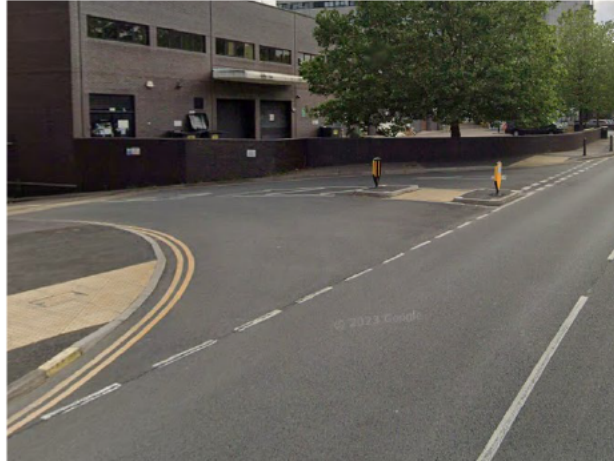
During the stage 3-4 site visit it was noted that traffic islands and dropped kerb crossing has been provided at this junction. This issue is resolved.
