Inspection_Batch_Photos

USRN13801554

Inspection Batch Inspection Route NameArea 16 Monthly Driven

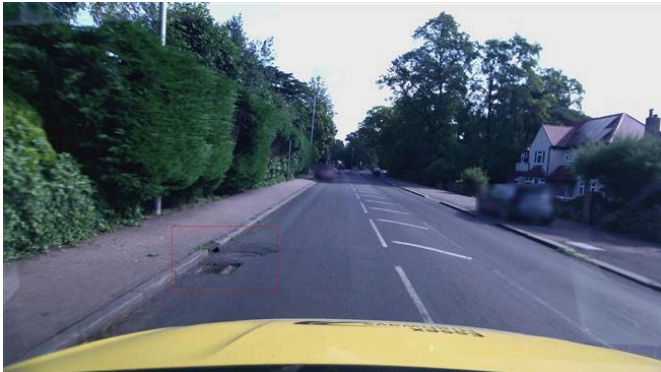
RANSA 6 = 2 x 3. C/w p/h to gully >0.6m x >0.2m x >60mm
Adj Forest Side
HW: Street S3
3813128
13801554

HW: carriageway defect

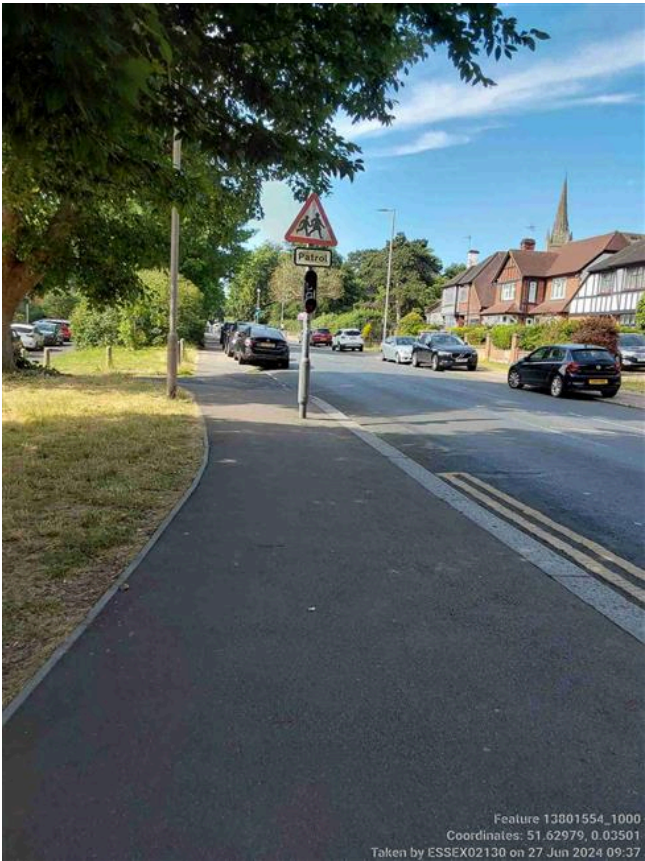
Feature 13801554_1000
Coordinates: 51.62979, 0.03501
Taken by ESSEX02130 on 27 Jun 2024 09:37

Observation Type Name	Grade Code	Notes
Carriageway Good	040	
surface state	DRY	Walked inspection 27.06.24 by tibe
Footway Good	050	
Footway Fair	040	
Footway Requires Improvement	010	
Carriageway Excellent	000	
Carriageway Fair	040	
cycleway condition	NA	
Footway Presence	3	
Footway Excellent	000	
Reduced inspection	ASS	
Re-inspection required	NO	
Carriageway Requires Improvemt	020

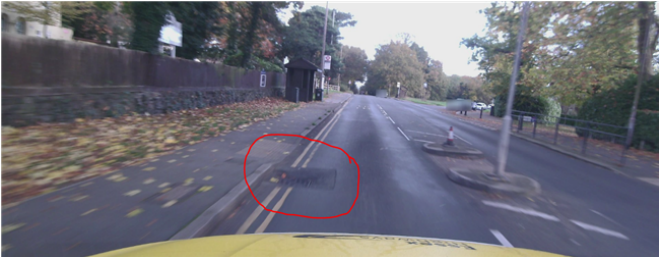
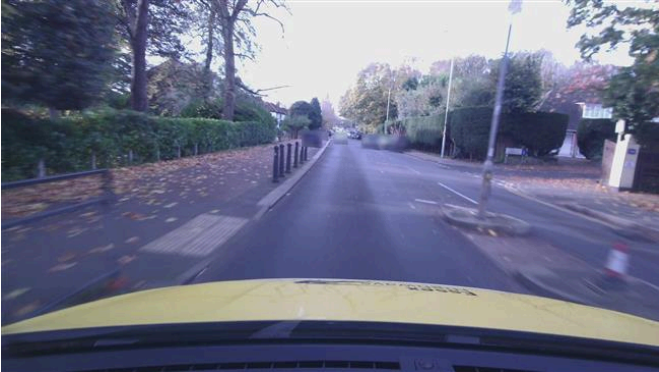
RA 12=3x4. Misaligned/rocking RS gully x 80mm
J/w Ardmore Lane by school
HW: Street S2 PR1/2
3853124
13801554
