Enquiry_Trace

Enquiry Number 2770719
Enquiry Classification Description fault reports
Enquiry Subject Name footway defects
Enquiry Subject Type Of Service Description Maintenance
Description Title=More than 2cm,resident fell on footpath
Address **MEMBER ENQUIRIES** between the BP garage and the bathstore
Central Site Address NETHER MAYNE
Central Site Notes
 SMO3 - Basildon // South Area // added as NSG update 7_7_2004; TRB // for further history see USRN 2002563, 2002063, 2000901
Central Site Area Description Basildon
Central Site Ward Name Basildon Westley Heights
Enquiry Customer Links

Defectdefect Number 3724126
Defectlogged Date 11 Jul 2023 11:45
Defect Defect Type Name HW: footway defect
Defect Description

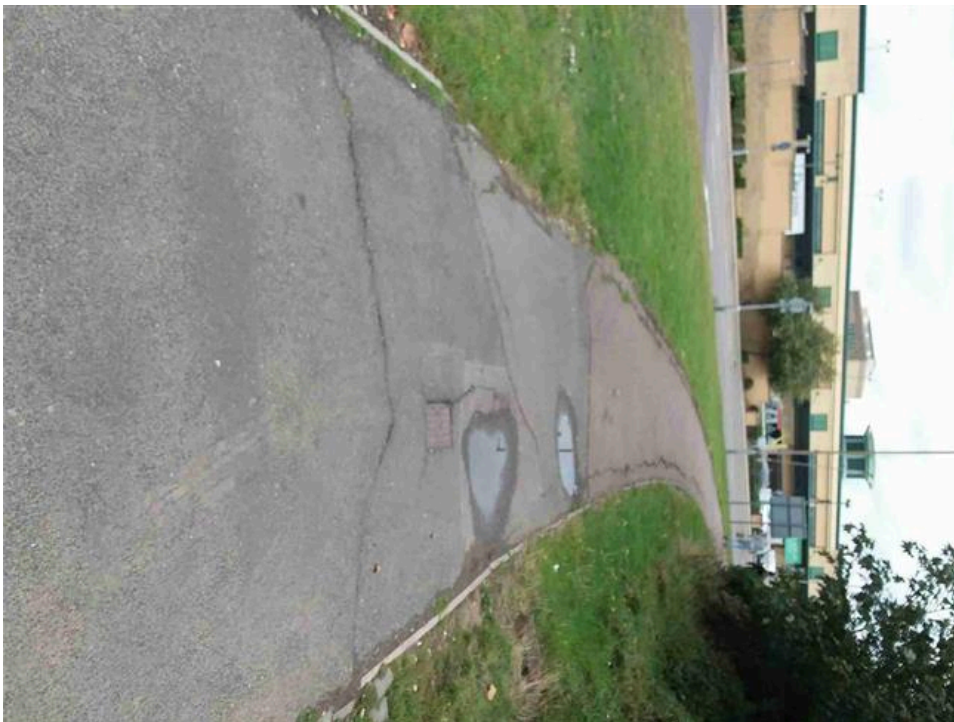
Ra6=2x3 fw cracked, sunken, uneven and undulating 5.0mx6.0mx 150mm at its deepest point, upstand against ESW SV cover is 40mm

Defect Location Rear L/c 12, adj electric vehicle chargers in BP garage
Supersededdefect Number 3495730
Supersededlogged Date 17 Aug 2020 10:38
Superseded Defect Type Name HW: footway defect
Superseded Description RA 6 = 2 x 3 Depression in tarmac Footway Patch 5.0 x 2.5 x 150mm at its deepest point
Superseded Location Rear L/c 12
Superseded Supersedes Defect Number 3416275
