Enquiry_Trace

Enquiry Number 2855162
Enquiry Classification Description fault reports
Enquiry Subject Name footway defects
Enquiry Subject Type Of Service Description Maintenance
Description PERSONAL INJURY - Trip/fall on uneven pavement sustaining injury

INSURANCE CLAIM - Near to "Basildon Kebab Van" and BP garage on the roundabout junctioning Laindon Link

Central Site Address NETHER MAYNE

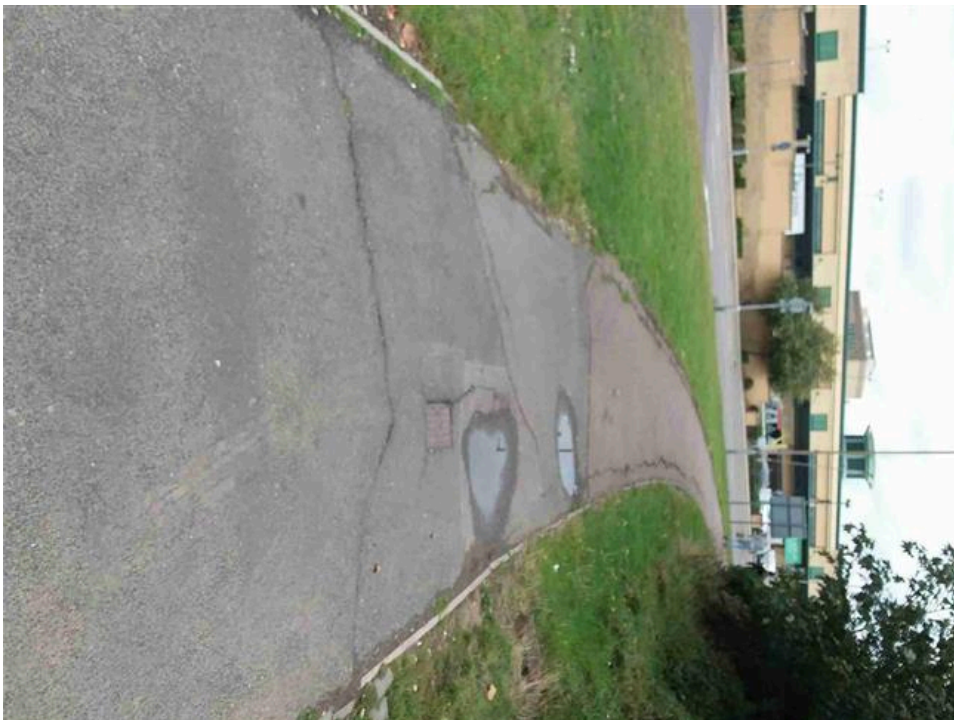
Document Date 10 Sep 2019 12:24

Ra6=2x3 fw cracked, sunken, uneven and undulating 5.0mx6.0mx 150mm at its deepest point, upstand against ESW SV cover is 40mm

Defect Location Rear L/c 12, adj electric vehicle chargers in BP garage

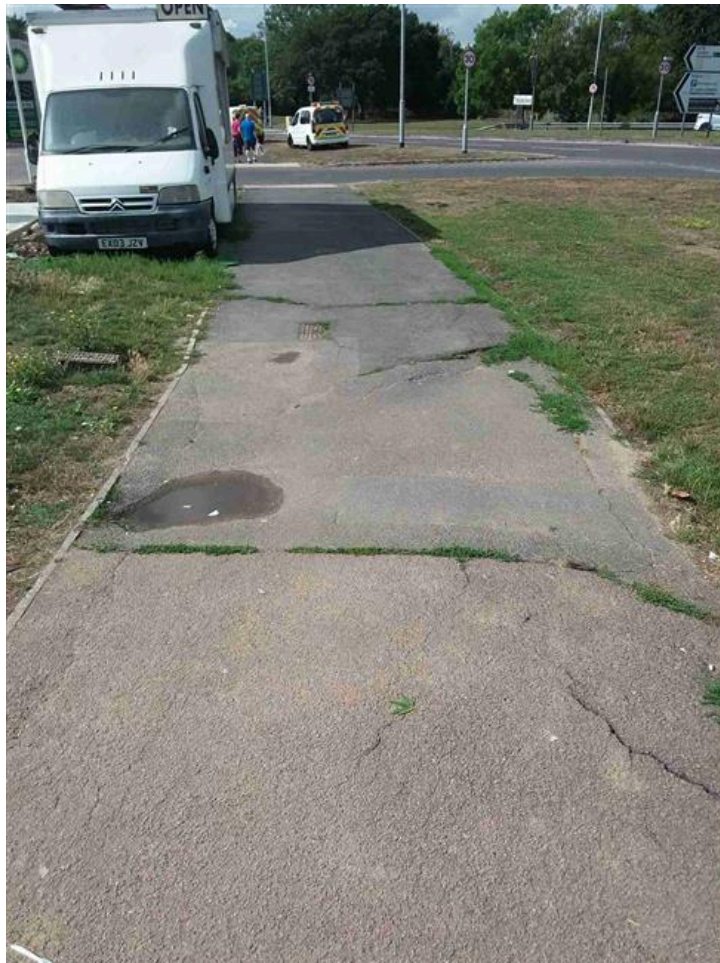
Superseded Description RA 6 = 2 x 3 Depression in tarmac Footway Patch 5.0 x 2.5 x 150mm at its deepest point

Superseded Location Rear L/c 12
